# Combined Inspection

**SURE Building Inspections**

### Combined Structural and Timber Pest Inspection

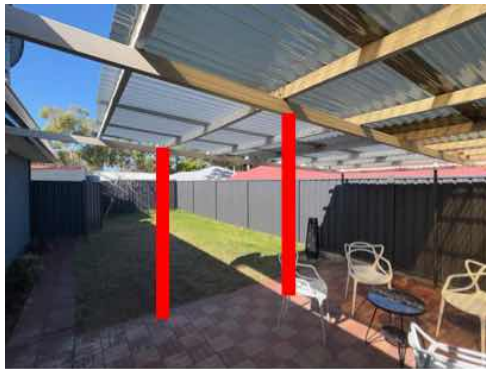
| Section | Location | Name | Comment |
|---|---|---|---|
| PERGOLA/S | Pergola Findings Rear | Frame Observations | 3. Structural Minor: The frame is poorly supported due to inadequate installation of posts, bearers and joists. Recommendation: Engage a carpenter for repairs. |

1. **Structural Minor:** The frame is poorly supported due to inadequate installation of posts, bearers and joists. Recommendation: Engage a carpenter for repairs.

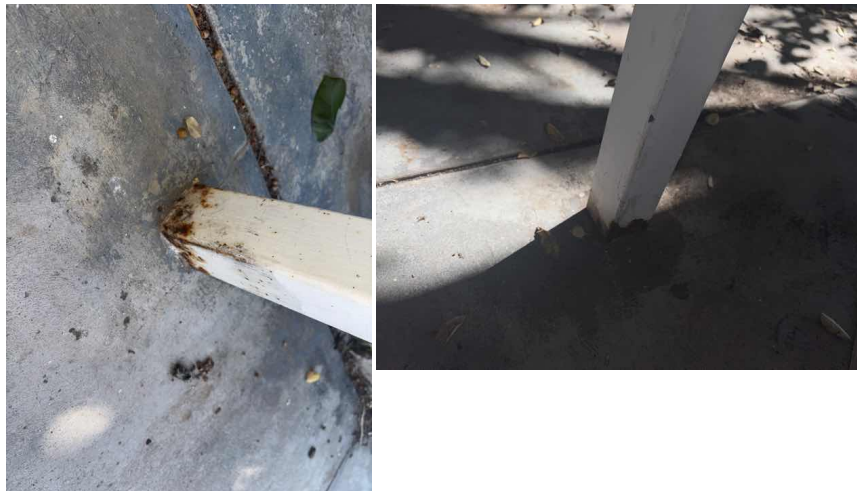
| Section | Location | Name | Comment |
|---|---|---|---|
| GARAGING | Attached Carport | Column or Post Observations | 4. Structural Minor: Post rust observed. If left unattended, overtime the post will become unstable. Recommendation: Engage a carpenter for repair. |

2. **Structural Minor:** Post rust observed. If left unattended, overtime the post will become unstable.  
Recommendation: Engage a carpenter for repair.

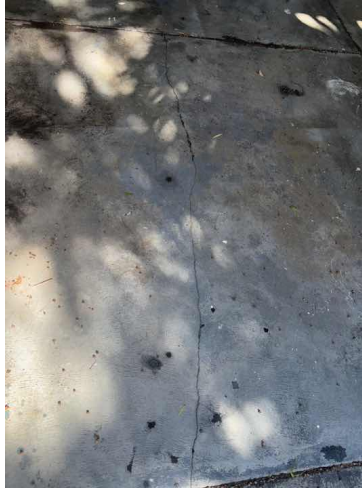
| Section | Location | Name | Comment |
|---|---|---|---|
| GARAGING | Attached Carport | Floor Observations | 5. Structural Minor: There appears to have been some settlement in the building which has caused some cracking to the slab. These crack are categorised as 0 to 2. This can also cause some doors to bind or be out of square. In the inspectors opinion these cracks are due to settlement, usually due to ground movement and subsequent movement to building materials can be expected. All cracks should be monitored and if cracks increase in size, further investigation should be carried out by a structural engineer. Engage a concreter to repair.<br>For clarification on the category of cracks with a damage category of 0 to 2, please refer to Cracking of Building Elements in Section 2G of the Terms and Conditions of this report. |

3. **Structural Minor:** There appears to have been some settlement in the building which has caused some cracking to the slab. These crack are categorised as 0 to 2. This can also cause some doors to bind or be out of square. In the inspectors opinion these cracks are due to settlement, usually due to ground movement and subsequent movement to building materials can be expected. All cracks should be monitored and if cracks increase in size, further investigation should be carried out by a structural engineer. Engage a concreter to repair.

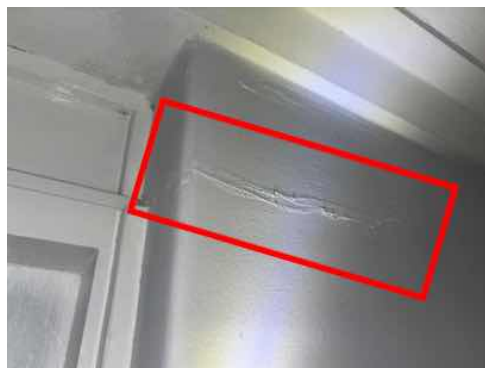
| Section | Location | Name | Comment |
|---|---|---|---|
| INTERIORS | Entry | Walls Observations | 6. Structural Minor: There appears to have been some settlement in the building which has caused some cracking to the walls. These crack/s are categorised as 0 to 2. This can also cause some doors to bind or be out of square. In the inspectors opinion these cracks are due to settlement, usually due to ground movement and subsequent movement to building materials can be expected. All cracks should be monitored and if cracks increase in size, further investigation should be carried out by a structural engineer.<br>Recommendation: Engage a painter to patch and paint. For clarification on the category of cracks with a damage category of 0 to 2, please refer to Cracking of Building Elements in Section 2G of the Terms and Conditions of this report. |

4. **Structural Minor:** There appears to have been some settlement in the building which has caused some cracking to the walls. These crack/s are categorised as 0 to 2. This can also cause some doors to bind or be out of square. In the inspectors opinion these cracks are due to settlement, usually due to ground movement and subsequent movement to building materials can be expected. All cracks should be monitored and if cracks increase in size, further investigation should be carried out by a structural engineer. Recommendation: Engage a painter to patch and paint.

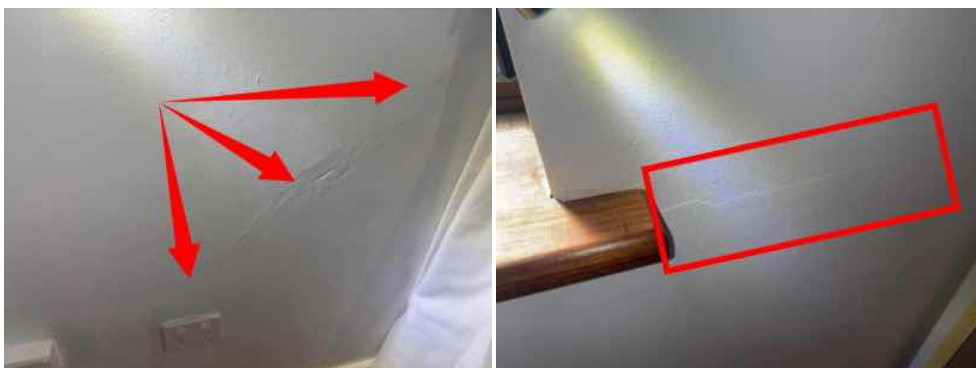
| Section | Location | Name | Comment |
|---|---|---|---|
| INTERIORS | Bedroom 1 | Walls Observations | 7. Structural Minor: There appears to have been some settlement in the building which has caused some cracking to the walls. These crack/s are categorised as 0 to 2. This can also cause some doors to bind or be out of square. In the inspectors opinion these cracks are due to settlement, usually due to ground movement and subsequent movement to building materials can be expected. All cracks should be monitored and if cracks increase in size, further investigation should be carried out by a structural engineer.<br>Recommendation: Engage a painter to patch and paint. For clarification on the category of cracks with a damage category of 0 to 2, please refer to Cracking of Building Elements in Section 2G of the Terms and Conditions of this report. |

5. **Structural Minor:** There appears to have been some settlement in the building which has caused some cracking to the walls. These crack/s are categorised as 0 to 2. This can also cause some doors to bind or be out of square. In the inspectors opinion these cracks are due to settlement, usually due to ground movement and subsequent movement to building materials can be expected. All cracks should be monitored and if cracks increase in size, further investigation should be carried out by a structural engineer. Recommendation: Engage a painter to patch and paint.

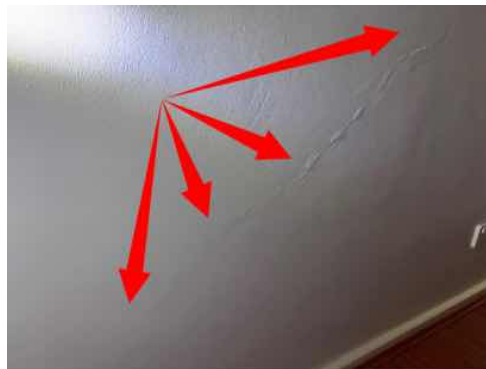
| INTERIORS | Bedroom 2 | Walls Observations | <p>8. Structural Minor: There appears to have been some settlement in the building which has caused some cracking to the walls. These crack/s are categorised as 0 to 2. This can also cause some doors to bind or be out of square. In the inspectors opinion these cracks are due to settlement, usually due to ground movement and subsequent movement to building materials can be expected. All cracks should be monitored and if cracks increase in size, further investigation should be carried out by a structural engineer.</p> <p>Recommendation: Engage a painter to patch and paint. For clarification on the category of cracks with a damage category of 0 to 2, please refer to Cracking of Building Elements in Section 2G of the Terms and Conditions of this report.</p> |

6. **Structural Minor:** There appears to have been some settlement in the building which has caused some cracking to the walls. These crack/s are categorised as 0 to 2. This can also cause some doors to bind or be out of square. In the inspectors opinion these cracks are due to settlement, usually due to ground movement and subsequent movement to building materials can be expected. All cracks should be monitored and if cracks increase in size, further investigation should be carried out by a structural engineer. Recommendation: Engage a painter to patch and paint.

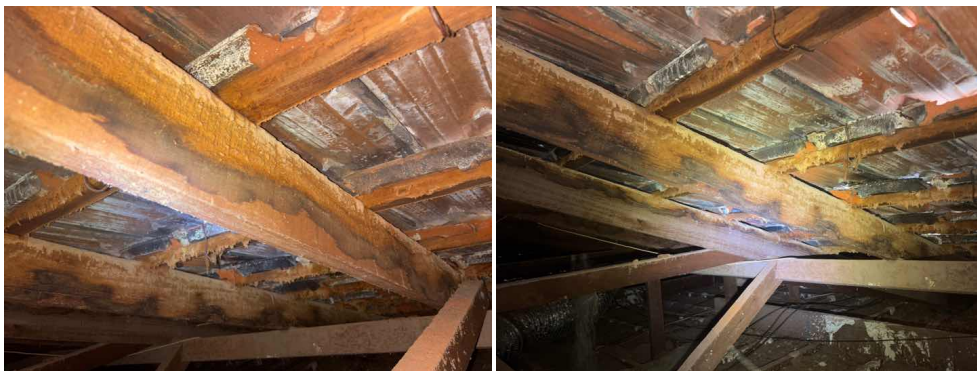
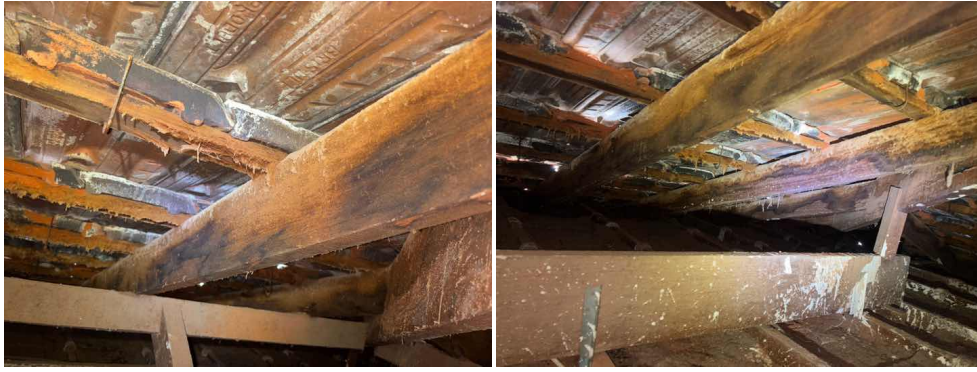
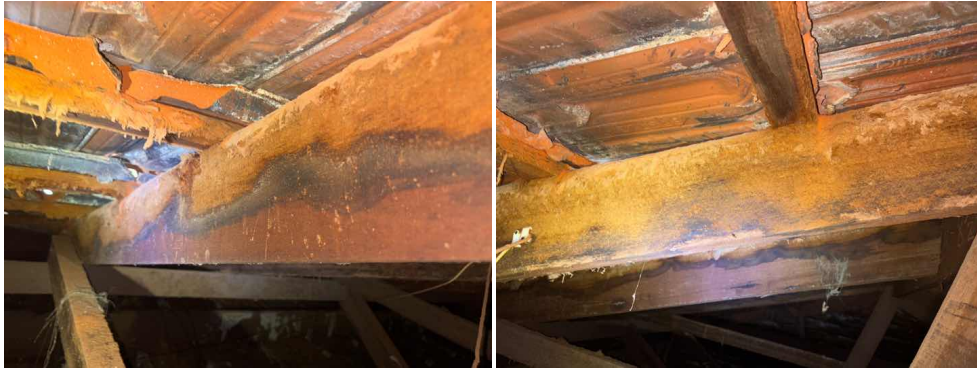
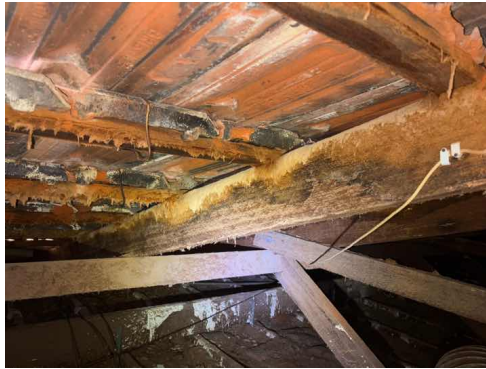
| Section | Location | Name | Comment |
|---|---|---|---|
| ROOF VOID | Roof Void Findings | Roof Framing Observations | <p>1. Structural Major: Chemical delignification observed to Structural Elements in the roof frame (rafters). It is expected that further deterioration will occur over time to such a point that reduced strength of the affected timbers is highly likely. Recommendation: Engage a structural engineer for confirmation of major defect.</p> <p>Engage a carpenter specialising in chemical Delignification for repair.</p> <p>The battens of the roof frame (North facing) are affected - non structural. The Delignification has spread into rafters on this elevation of the house to a significant degree.</p> |

7. **Structural Major:** Chemical delignification observed to Structural Elements in the roof frame (rafters). It is expected that further deterioration will occur over time to such a point that reduced strength of the affected timbers is highly likely. Recommendation: Engage a structural engineer for confirmation of major defect.

The battens of the roof frame (North facing) are affected - non structural. The Delignification has spread into rafters on this elevation of the house to a significant degree.

Engage a carpenter specialising in chemical Delignification for repair.

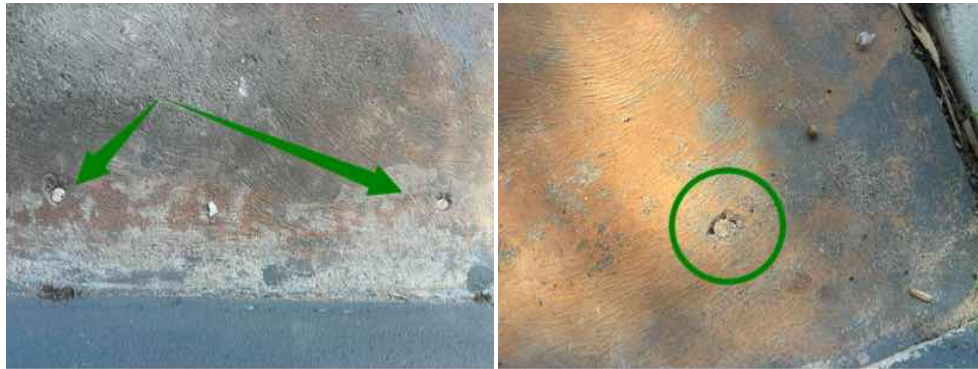
Yes, Drill Holes (Chemical Treatment) were located at the property.

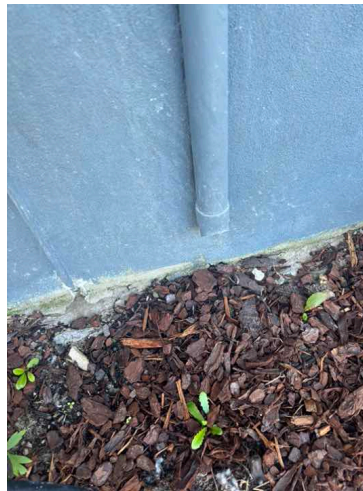
No. Airconditioning overflow should be diverted away from the building perimeter or into a drain.
