# Commercial Combined

**SURE Building Inspections**

### Commercial Combined Structural and Timber Pest Inspection

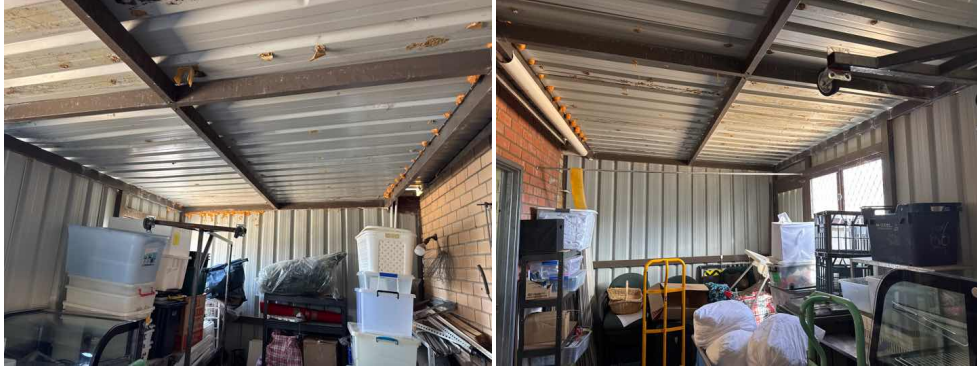
On visual inspection, the structural condition of the pergola is serviceable for the age of the building.

Roof leaks noted.

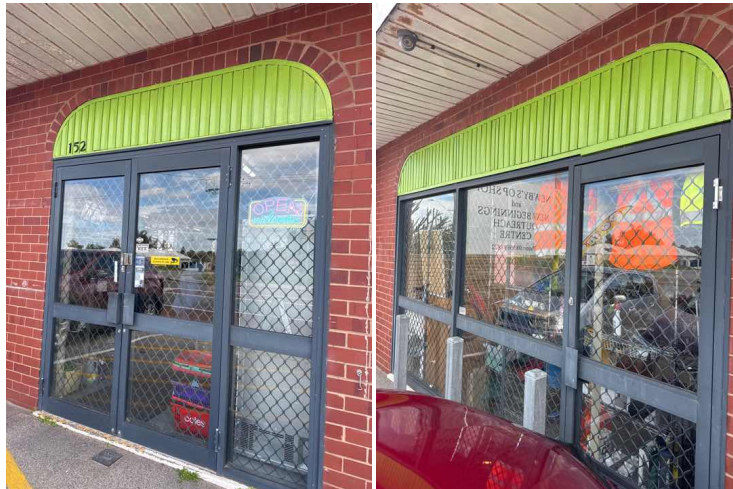
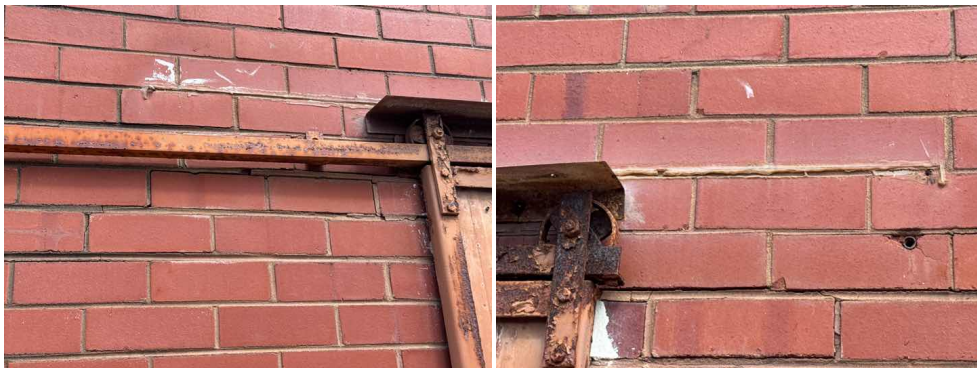
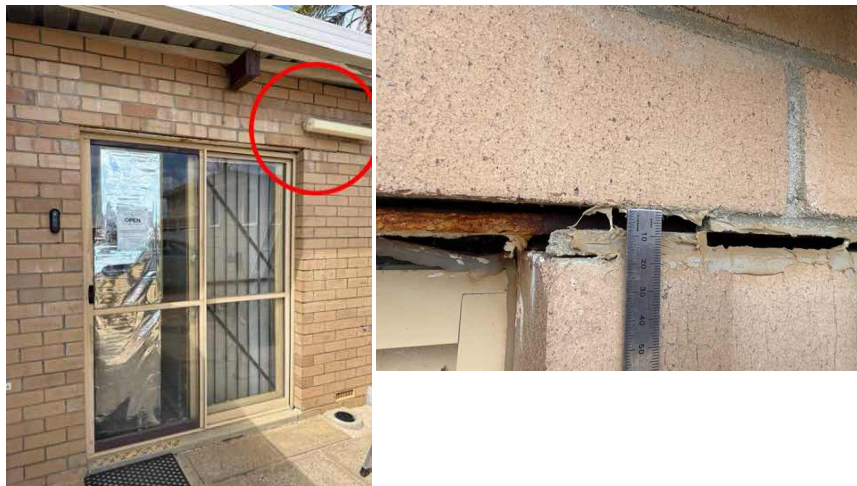
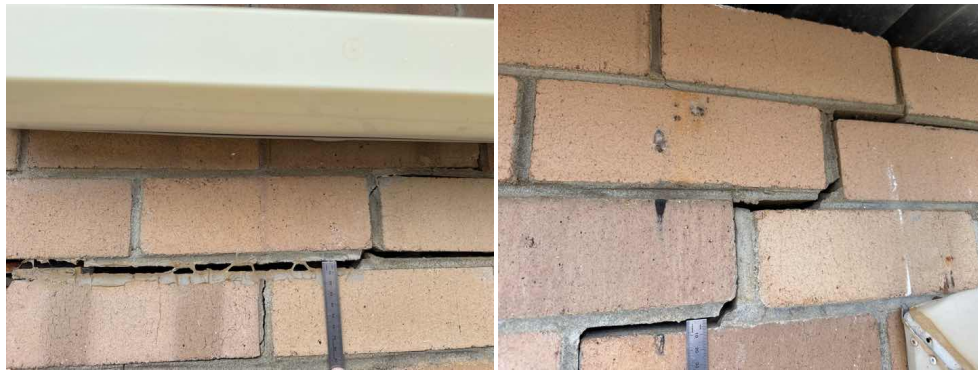
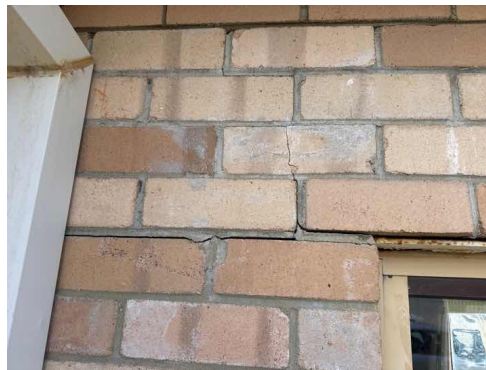
### External Door Lintel Observations

#1. **Structural Major:** Lintel rust observed with cracking above door/s. These crack/s are categorised as 3 to 4. Recommendation: Engage a bricklayer to replace affected lintel/s and repair brickwork.

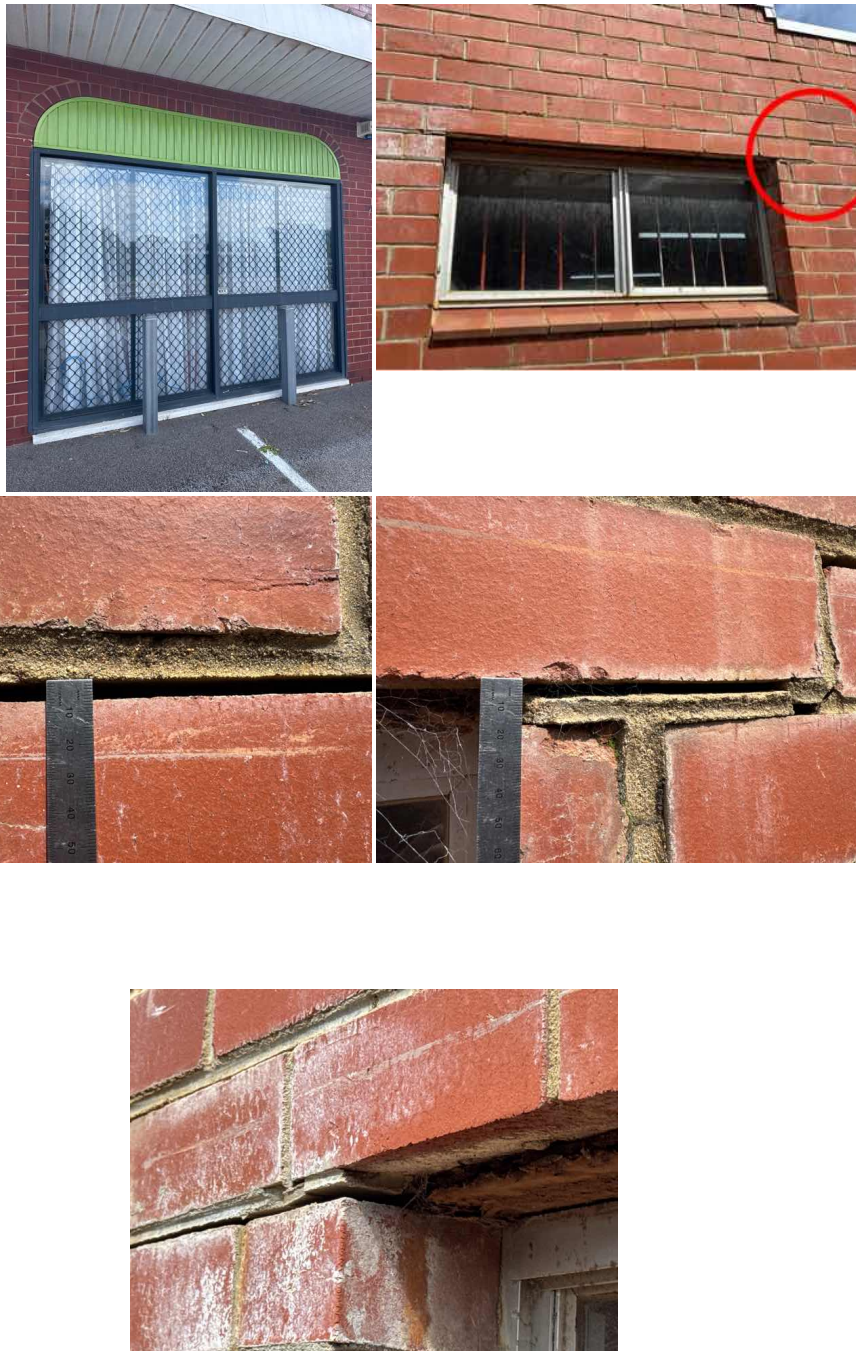
### External Window Lintel Observations

#2. **Structural Major:** Lintel rust observed with cracking above window/s. These crack/s are categorised as 3 to 4. Recommendation: Engage a bricklayer to replace affected lintel/s and repair brickwork.

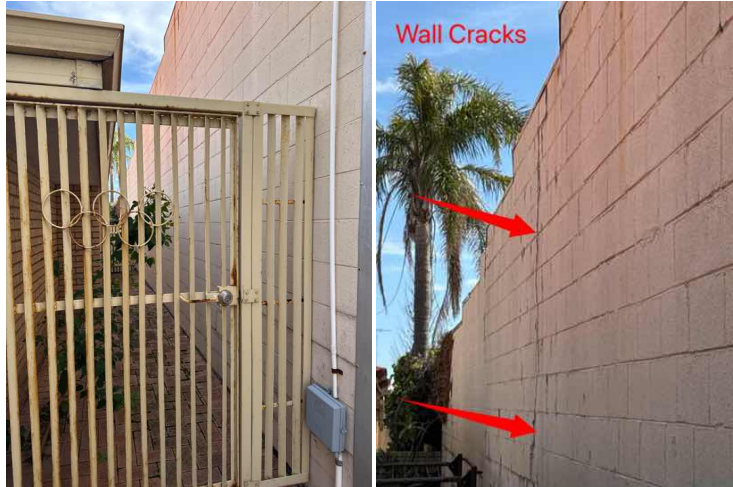
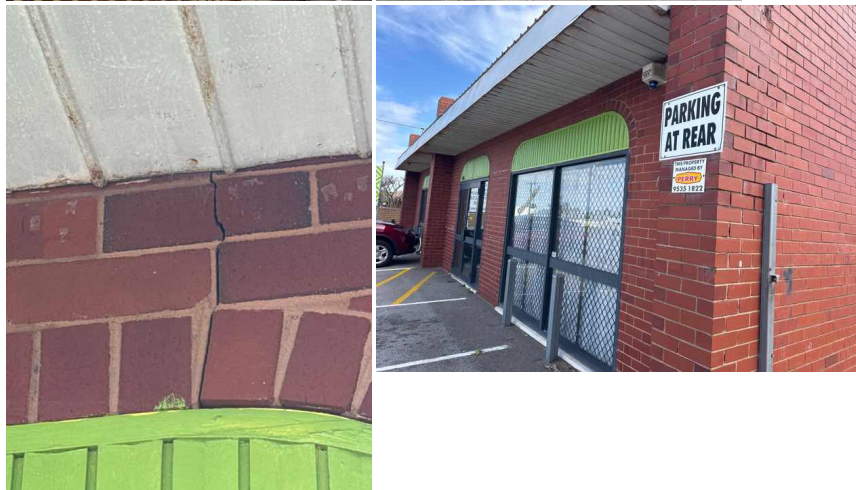
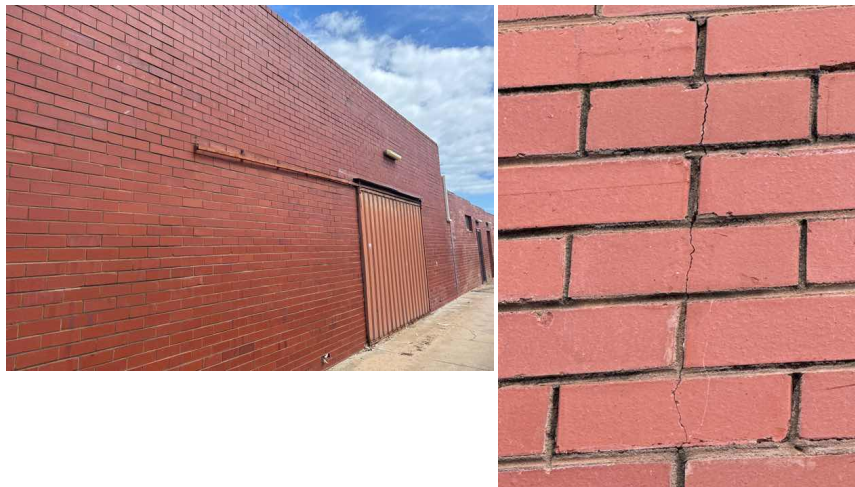
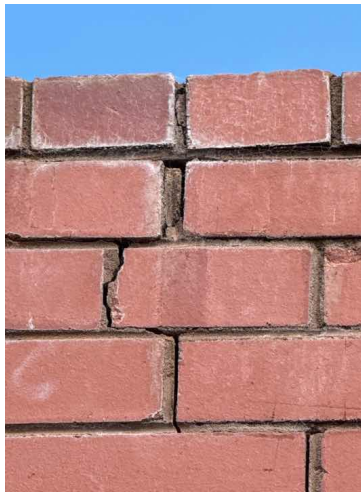
### External Wall Observations

Cracks noted in neighbouring wall from a distance, but unable to access

#3. **Structural Minor:** There appears to have been some settlement in the building which has caused some cracking to the walls. These crack/s are categorised as 0 to 2. This can also cause some doors to bind or be out of square. In the inspectors opinion these cracks are due to settlement, usually due to ground movement and subsequent movement to building materials can be expected. All cracks should be monitored and if cracks increase in size, further investigation should be carried out by a structural engineer. Engage a bricklayer to repair.

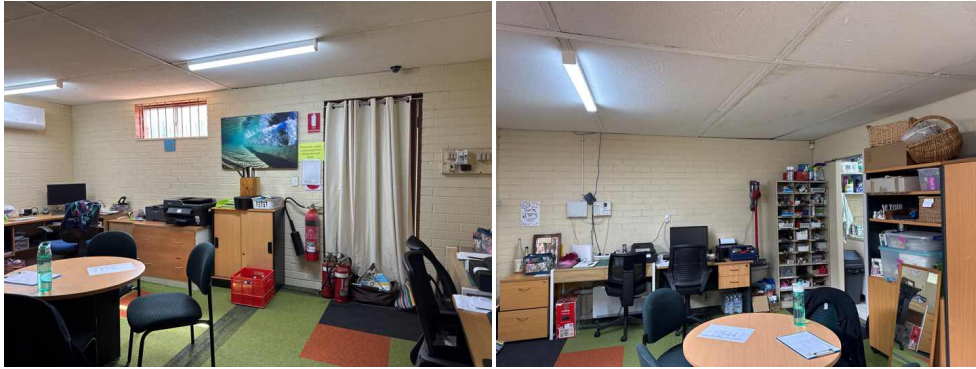
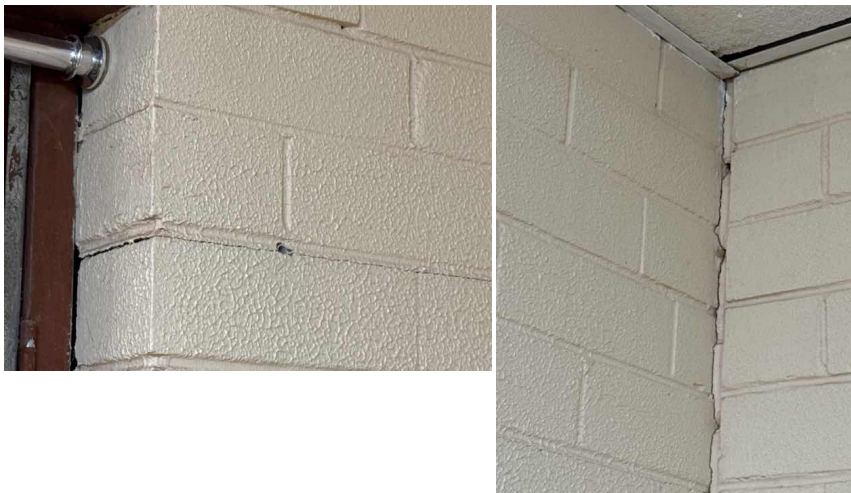
### Walls Observations

#4. **Structural Minor:** There appears to have been some settlement in the building which has caused some cracking to the walls. These crack/s are categorised as 0 to 2. This can also cause some doors to bind or be out of square. In the inspectors opinion these cracks are due to settlement, usually due to ground movement and subsequent movement to building materials can be expected. All cracks should be monitored and if cracks increase in size, further investigation should be carried out by a structural engineer. Recommendation: Engage a painter to patch and paint.

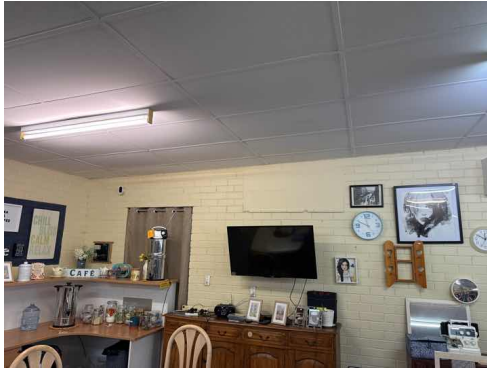
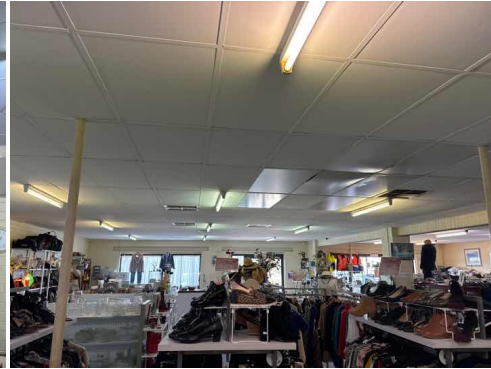
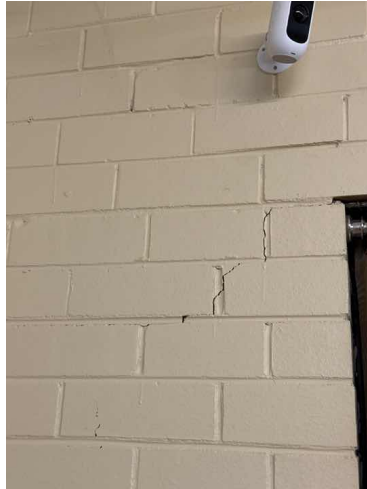
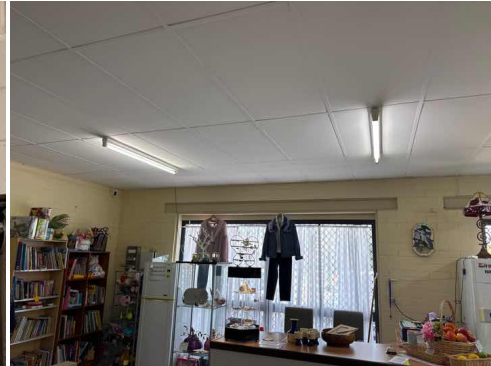
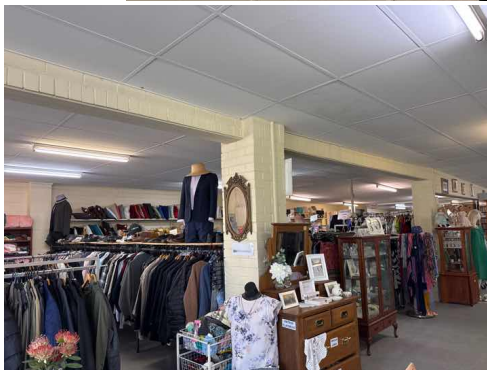
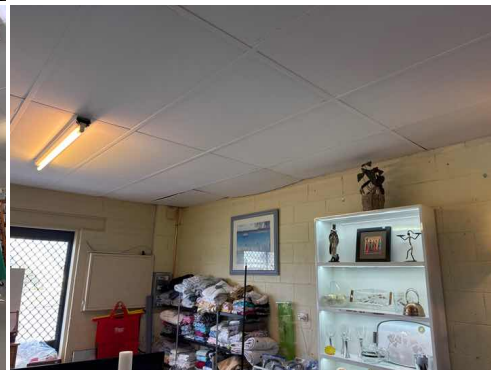
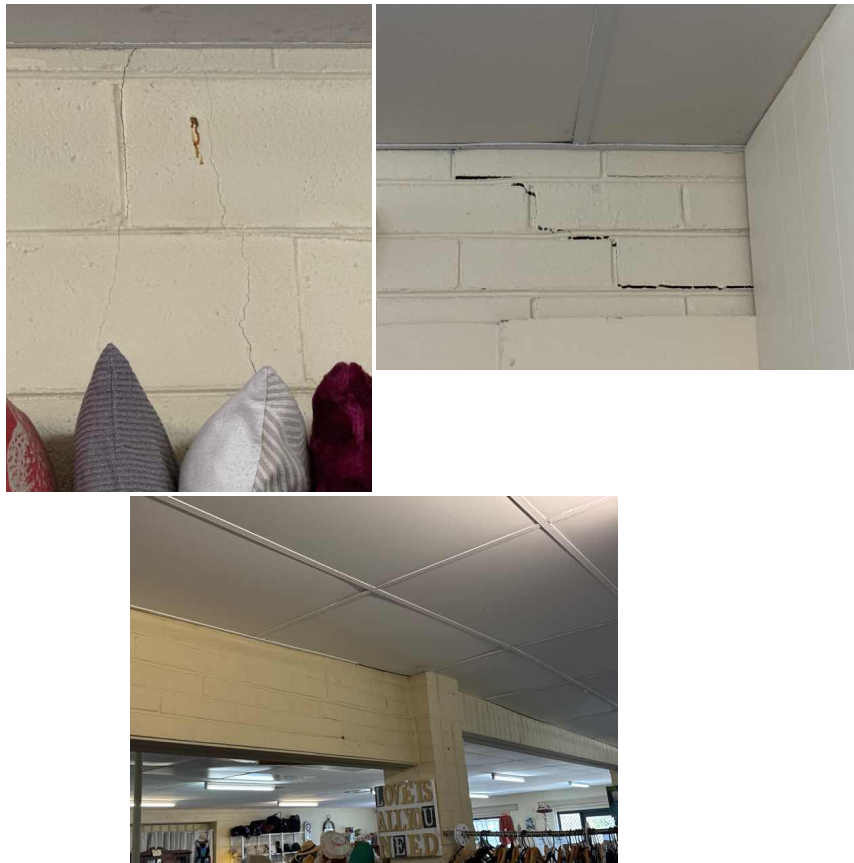
## Walls Observations

#5. **Structural Major:** Crack/s observed in damage Category 3 to 4. Possible causes may be foundation movement, support structure deflection, thermal movement, moisture uptake or loss or failure under external loads. Recommendation: Engage a registered builder to complete repair works. A structural engineer should be consulted for further evaluation to determine scope of repair.

#6. **Structural Minor:** There appears to have been some settlement in the building which has caused some cracking to the walls. These crack/s are categorised as 0 to 2. This can also cause some doors to bind or be out of square. In the inspectors opinion these cracks are due to settlement, usually due to ground movement and subsequent movement to building materials can be expected. All cracks should be monitored and if cracks increase in size, further investigation should be carried out by a structural engineer. Recommendation: Engage a painter to patch and paint.

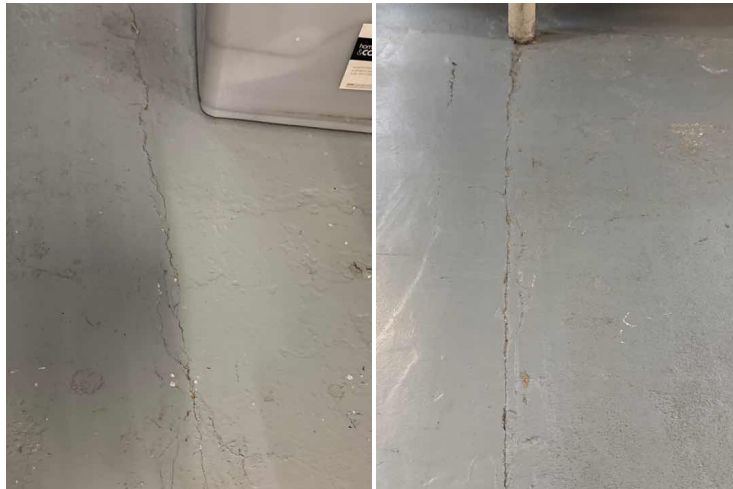
#7. **Structural Minor:** There appears to have been some settlement in the building which has caused some cracking to the slab. These crack/s are categorised as 0 to 2. This can also cause some doors to bind or be out of square. In the inspectors opinion these crack/s are due to settlement, usually due to ground movement and subsequent movement to building materials can be expected. All cracks should be monitored and if cracks increase in size, further investigation should be carried out by a structural engineer. Recommendation: Engage a concreter to repair.

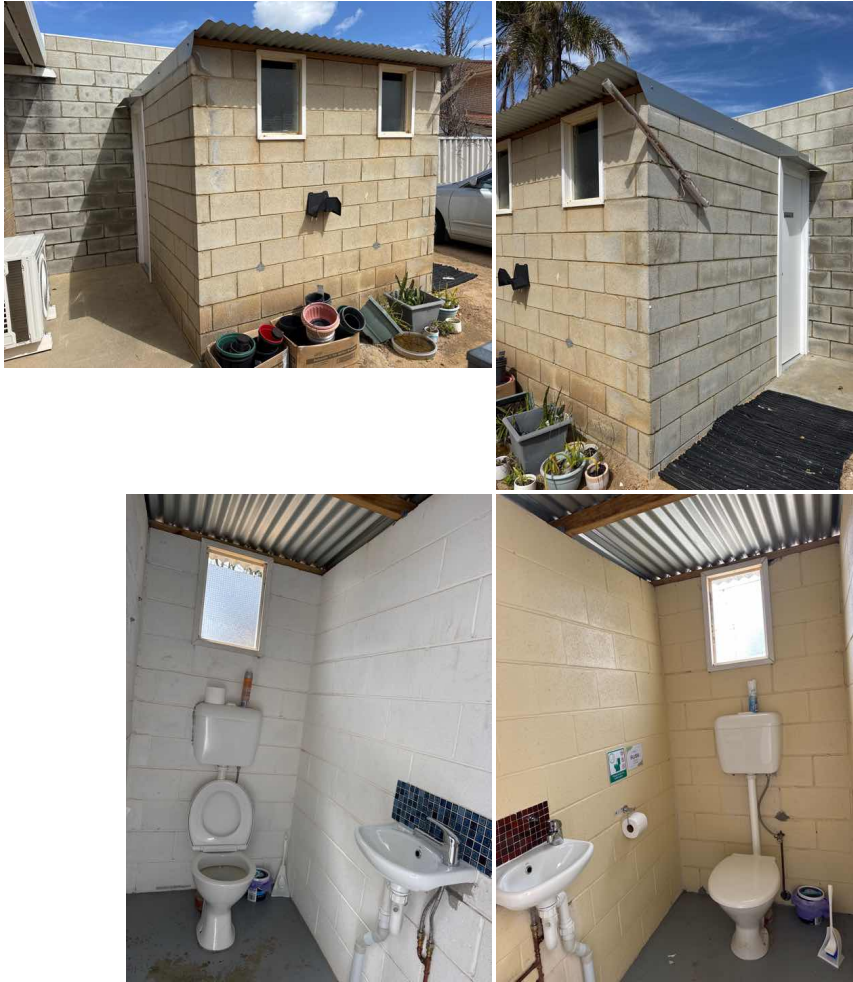
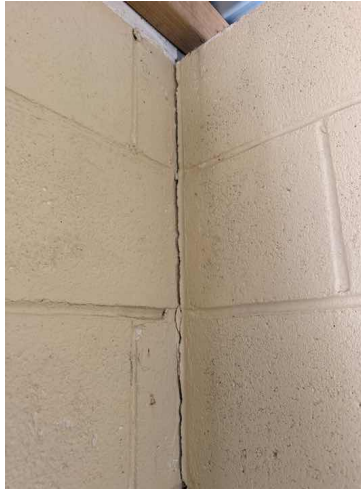
## Walls Observations

#8. **Structural Minor:** There appears to have been some settlement in the building which has caused some cracking to the walls. These crack/s are categorised as 0 to 2. This can also cause some doors to bind or be out of square. In the inspectors opinion these cracks are due to settlement, usually due to ground movement and subsequent movement to building materials can be expected. All cracks should be monitored and if cracks increase in size, further investigation should be carried out by a structural engineer. Engage a painter to patch and paint.

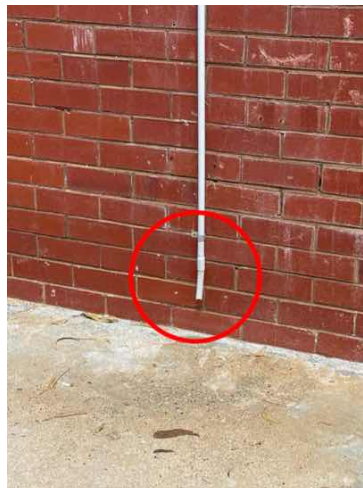
#### **Was the Air Conditioner Sufficiently Drained**

No. Airconditioning overflow should be diverted away from the building perimeter or into a drain.
