# Commercial Comprehensive Inspection

**SURE Building Inspections**

### Commercial Comprehensive Building and Timber Pest Inspection

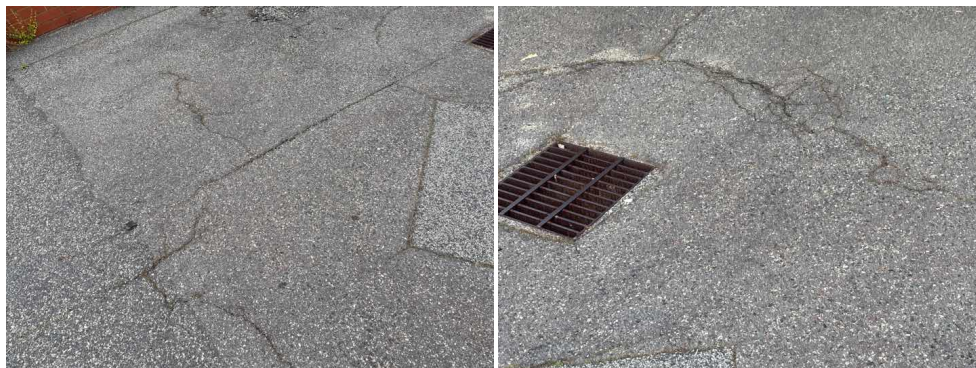
**Maintenance:** Common cracks and settlement were observed on the driveway. Recommendation: Whilst these cracks appeared to be typical at the time of inspection, we recommend you monitor these cracks and if worsening occurs engage a concreter for further advice and repair.

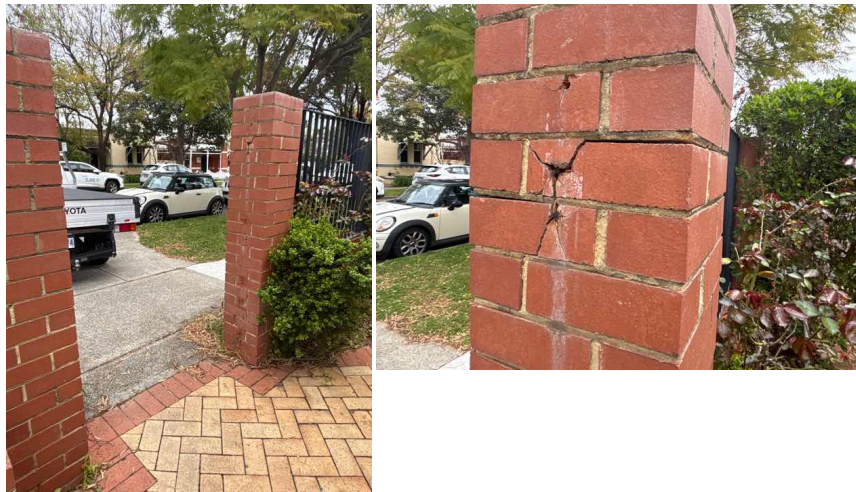
**Maintenance:** Damage was noted to the fence. Recommendation: Engage a fencing contractor for repairs.

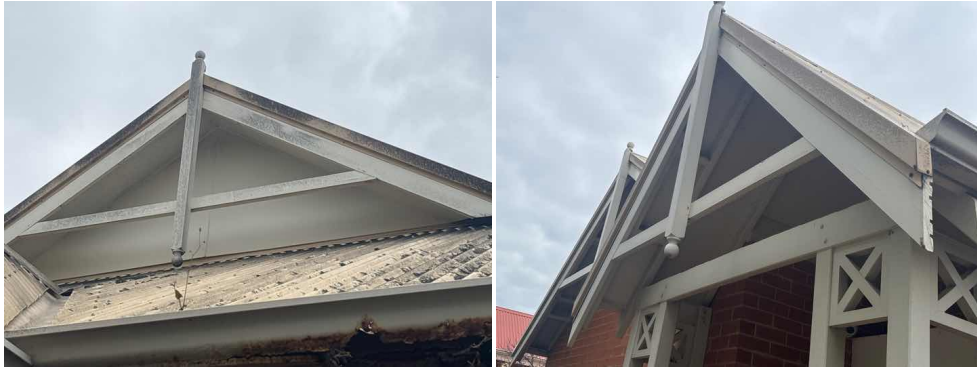
**Maintenance:** Paint deterioration observed in areas. Recommendation: Engage a painter for repairs.

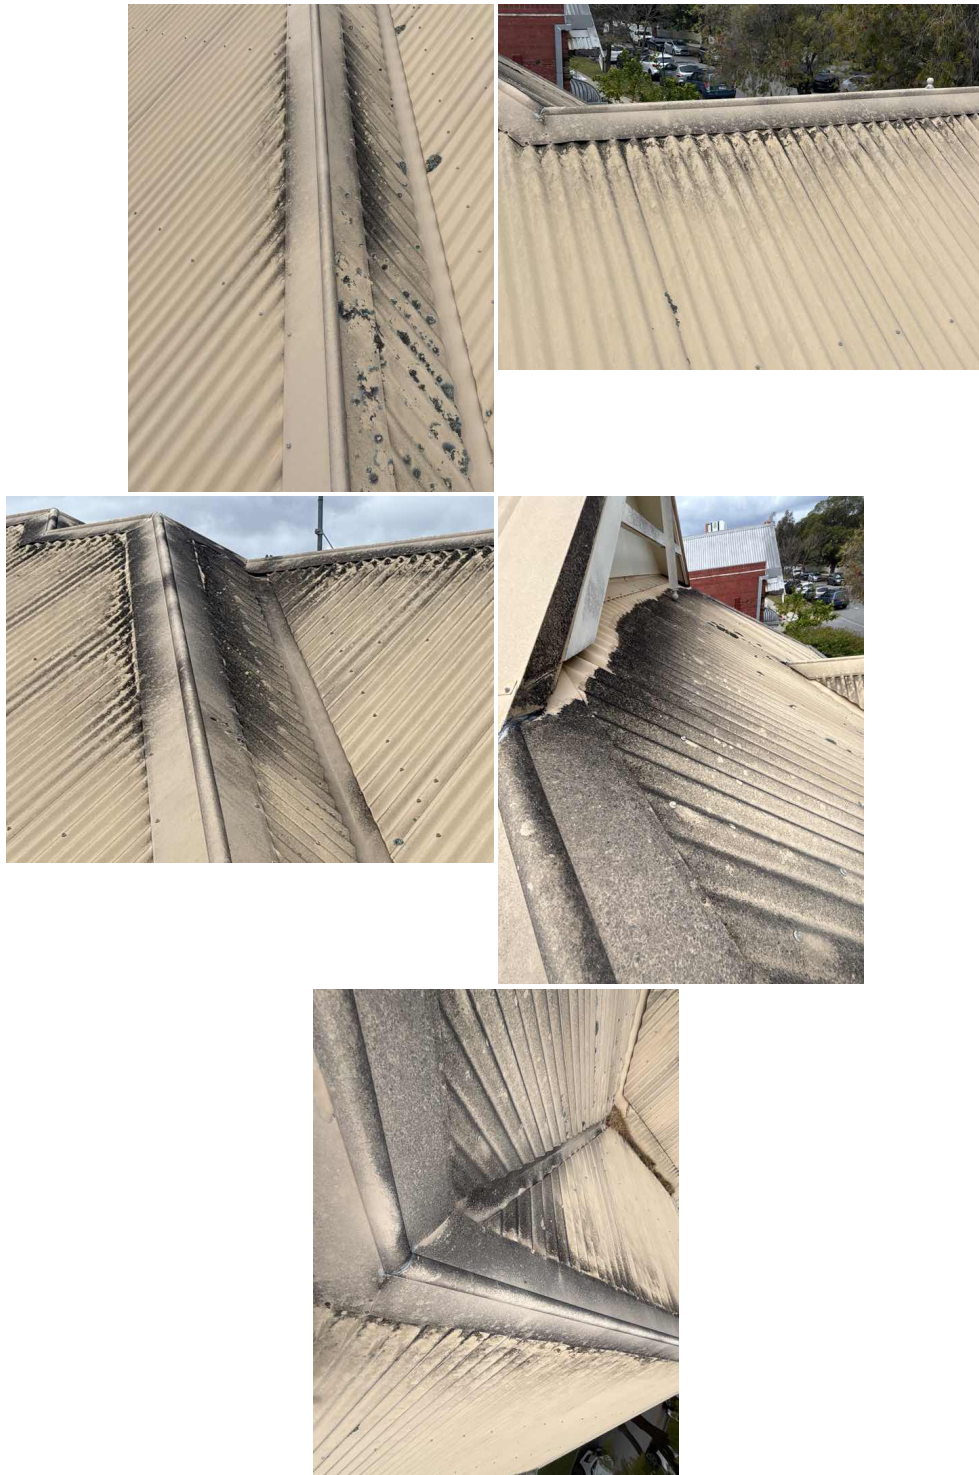
**Maintenance:** Moss / mould has built up on the roofing sheets over time. Recommendation: It is preferable to have moss removed / cleaned to prevent deterioration. Engage a roofing contractor for removal.

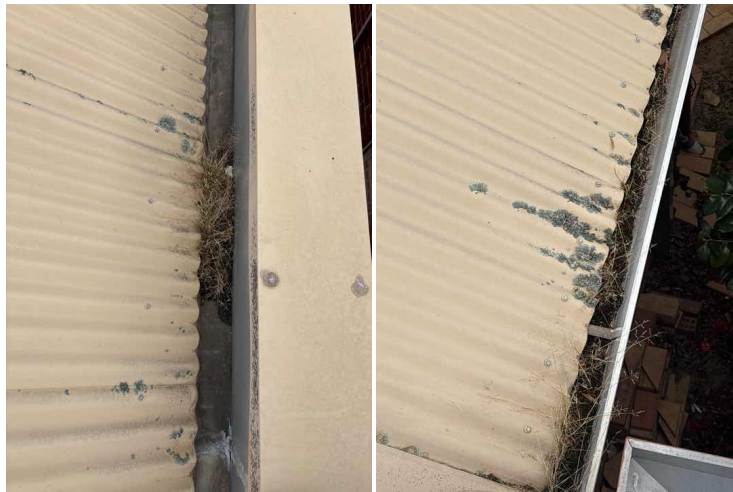
**Maintenance:** Debris observed in guttering area - this requires cleaning out to prevent blocking of downpipes and leaking into eaves and fascia. Recommendation: Engage a handyman to clean out. Regularly debris removal should be completed to prevent ponding. Ponding water will contribute to rust.

**Maintenance:** Rust penetration observed to sections of the gutter. Recommendation: Engage a roofing contractor for repairs or replacement of affected areas.

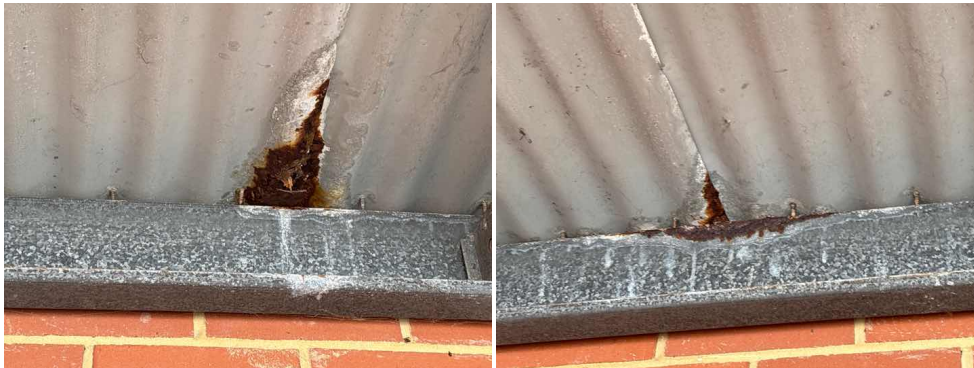
**Maintenance:** Rust penetration observed to sections of the metal roof - leakage to roof void imminent.  
 Recommendation: Engage a roofing contractor for repairs or replacement of affected areas.

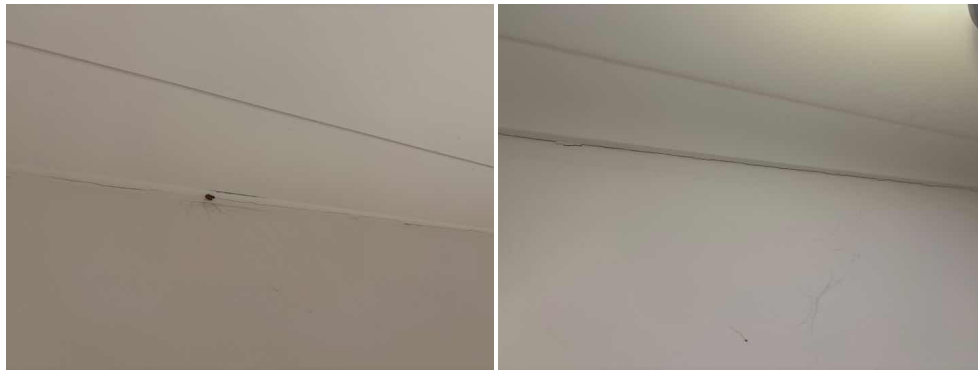
**Maintenance:** Ceiling/cornice join crack/s observed. Recommendation: Engage a painter for repairs.

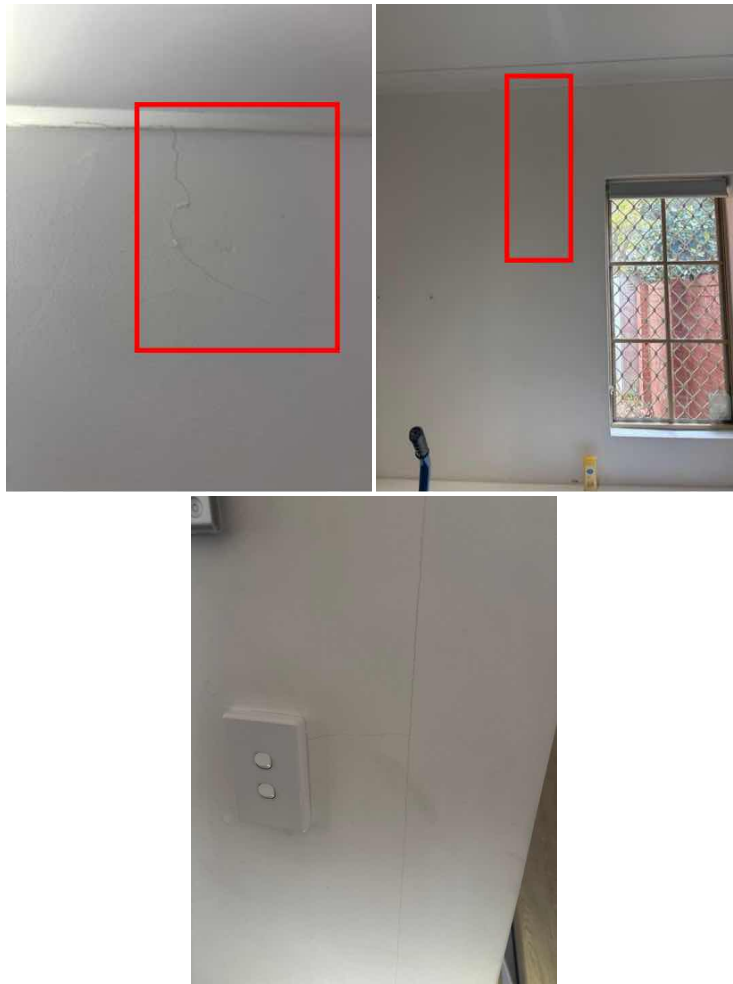
| Section | Location | Name | Comment |
|---|---|---|---|
| INTERIORS | Reception Area | Walls Observations | #1. Structural Minor: There appears to have been some settlement in the building which has caused some cracking to the walls. These crack/s are categorised as 0 to 2. This can also cause some doors to bind or be out of square. In the inspectors opinion these cracks are due to settlement, usually due to ground movement and subsequent movement to building materials can be expected. All cracks should be monitored and if cracks increase in size, further investigation should be carried out by a structural engineer.<br>Recommendation: Engage a painter to patch and paint. For clarification on the category of cracks with a damage category of 0 to 2, please refer to Cracking of Building Elements in Section 2G of the Terms and Conditions of this report. |

#1. **Structural Minor:** There appears to have been some settlement in the building which has caused some cracking to the walls. These crack/s are categorised as 0 to 2. This can also cause some doors to bind or be out of square. In the inspectors opinion these cracks are due to settlement, usually due to ground movement and subsequent movement to building materials can be expected. All cracks should be monitored and if cracks increase in size, further investigation should be carried out by a structural engineer. Recommendation: Engage a painter to patch and paint.

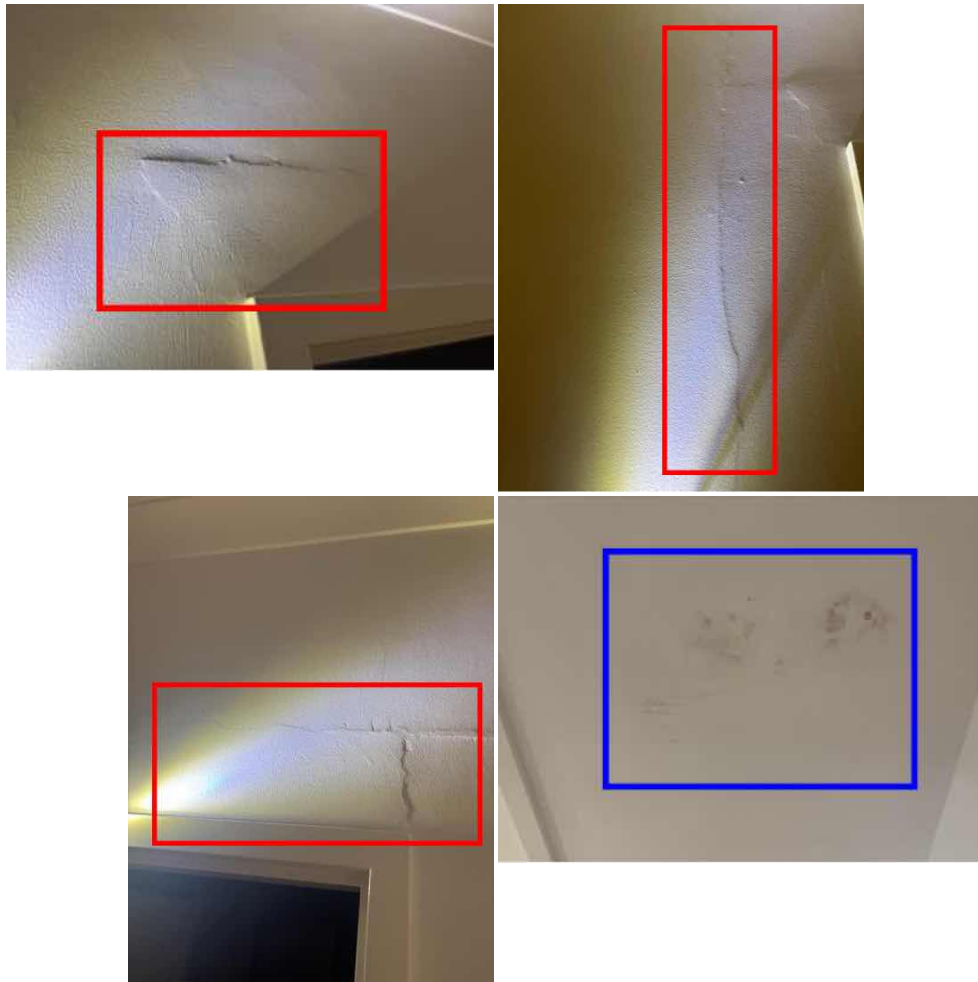
| Section | Location | Name | Comment |
|---|---|---|---|
| INTERIORS | Hallway / Corridor | Walls Observations | #2. Structural Minor: There appears to have been some settlement in the building which has caused some cracking to the walls. These crack/s are categorised as 0 to 2. This can also cause some doors to bind or be out of square. In the inspectors opinion these cracks are due to settlement, usually due to ground movement and subsequent movement to building materials can be expected. All cracks should be monitored and if cracks increase in size, further investigation should be carried out by a structural engineer.<br>Recommendation: Engage a painter to patch and paint. For clarification on the category of cracks with a damage category of 0 to 2, please refer to Cracking of Building Elements in Section 2G of the Terms and Conditions of this report. |
| INTERIORS | Hallway / Corridor | Walls Observations | #3. Maintenance: Mould observed to lining. Recommendation: Engage a professional cleaning service to remove and treat. |

#2. **Structural Minor:** There appears to have been some settlement in the building which has caused some cracking to the walls. These crack/s are categorised as 0 to 2. This can also cause some doors to bind or be out of square. In the inspectors opinion these cracks are due to settlement, usually due to ground movement and subsequent movement to building materials can be expected. All cracks should be monitored and if cracks increase in size, further investigation should be carried out by a structural engineer. Recommendation: Engage a painter to patch and paint.

#3. **Maintenance:** Mould observed to lining. Recommendation: Engage a professional cleaning service to remove and treat.

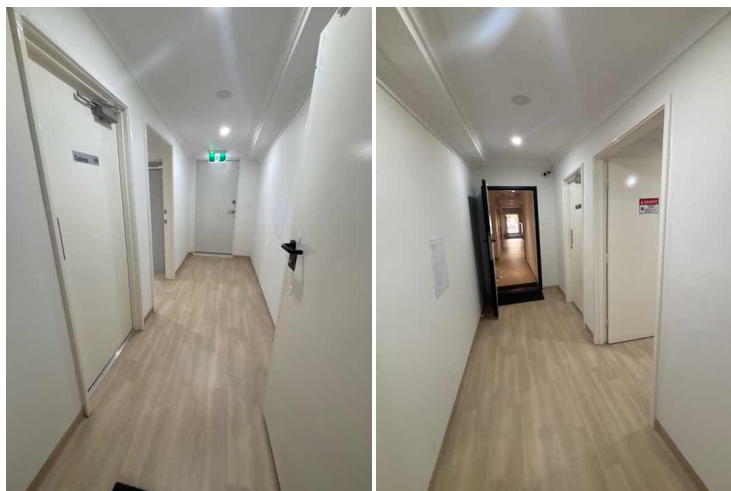
**Maintenance:** General scuffs and marks to walls. Recommendation: Engage a painter for repairs.

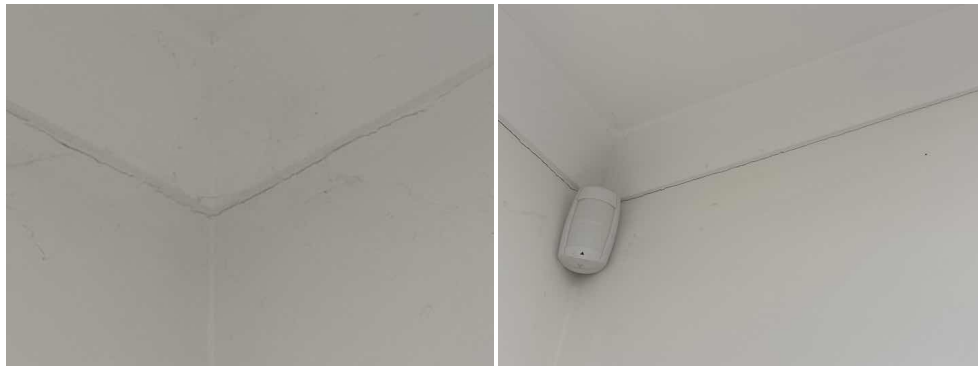
**Maintenance:** Ceiling/cornice join crack/s observed. Recommendation: Engage a painter for repairs.

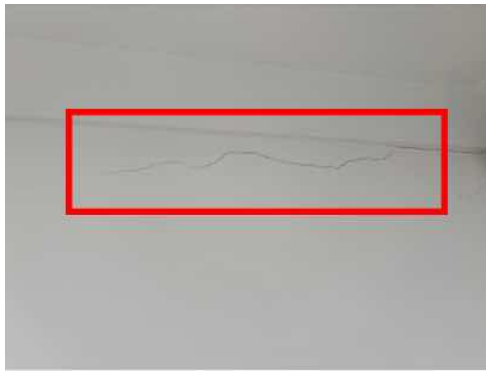
| Section | Location | Name | Comment |
|---|---|---|---|
| INTERIORS | Examination Room 1 | Walls Observations | #4. Structural Minor: There appears to have been some settlement in the building which has caused some cracking to the walls. These crack/s are categorised as 0 to 2. This can also cause some doors to bind or be out of square. In the inspectors opinion these cracks are due to settlement, usually due to ground movement and subsequent movement to building materials can be expected. All cracks should be monitored and if cracks increase in size, further investigation should be carried out by a structural engineer.<br>Recommendation: Engage a painter to patch and paint. For clarification on the category of cracks with a damage category of 0 to 2, please refer to Cracking of Building Elements in Section 2G of the Terms and Conditions of this report. |

#4. **Structural Minor:** There appears to have been some settlement in the building which has caused some cracking to the walls. These crack/s are categorised as 0 to 2. This can also cause some doors to bind or be out of square. In the inspectors opinion these cracks are due to settlement, usually due to ground movement and subsequent movement to building materials can be expected. All cracks should be monitored and if cracks increase in size, further investigation should be carried out by a structural engineer. Recommendation: Engage a painter to patch and paint.

**Maintenance:** General scuffs and marks to walls. Recommendation: Engage a painter for repairs.

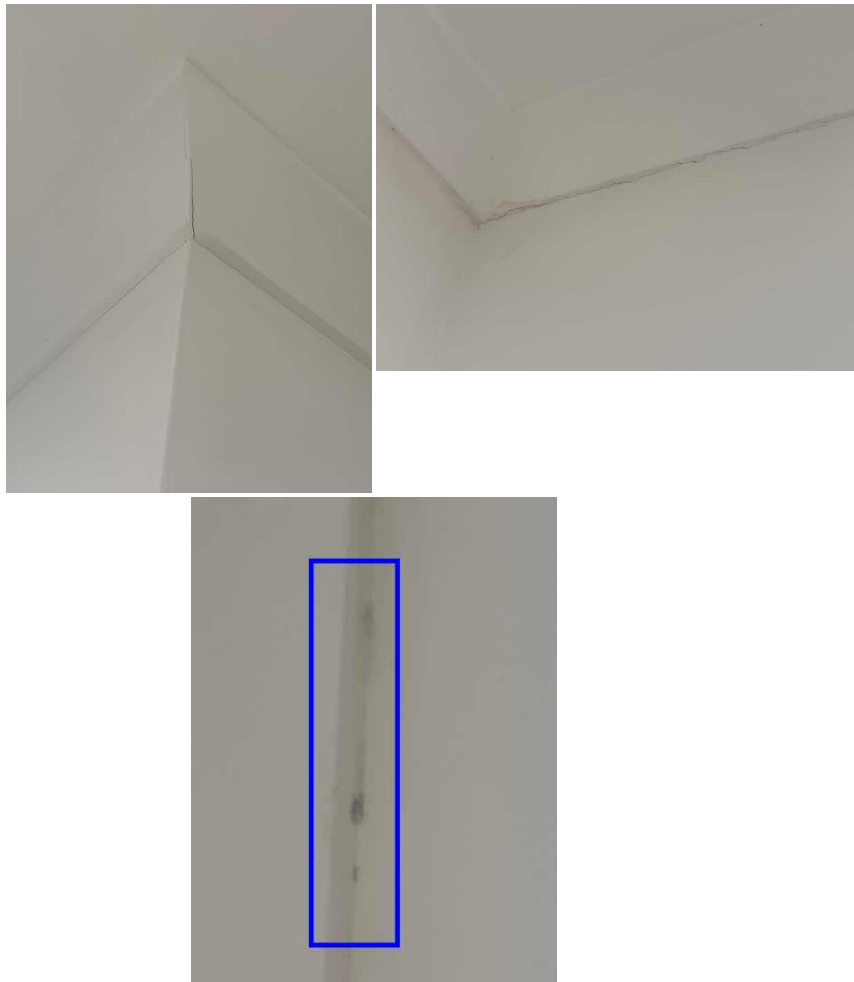
**Maintenance:** Ceiling/cornice join crack/s observed. Recommendation: Engage a painter for repairs.

**Maintenance:** Mould observed to lining. Recommendation: Engage a professional cleaning service to remove and treat.

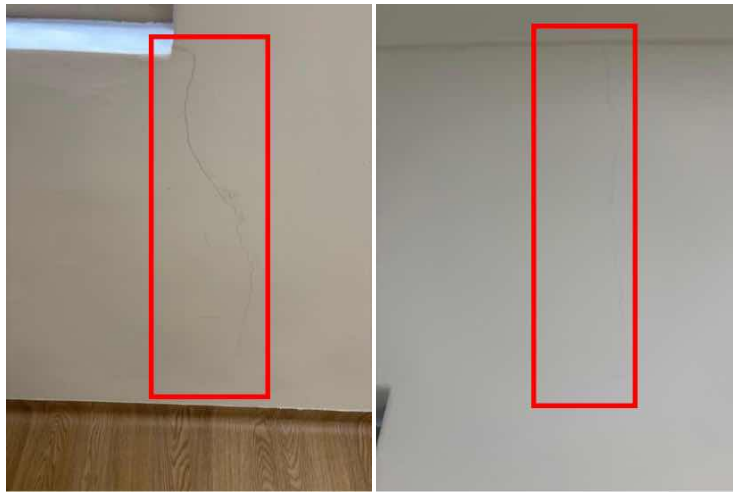
| INTERIORS | Examination Room 2 | Walls Observations | #5. Structural Minor: There appears to have been some settlement in the building which has caused some cracking to the walls. These crack/s are categorised as 0 to 2. This can also cause some doors to bind or be out of square. In the inspectors opinion these cracks are due to settlement, usually due to ground movement and subsequent movement to building materials can be expected. All cracks should be monitored and if cracks increase in size, further investigation should be carried out by a structural engineer.<br>Recommendation: Engage a painter to patch and paint. For clarification on the category of cracks with a damage category of 0 to 2, please refer to Cracking of Building Elements in Section 2G of the Terms and Conditions of this report. |

#5. **Structural Minor:** There appears to have been some settlement in the building which has caused some cracking to the walls. These crack/s are categorised as 0 to 2. This can also cause some doors to bind or be out of square. In the inspectors opinion these cracks are due to settlement, usually due to ground movement and subsequent movement to building materials can be expected. All cracks should be monitored and if cracks increase in size, further investigation should be carried out by a structural engineer. Recommendation: Engage a painter to patch and paint.

**Maintenance:** General scuffs and marks to walls. Recommendation: Engage a painter for repairs.

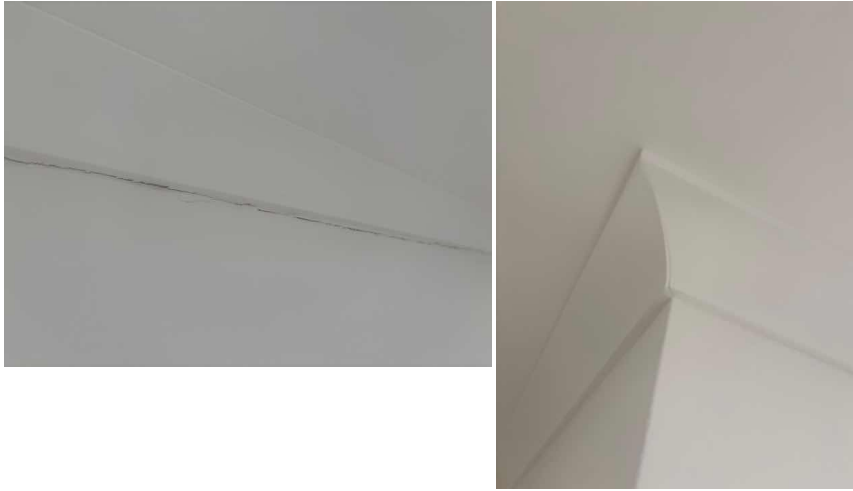
**Maintenance:** Ceiling/cornice join crack/s observed. Recommendation: Engage a painter for repairs.

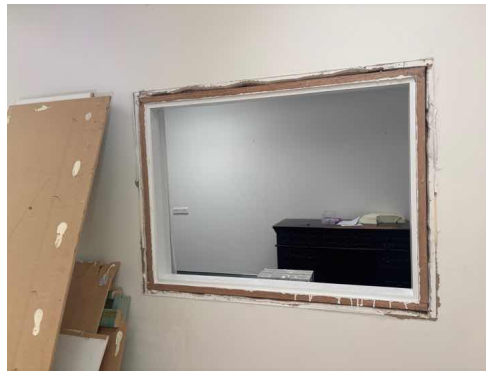
**Maintenance:** General scuffs and marks to walls. Recommendation: Engage a painter for repairs.

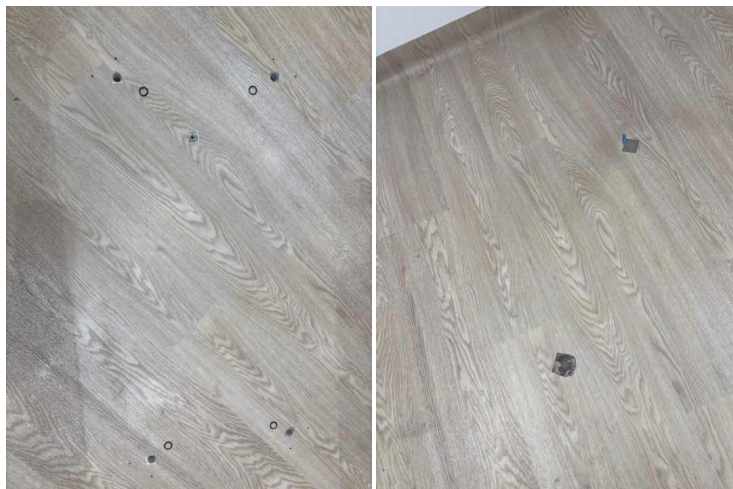
**Maintenance:** Area of linoleum flooring requires repair.

Engage a flooring contractor for repairs.

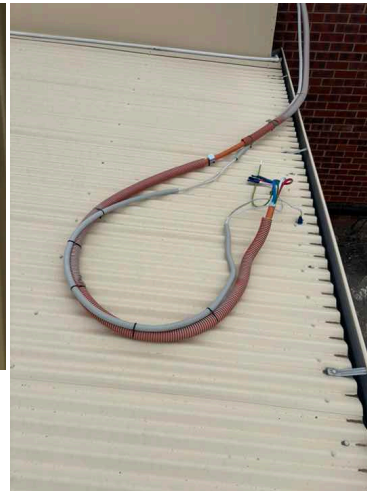
| ELECTRICAL | Observations | . | #6. It is recommended by the inspector that an electrical inspection - Certificate of Compliance - be carried out. Incomplete electrical wiring. |

- #6. It is recommended by the inspector that an electrical inspection - Certificate of Compliance - be carried out.  
Incomplete electrical wiring.

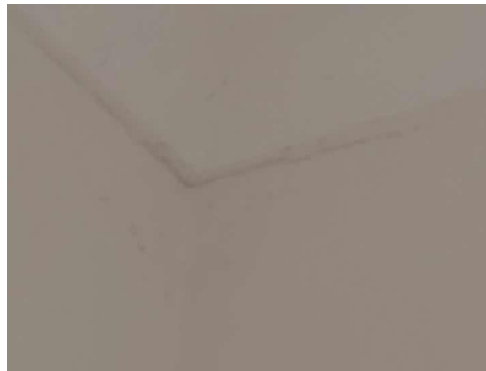
**Maintenance:** Ceiling/cornice join crack/s observed. Recommendation: Engage a painter for repairs.

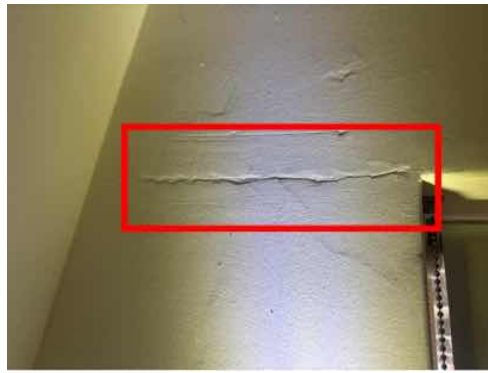
| BATHROOM(S) | Toilet - Disabled Access | Walls Observations | #7. Structural Minor: There appears to have been some settlement in the building which has caused some cracking to the walls. These crack/s are categorised as 0 to 2. This can also cause some doors to bind or be out of square. In the inspectors opinion these cracks are due to settlement, usually due to ground movement and subsequent movement to building materials can be expected. All cracks should be monitored and if cracks increase in size, further investigation should be carried out by a structural engineer. Engage a painter to patch and paint. For clarification on the category of cracks with a damage category of 0 to 2, please refer to Cracking of Building Elements in Section 2G of the Terms and Conditions of this report. |

**#7. Structural Minor:** There appears to have been some settlement in the building which has caused some cracking to the walls. These crack/s are categorised as 0 to 2. This can also cause some doors to bind or be out of square. In the inspectors opinion these cracks are due to settlement, usually due to ground movement and subsequent movement to building materials can be expected. All cracks should be monitored and if cracks increase in size, further investigation should be carried out by a structural engineer. Engage a painter to patch and paint.

**Maintenance:** General scuffs and marks to walls. Recommendation: Engage a painter for repairs.

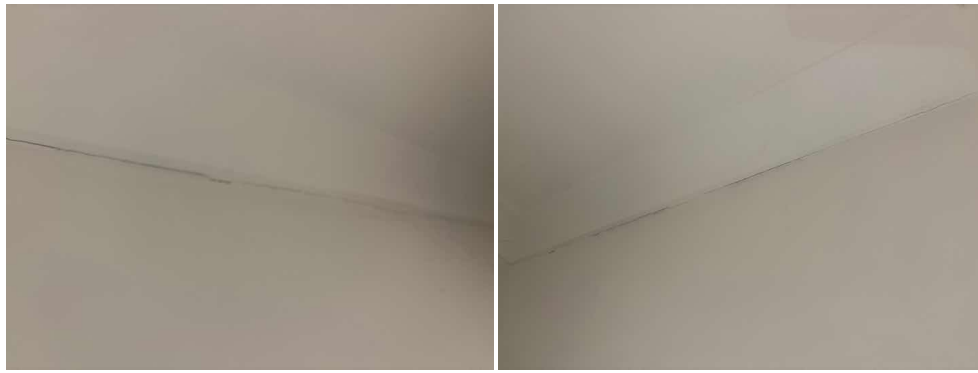
**Maintenance:** Ceiling/cornice join crack/s observed. Recommendation: Engage a painter for repairs.

**Maintenance:** Cosmetic crack/damage observed to cornice. Recommendation: Engage a plasterer for repairs.
