# Comprehensive Inspection

**SURE Building Inspections**

### Comprehensive Building and Timber Pest Inspection

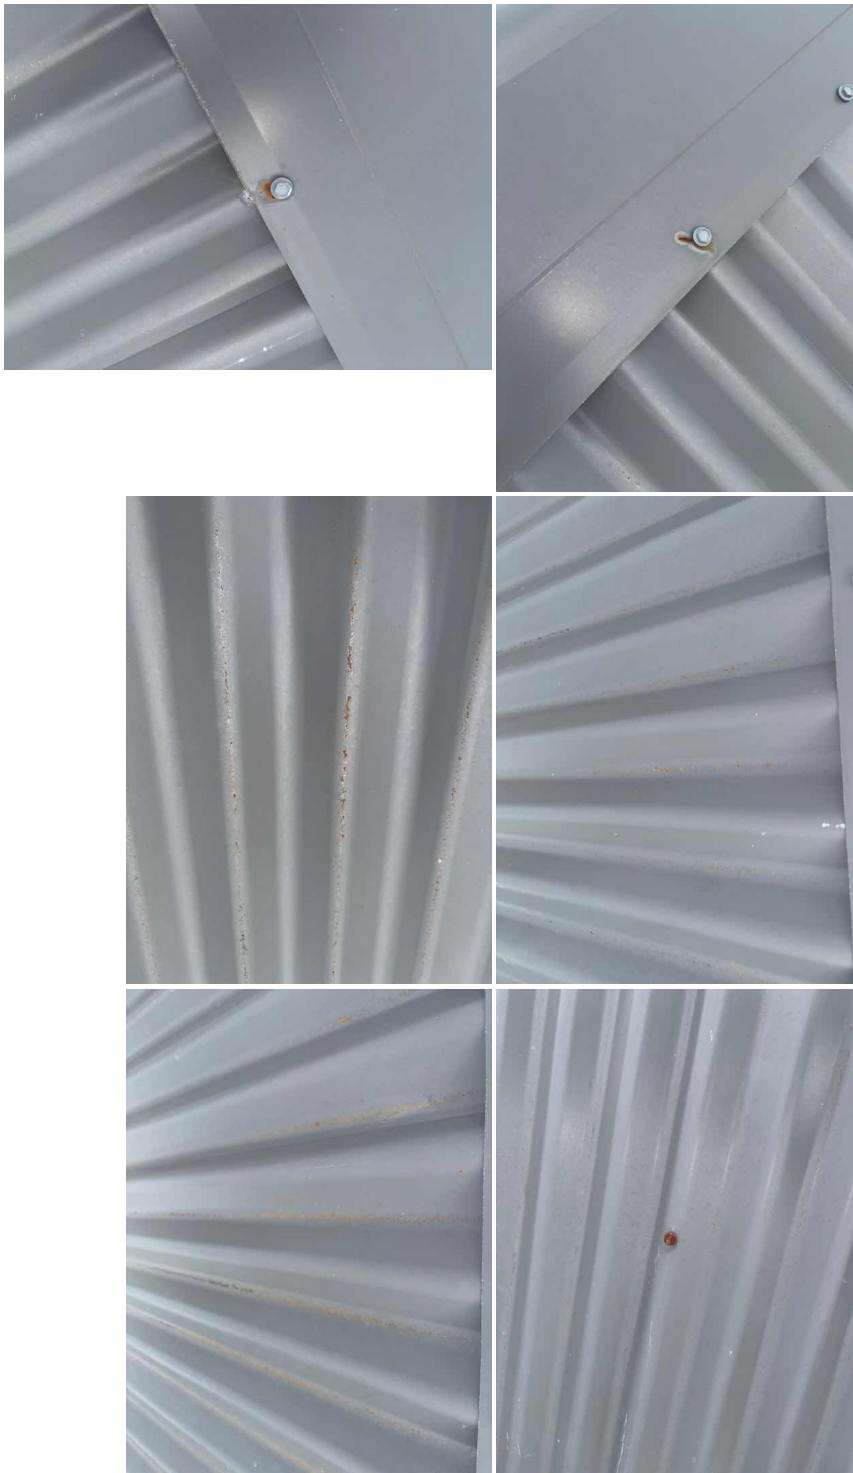
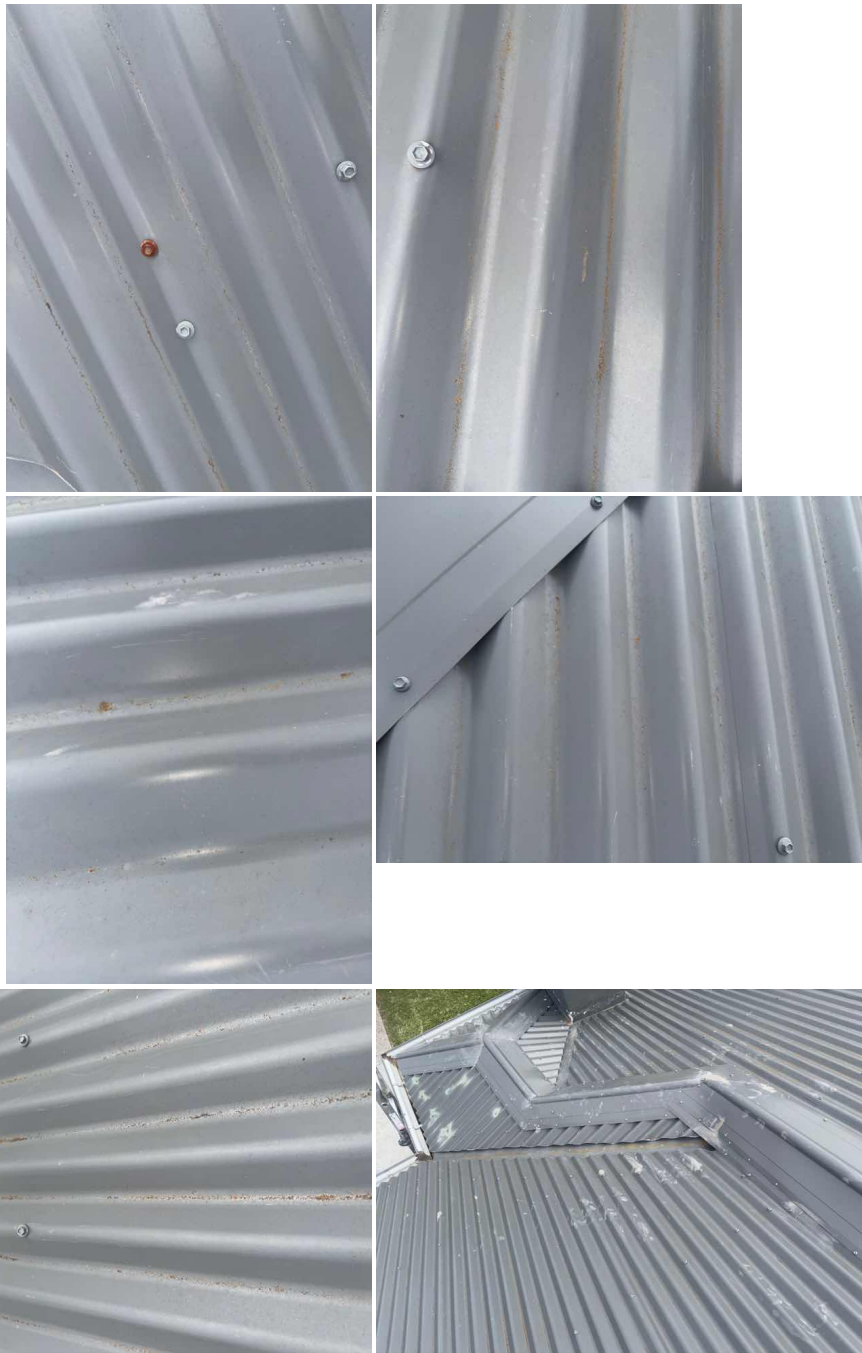
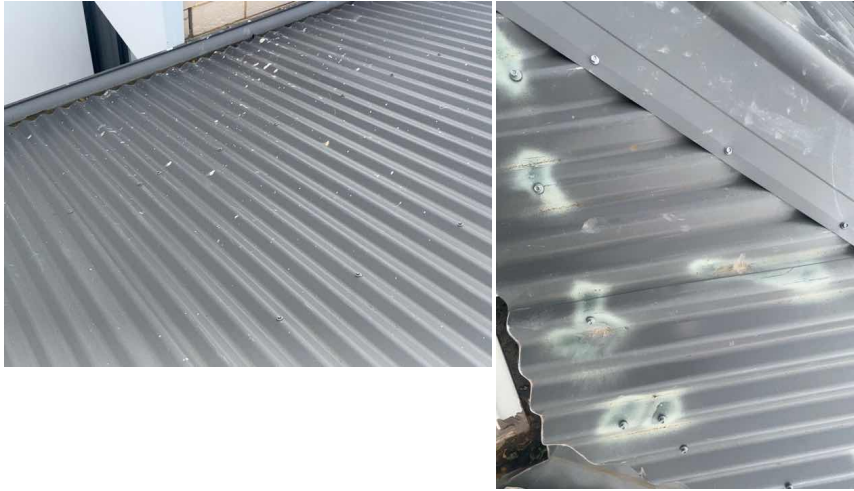
**Maintenance:** Metal swarf debris on roof cover. The debris has corroded causing rust, which if left may cause corrosion to sections of the metal roof. Recommendation: Engage a roofing contractor for repairs (cleaning) of affected areas.

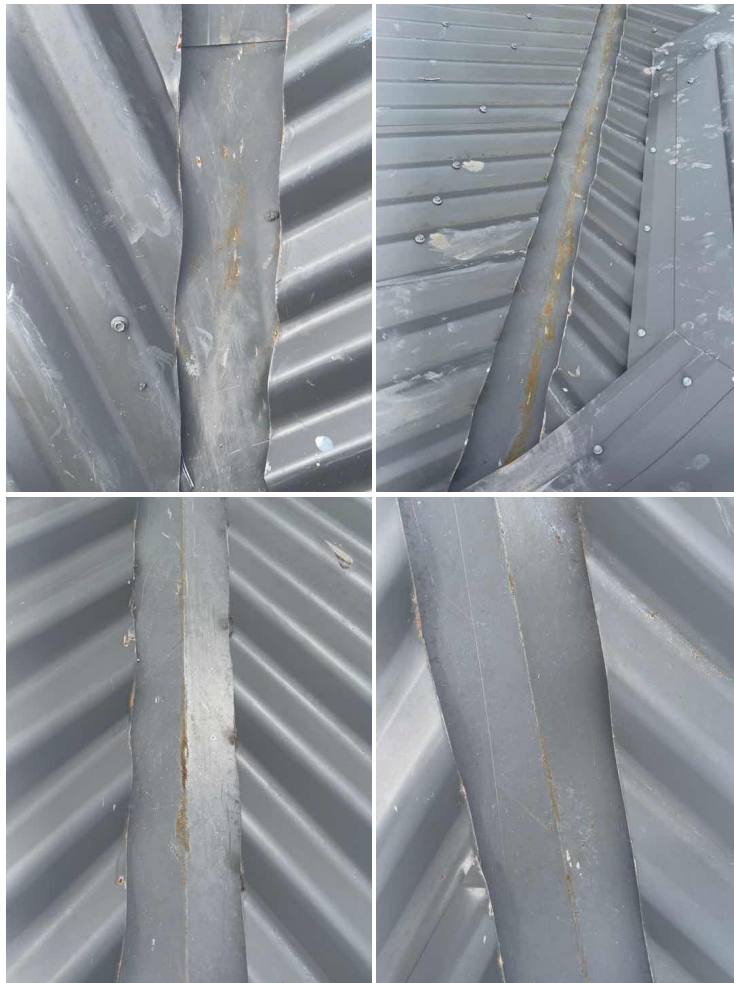
**Maintenance:** Flashing surface rust observed. Recommendation: Engage a roofing contractor for repairs.

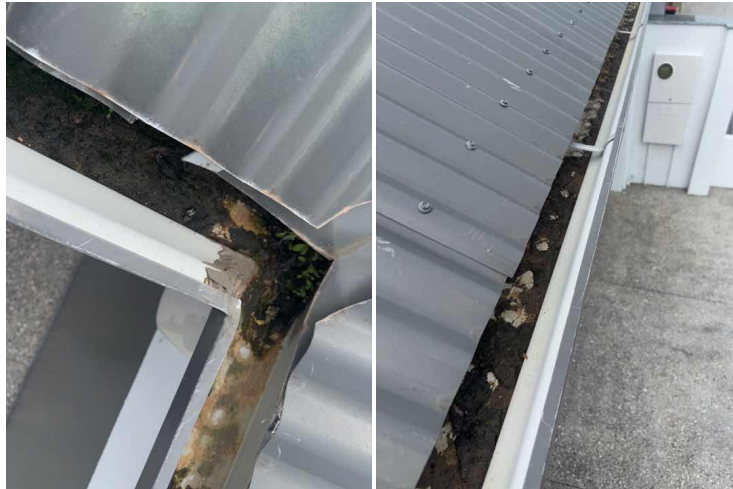
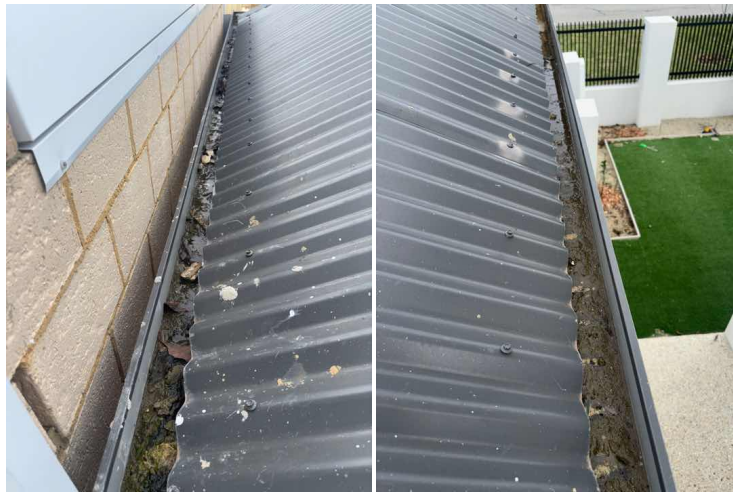
**Maintenance:** Debris observed in guttering area - this requires cleaning out to prevent blocking of downpipes and leaking into eaves and fascia. Recommendation: Engage a handyman to clean out. Regularly debris removal should be completed to prevent ponding. Ponding water will contribute to rust.

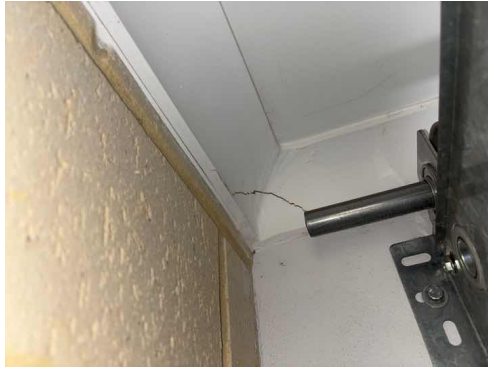
**Maintenance:** Cornice damage observed. Recommendation: Engage a painter for repairs.

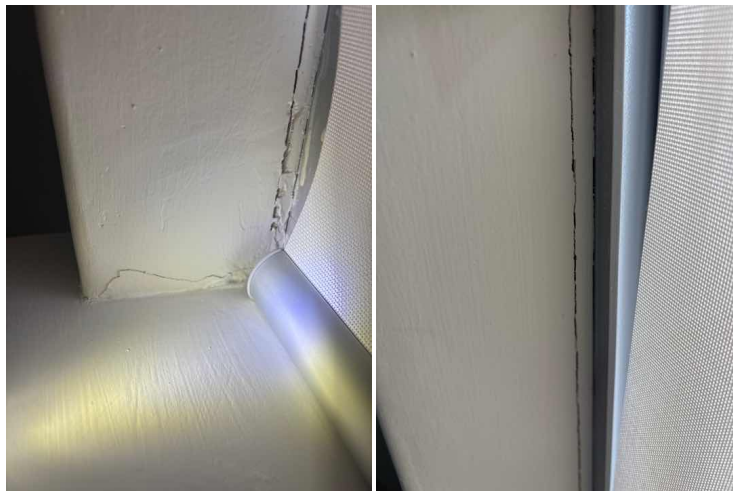
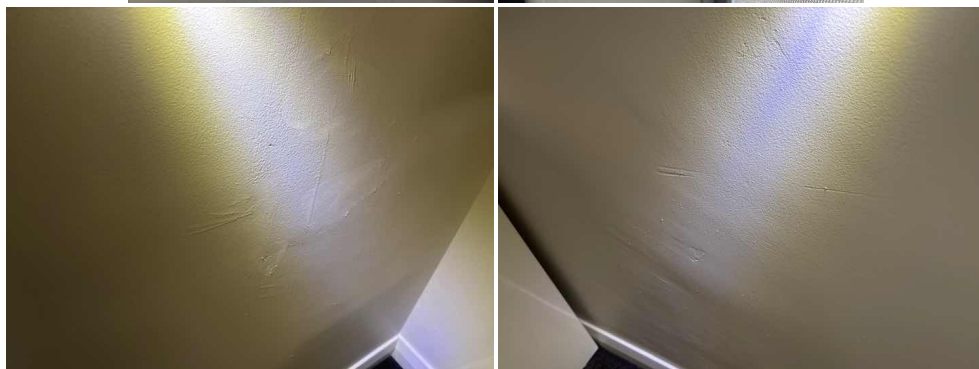
**Maintenance:** General scuffs and marks to walls. Recommendation: Engage a painter for repairs.

**Maintenance:** Cosmetic cracking observed.

**Maintenance:** Gouges observed to areas of wall lining.

Recommendation - Engage a painter for repairs.

Recommendation - Engage a painter for repair.

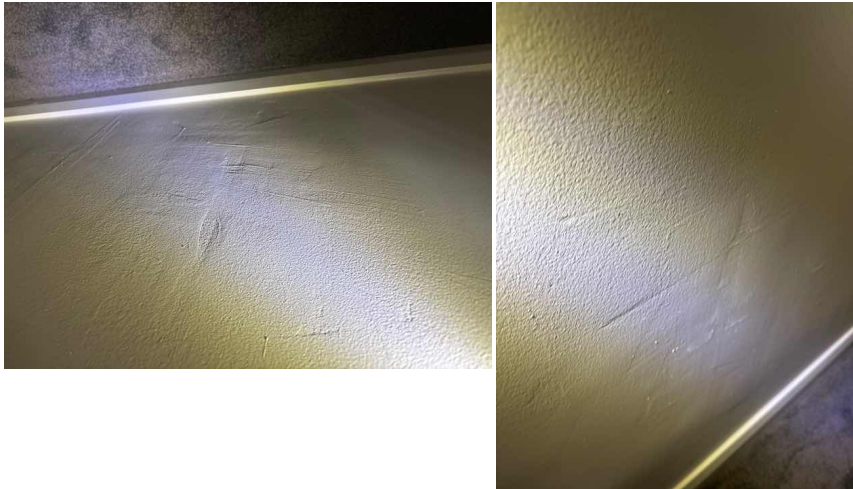
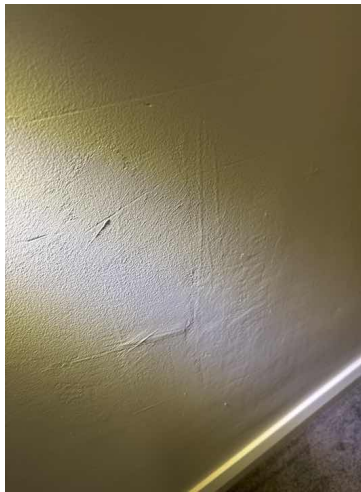
**Maintenance:** General scuffs and marks to walls. Recommendation: Engage a painter for repairs.

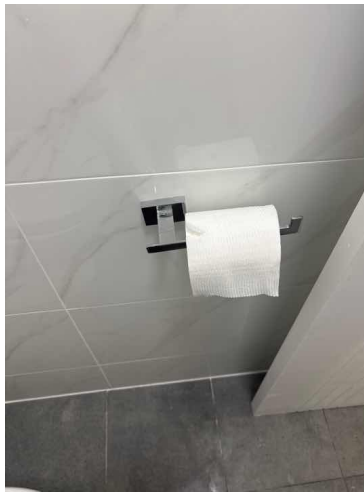
**Maintenance:** The toilet roll holder is damaged/loose. Recommendation: Engage a handyman to repair or replace.

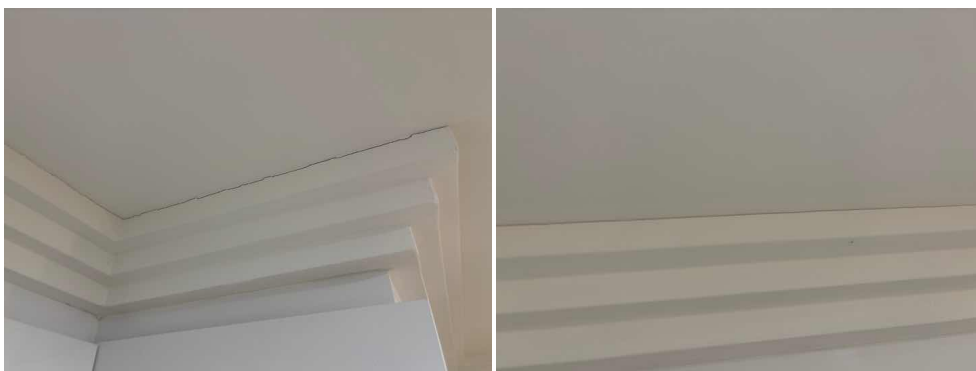
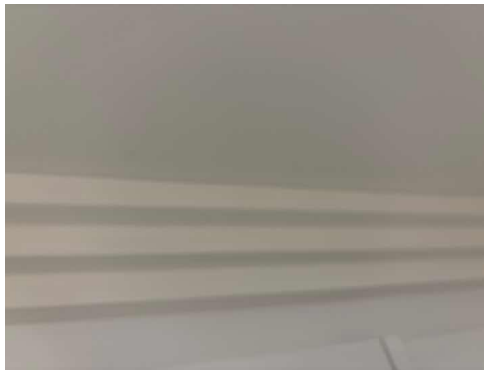
**Maintenance:** Ceiling/cornice join crack/s observed. Recommendation: Engage a painter for repairs.

**Maintenance:** The cornice is separating from the ceiling/wall. Recommendation: Engage a plasterer for repairs.

**Maintenance:** Marks / scuffs observed to areas of ceiling linings.

Recommendation - Engage a painter for repair.

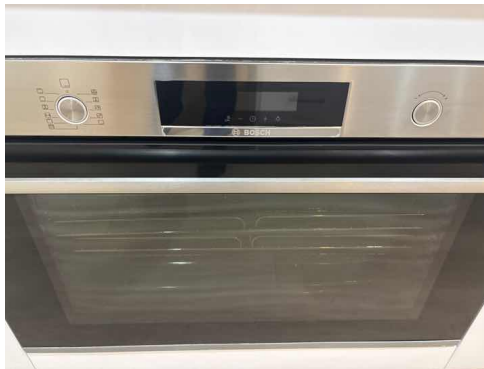
#1. No power to test oven Recommend testing upon final inspection.

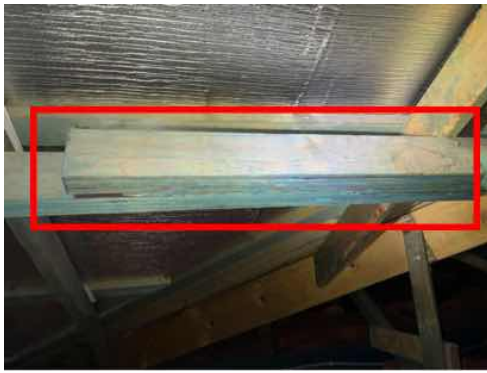
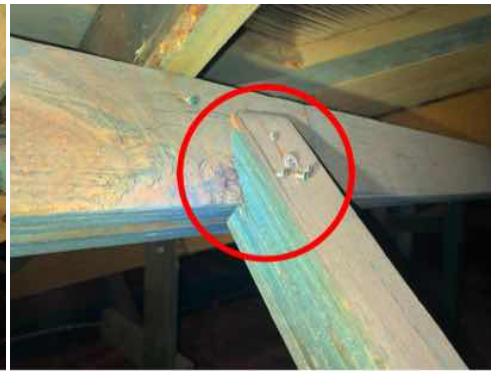
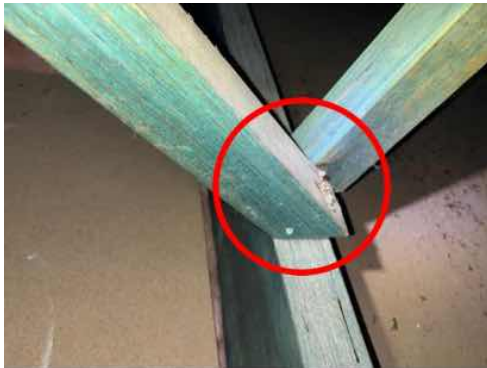
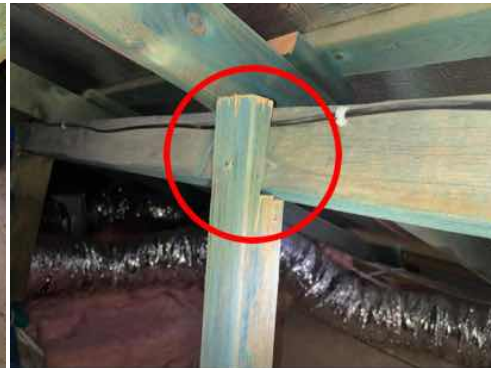
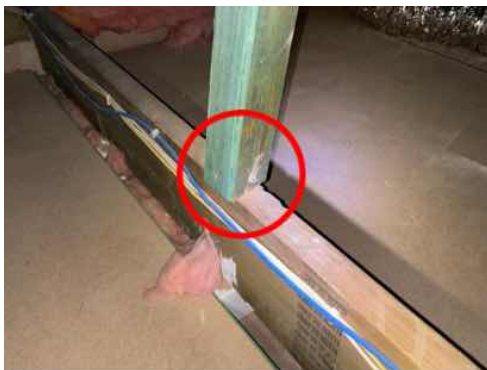
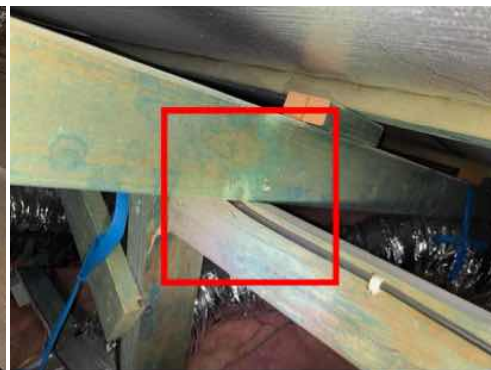
| Section | Location | Name | Comment |
|---|---|---|---|
| ROOF VOID | Roof Void Findings | Roof Framing Observations | #2. Structural Major: Strapping to struts (top and bottom connections) and triple grips to rafters for metal roof cover construction do not comply with current standards set out in AS1684.2. This standard was a requirement at the time of build.<br>Recommendation: Engage a carpenter to install metal connectors to all timber connections and joints. |
| ROOF VOID | Roof Void Findings | Roof Framing Observations | #3. Structural Major: Overlap to underpurlin Timbers not sufficiently connected. M10 bolts to be installed to overlap connections.<br>Engage a carpenter for repairs. |
| ROOF VOID | Roof Void Findings | Roof Framing Observations | #5. Structural Major: The bracing timber has been attached to the fan struts with nails only. These connections should be secured using 1 x 75mm No. 14 Type 17 Bugle screws.<br>Recommendation - Engage a carpenter to install. |

Strapping/anchors missing from base and top of struts. This is a requirement to homes with metal roof covers.  
Recommendation: Engage a carpenter for repair.

Triple Grips not fitted securing rafters to underpurlin. This is a requirement to homes with metal roof covers.  
Recommendation: Engage a carpenter for repair.

#4. **Structural Minor:** Areas observed of poor quality workmanship. All battens to the South East facing roof plane have been packed into position due to incorrect frame layout.

#5. **Structural Major:** The bracing timber has been attached to the fan struts with nails only. These connections should be secured using 1 x 75mm No. 14 Type 17 Bugle screws.

Recommendation: Engage a carpenter to install metal connectors to all timber connections and joints.

Engage a carpenter for repairs.

Recommendation - Engage a roof carpenter to further assess the cause behind the reason to pack battens as observed.

Recommendation - Engage a carpenter to install.

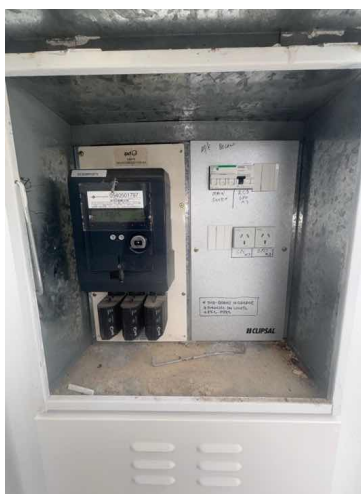
#8. **Timber Pest:** A durable notice was not found during the inspection. It must be assumed that there is no current management plan in place. Recommendation: Engage a pest control technician to implement a termite site management plan.
