# Root Cause Inspection

## SURE Services Group Pty Ltd

### Defect Root Cause Inspection

Roof frame unevenness/sagging.

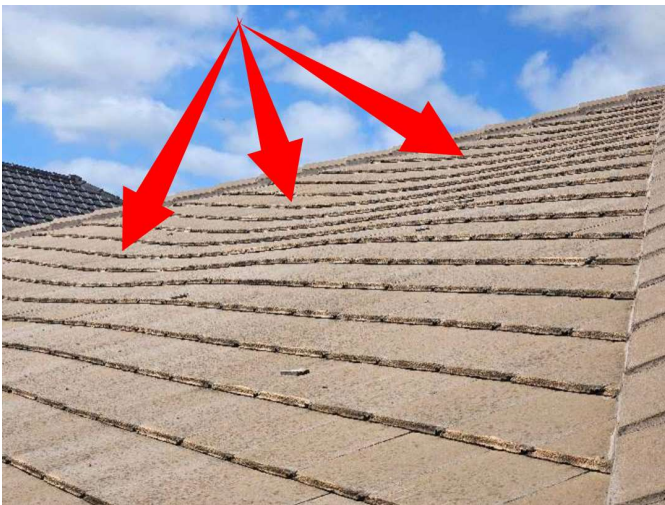
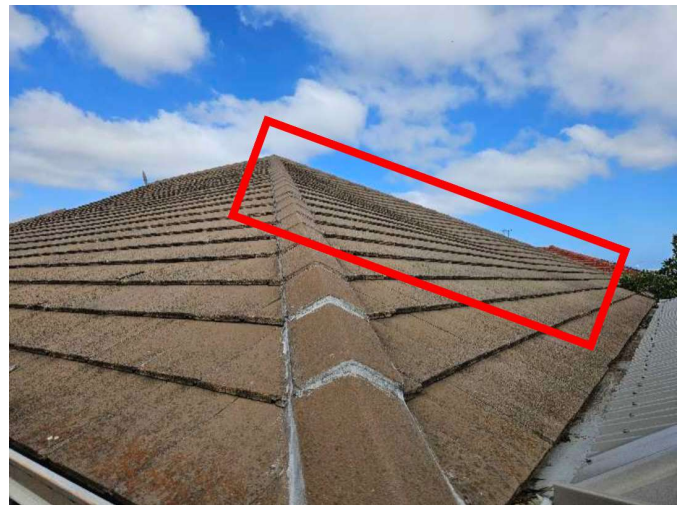
Indication of roof frame defect/s visible from external areas.  
Significant, visible unevenness to roof frame.

Upon inspection of the roof frame from the roof void, multiple defects were observed.

**Structural Failure** of framing components to the four main planes of the roof frame.

The condition of the frame has to be deemed a **Major Safety Hazard** due to overall deterioration/failure of structural support components

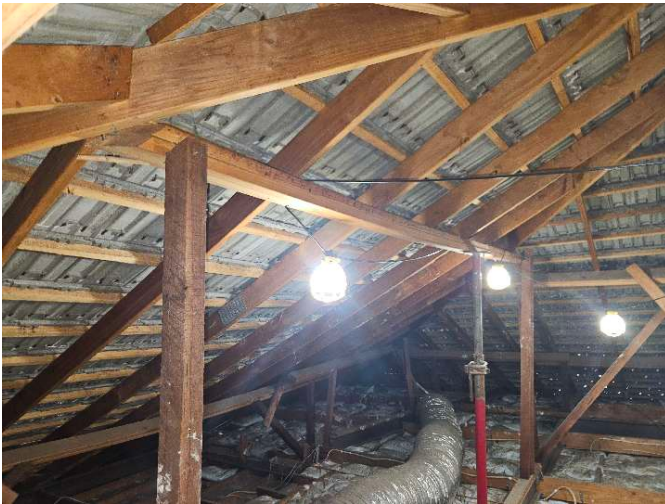
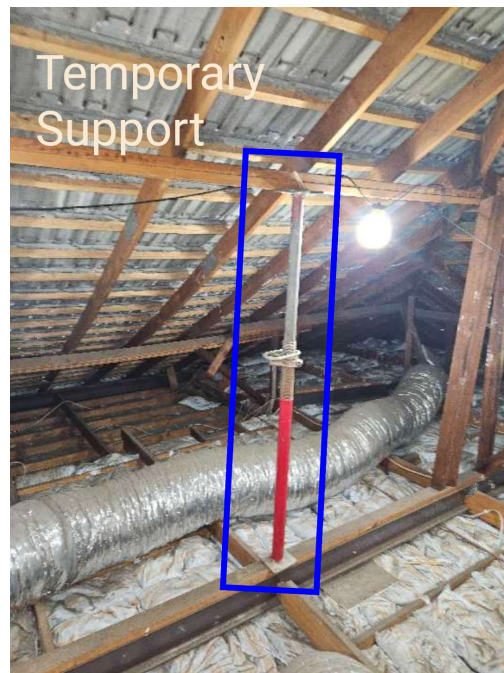
Temporary Support

Both the upper and lower underpurlins have rolled out of position, pushing strut timbers out of their original position.

Considered to be **Structural Failure** of these framing members.

Due to the failure of structural components there is inadequate mid span support to the load bearing rafters. This has caused the rafters to distort and bow with the weight of the roof cover tiles.

This section of roof frame is a **Major Safety Hazard** with the potential for collapse.

Insurance company / roof carpenter for immediate make safe works to sufficiently support defective sections of roof frame.

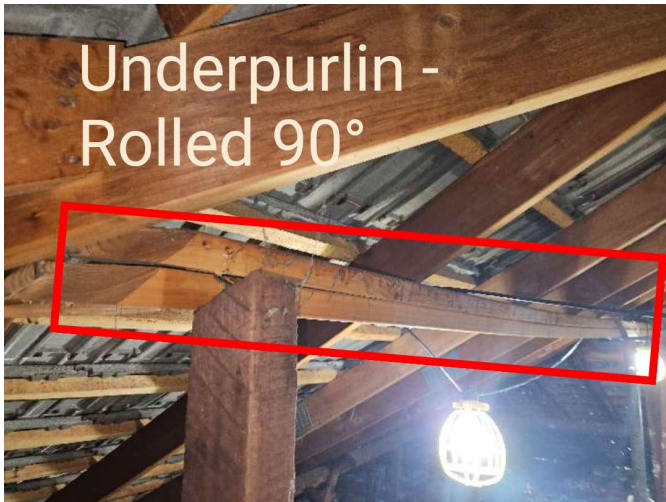
Underpurlin - Rolled 90°

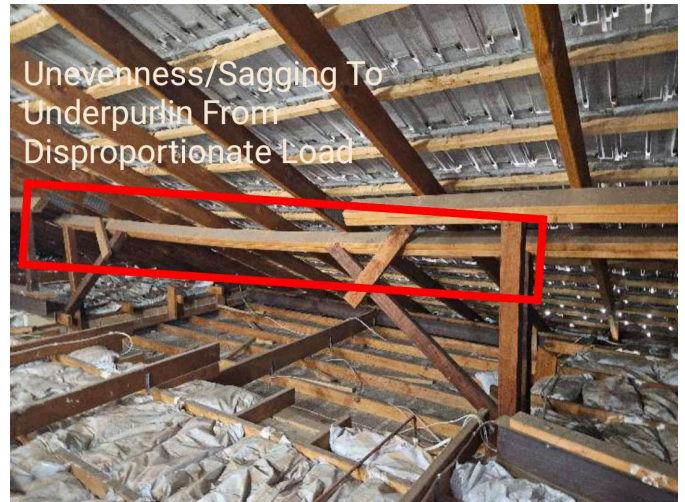
Unevenness/Sagging To Underpurlin From Disproportionate Load

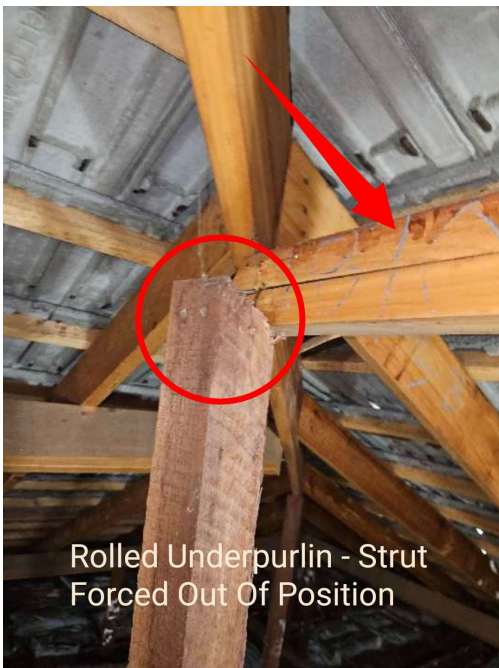
Rolled Underpurlin - Strut Forced Out Of Position

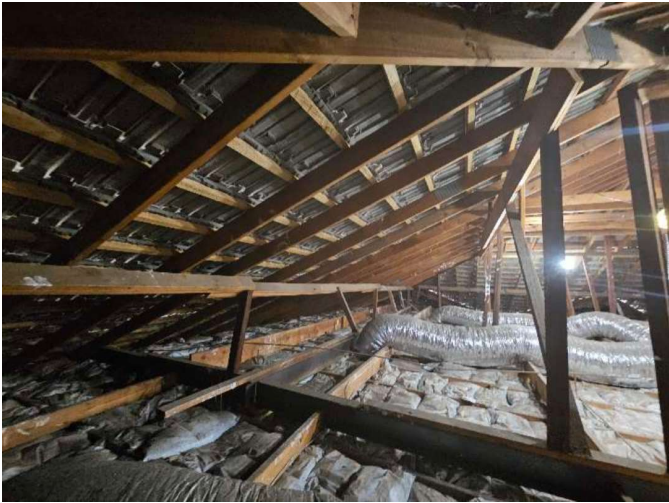
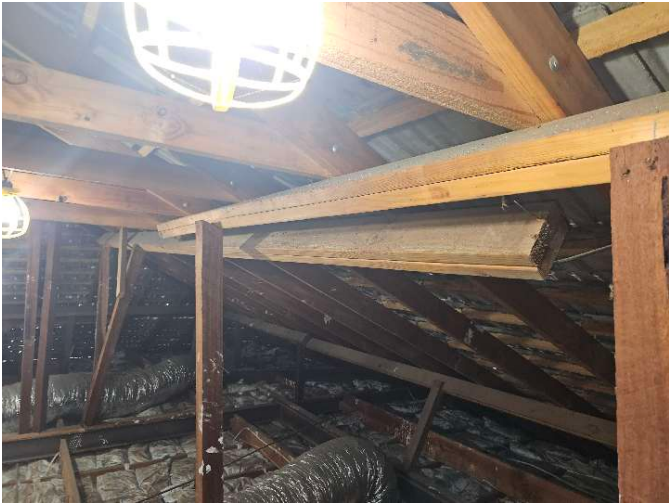
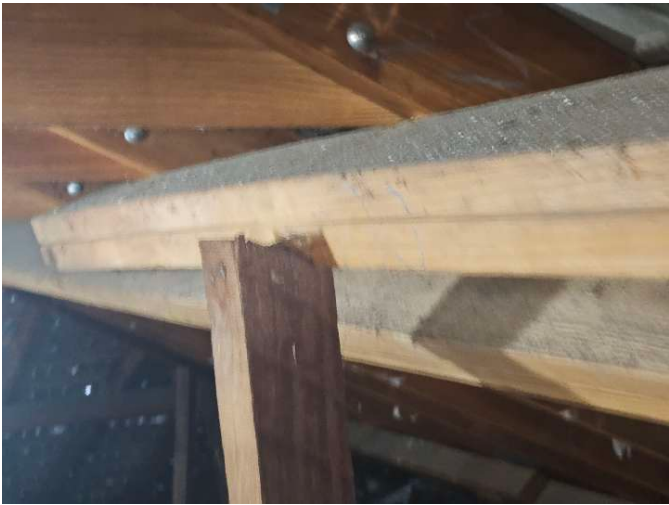
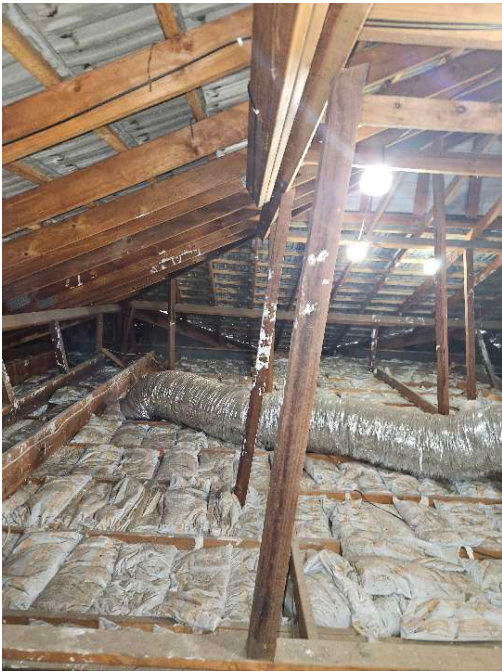
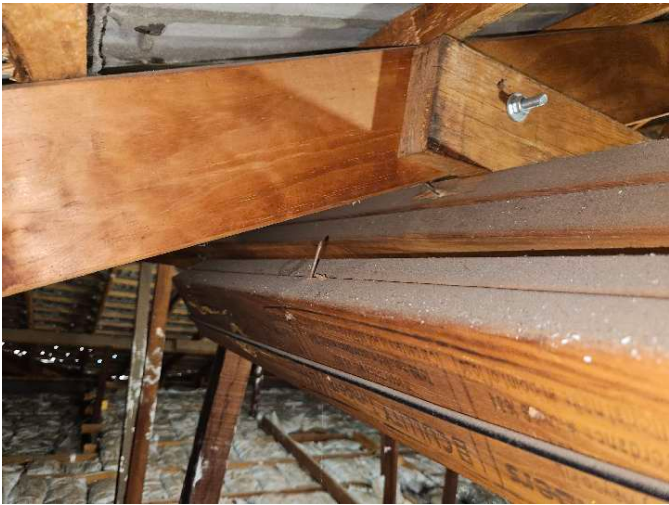
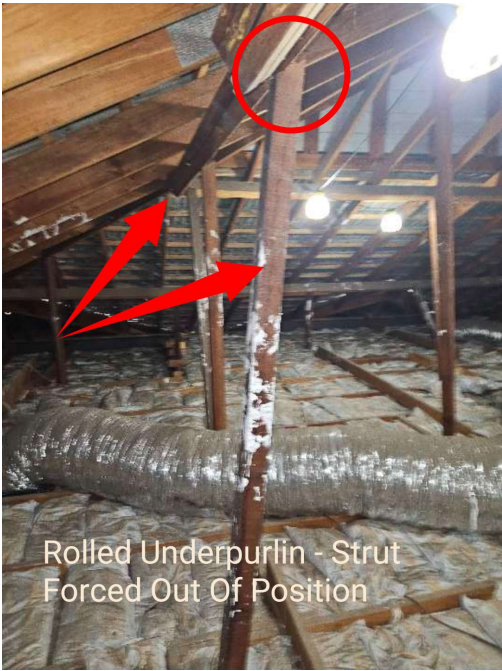
The Underpurlins to this plane of the roof frame have rolled out of position. Pushing the strutting timbers into an inadequate supporting angle. Fixings have failed and therefore are not holding structural components in the correct position.

This has compromised the structural support to this area of roof frame. Due to the downward force of the tiled roof cover further deterioration will occur which may lead to complete structural failure.

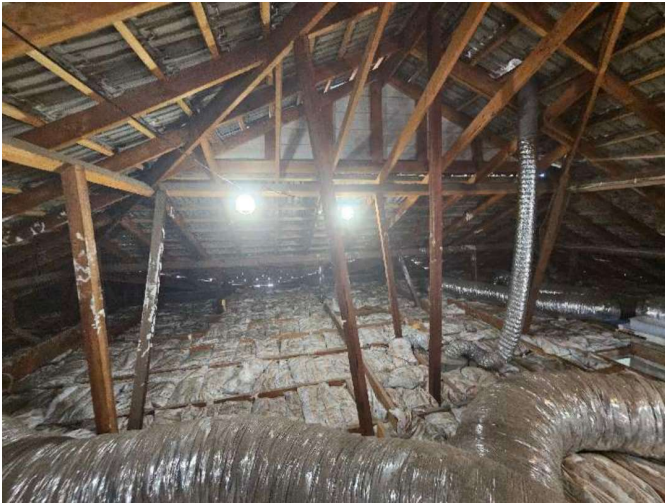
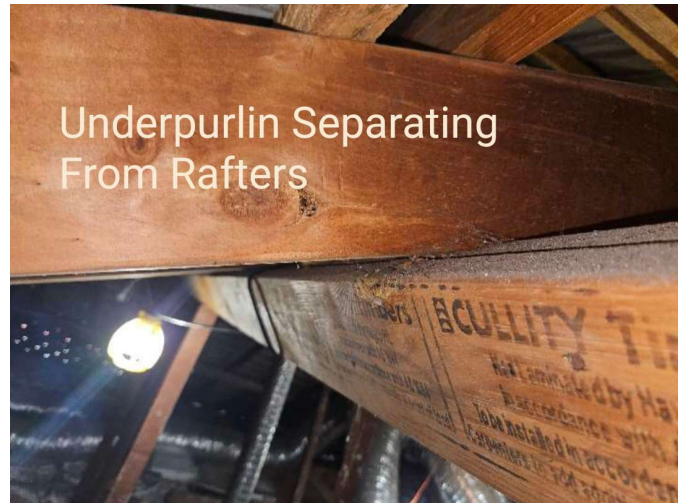
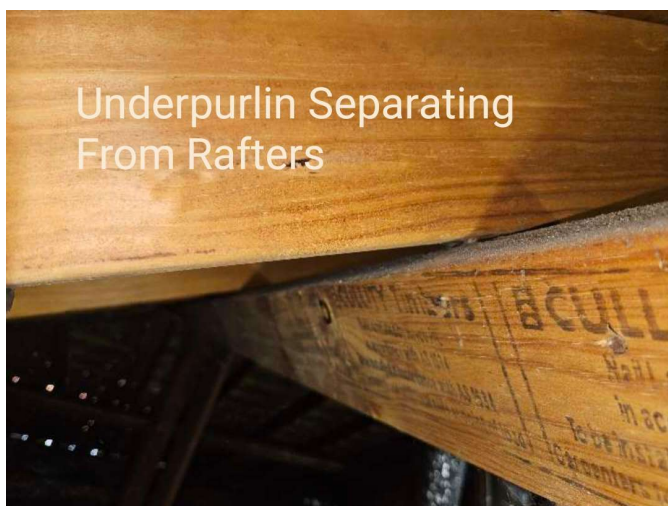
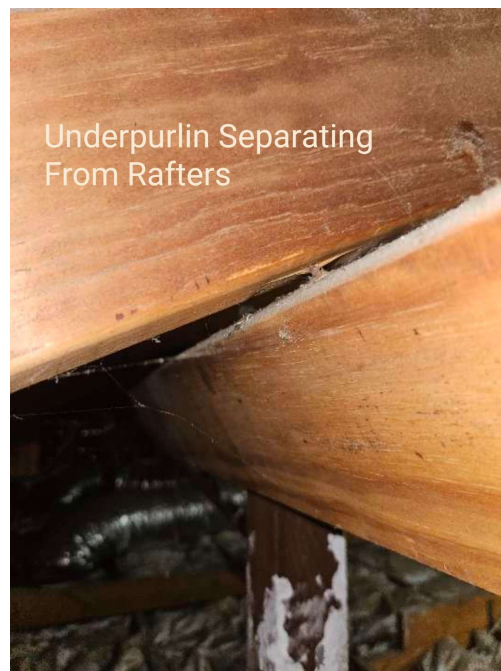
The Underpurlins to this plane of the roof are separating from the rafters pulling the fixings from the timbers. Through load stress this is reducing the efficiency of the structural members.

The underpurlins will continue to roll further out of position due to the structural load, which may lead to complete structural failure.

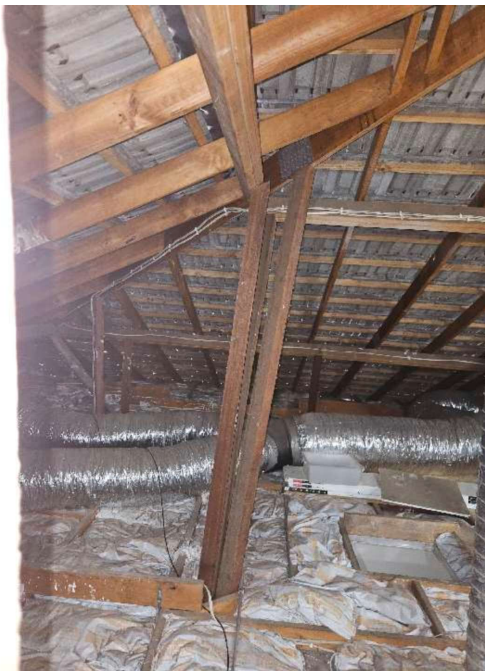
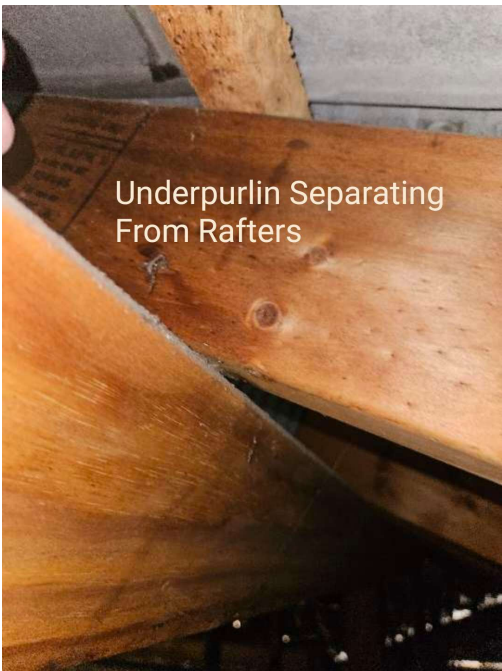
Underpurlin / rafter separation observed.

The roof cover load will continue to cause the underpurlins to roll and fixings to fail, as strutting timbers have been forced into an inadequate supporting angle.

Reduced structural integrity further deterioration can be expected.

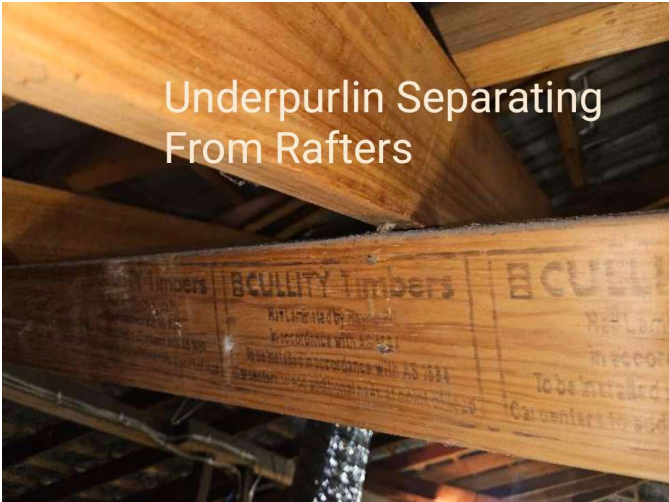
Underpurlin Separating From Rafters

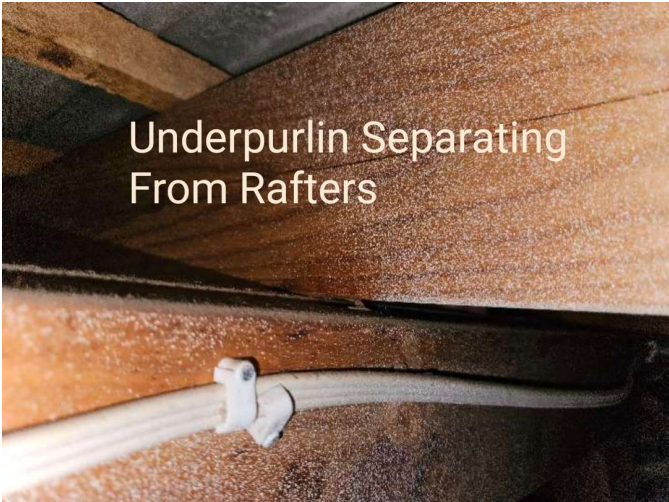
Underpurlin Separating From Rafters

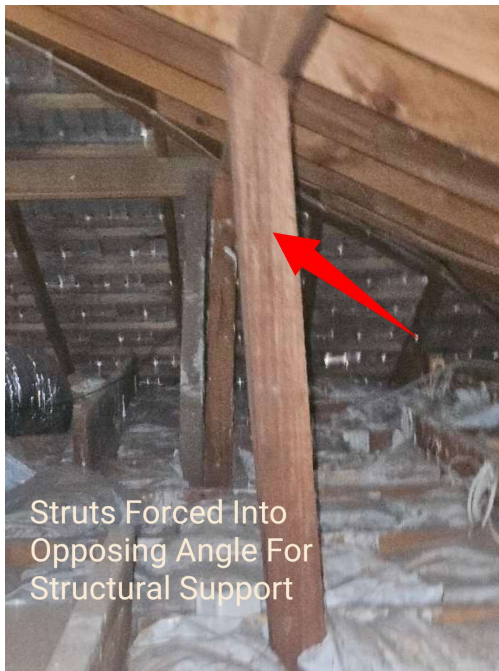
Underpurlin Separating From Rafters
