# Dilapidation Inspection

**SURE Building Inspections**

### Dilapidation Inspection Report

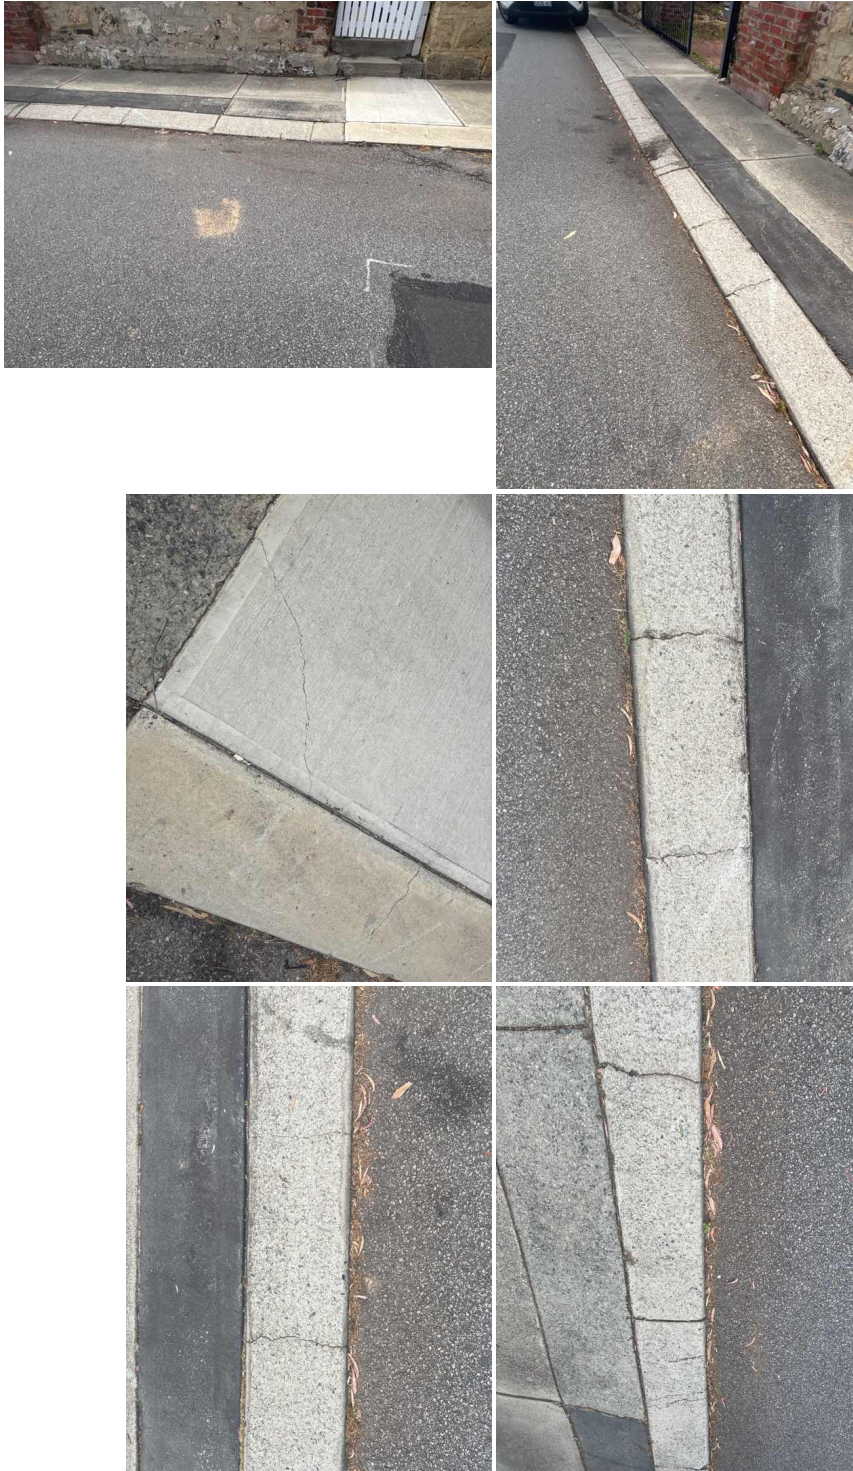
*i***STREET 1 (ZONE OF INFLUENCE)****Condition Of Surfaces Along Elevation****Path**

Cracking 1mm - 5mm (Typical).

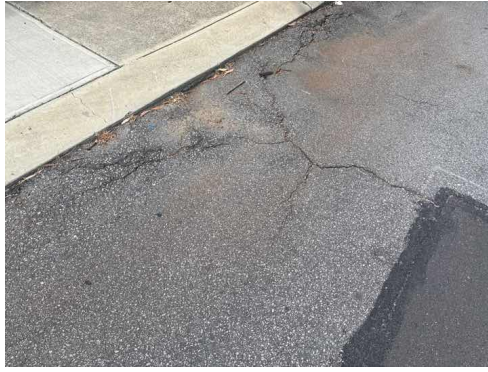
**Road**

Cracking 5mm - 10mm

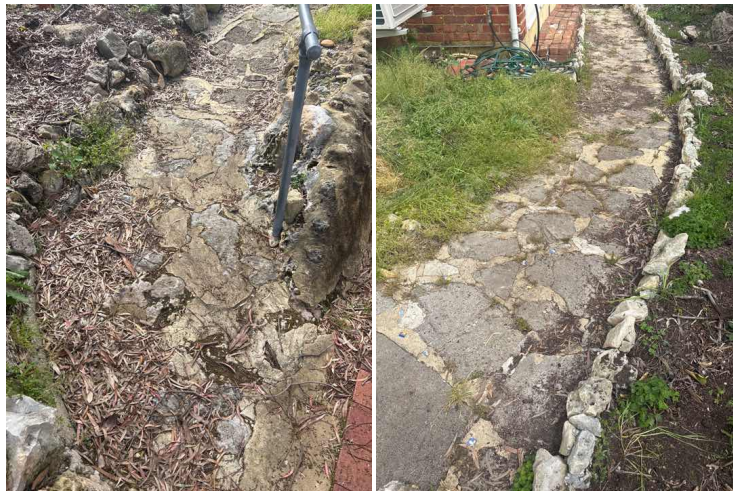
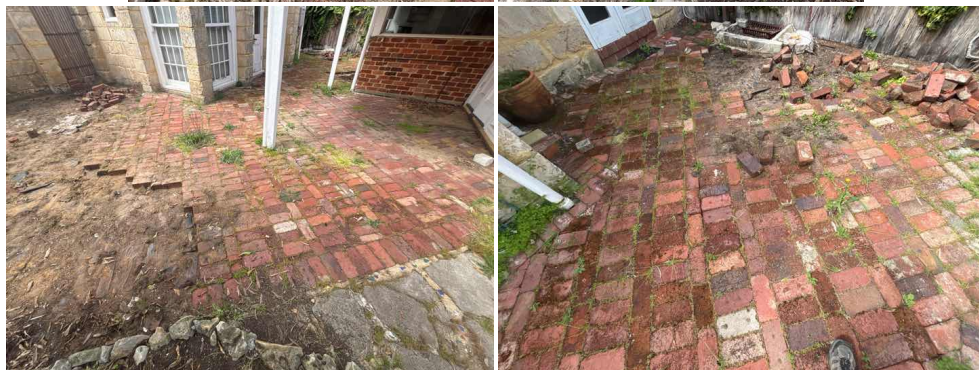
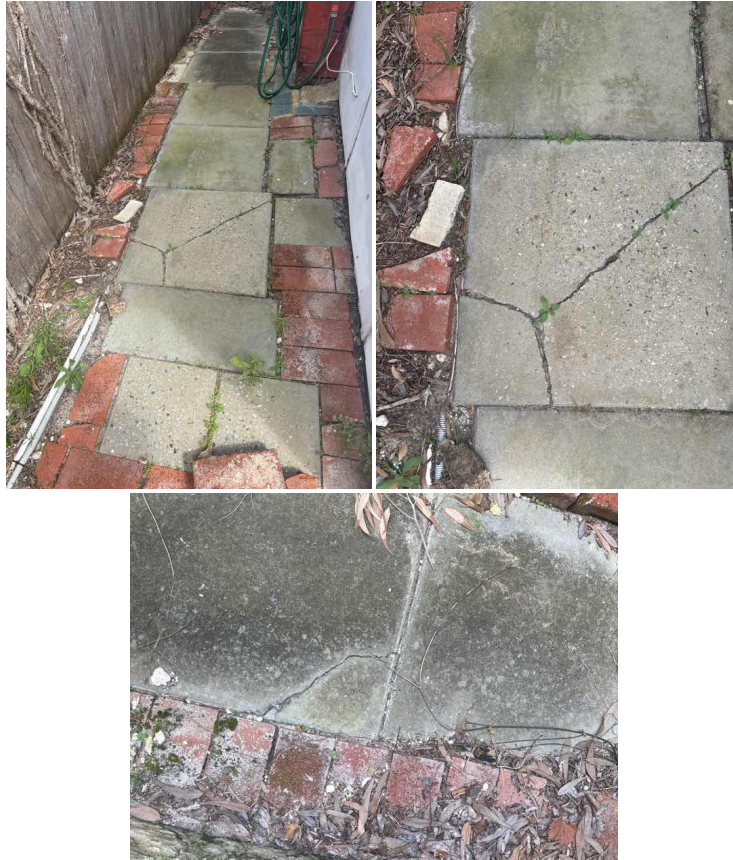
#### Path/s

Cracking 5mm - 10mm

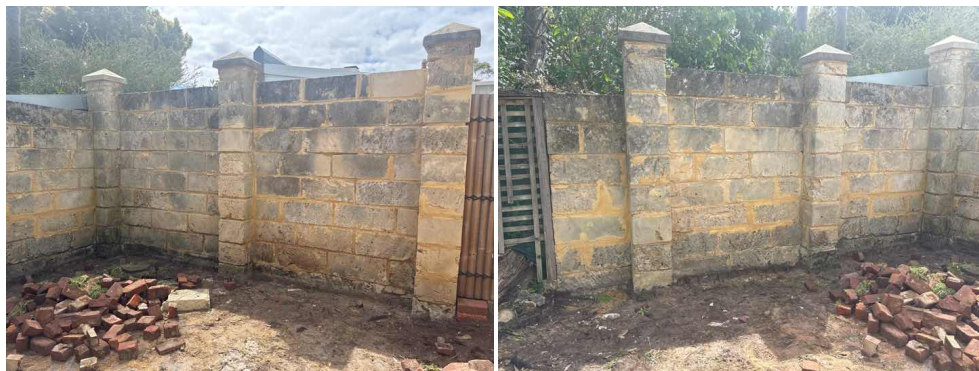
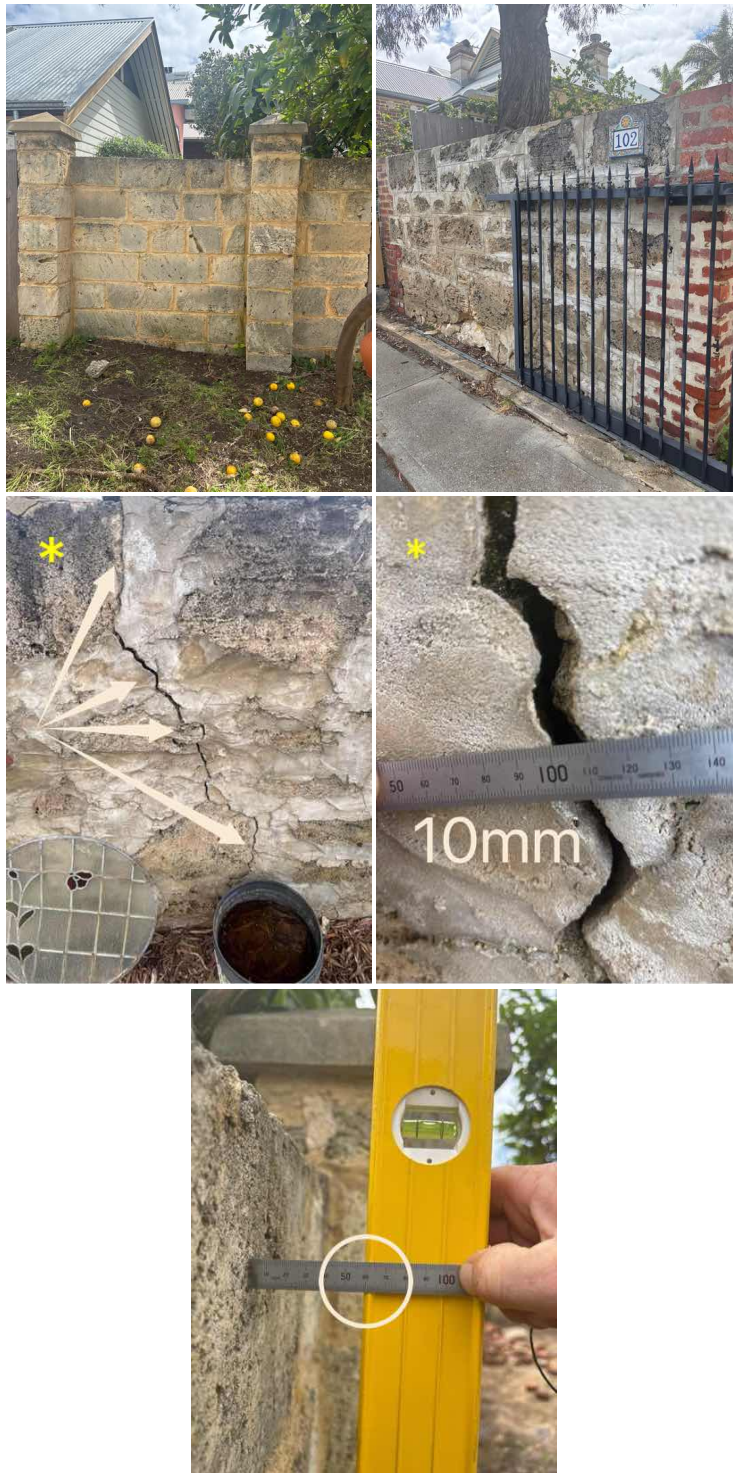
## Brick Fence

Cracking 5mm - 10mm

Section of rear garden limestone wall is leaning.

1.7m high wall approximately 60mm out of plumb.

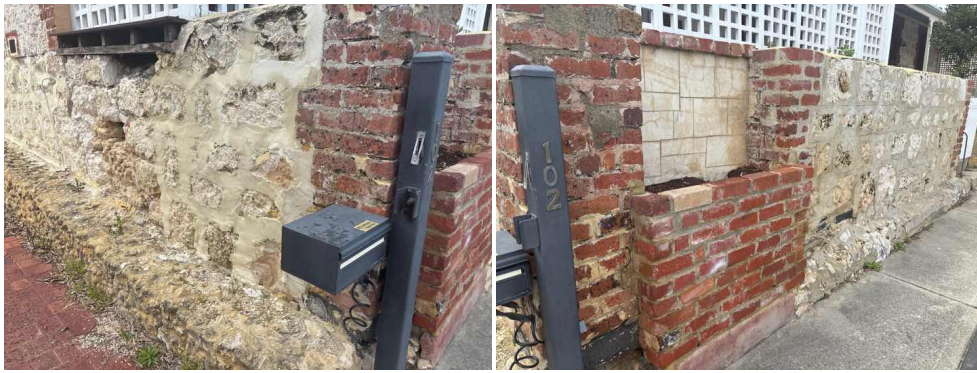
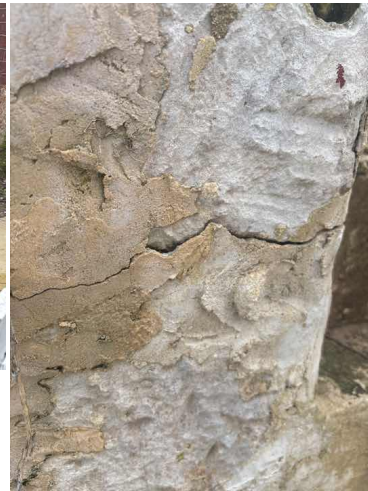
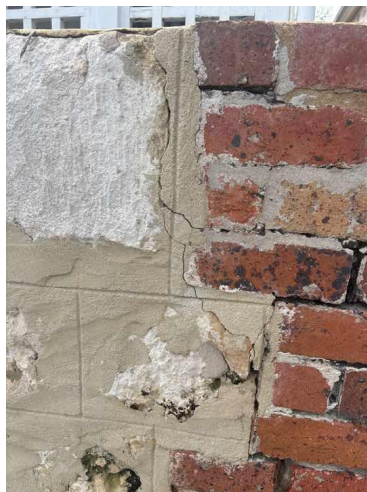
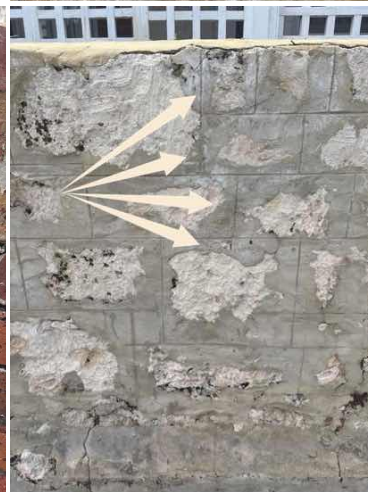
**Retaining Wall/s**  
Cracking 1mm - 5mm

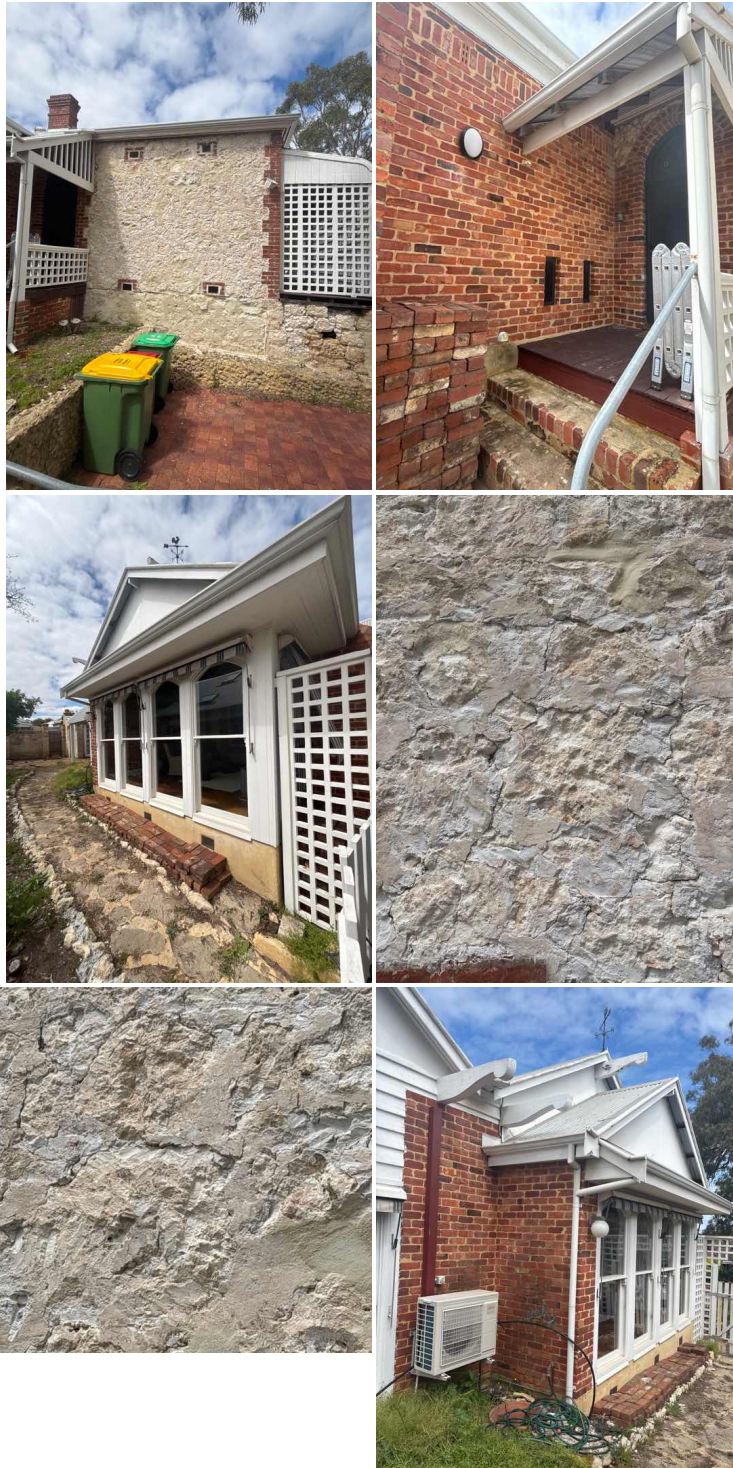
Numerous Hairline mortar cracks observed.

Cracking 0.01mm - 0.5mm

Brick cracking to areas observed.

Not considered to be of structural concern.

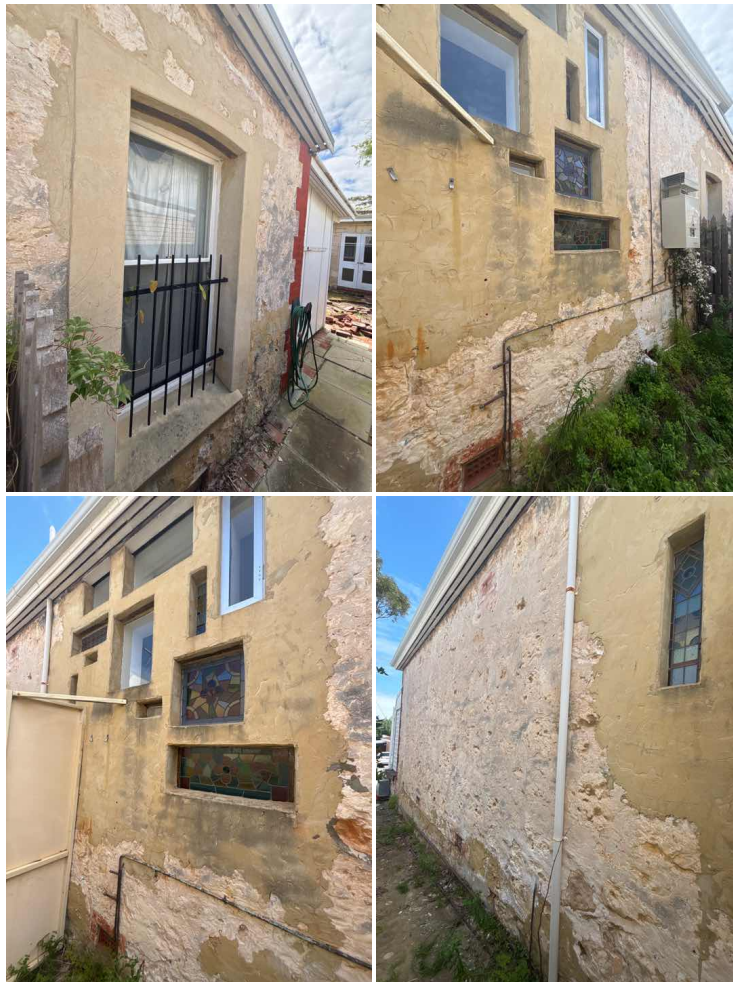
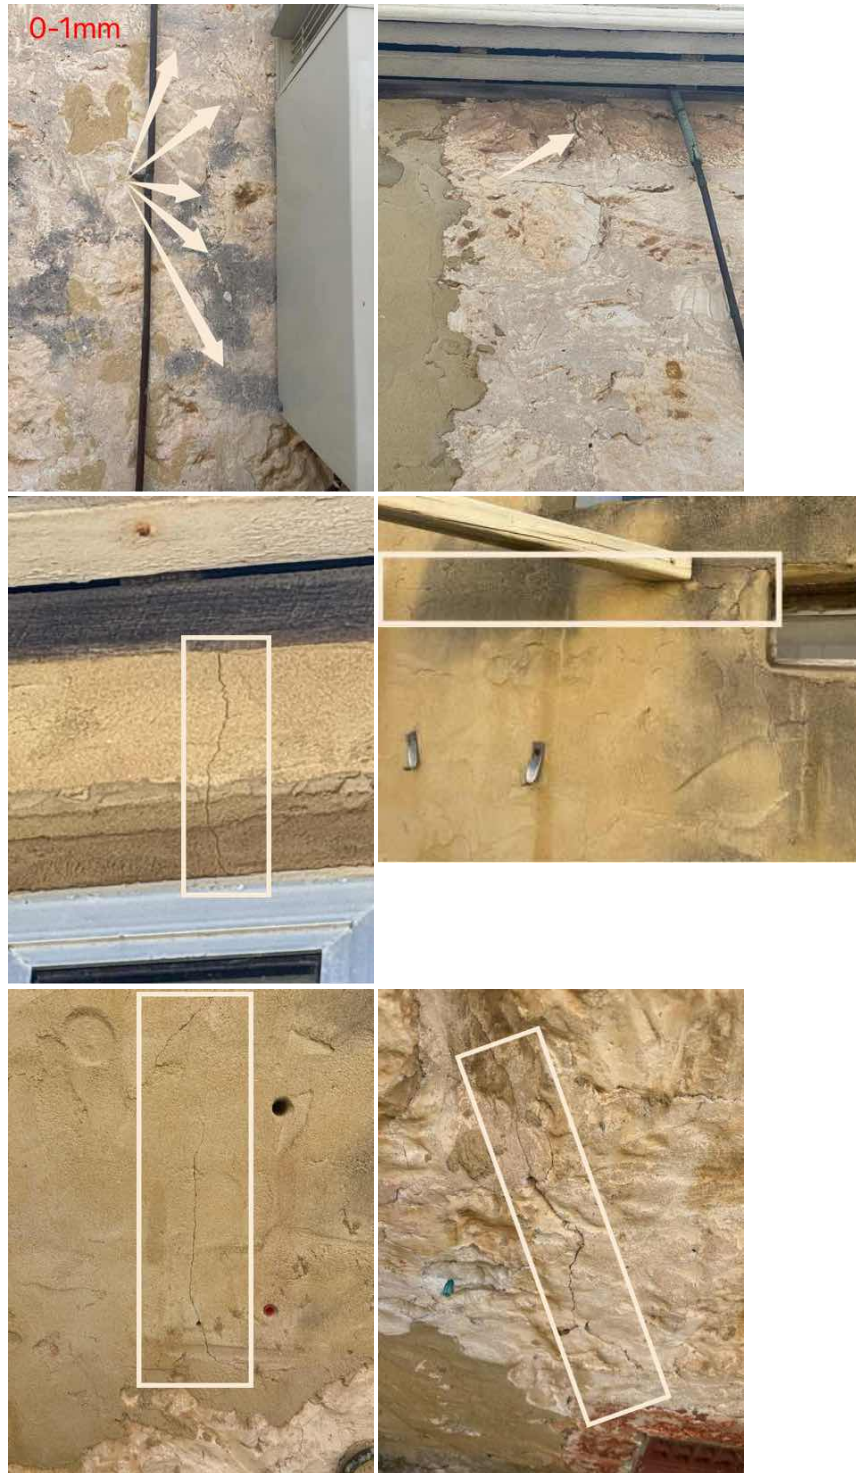
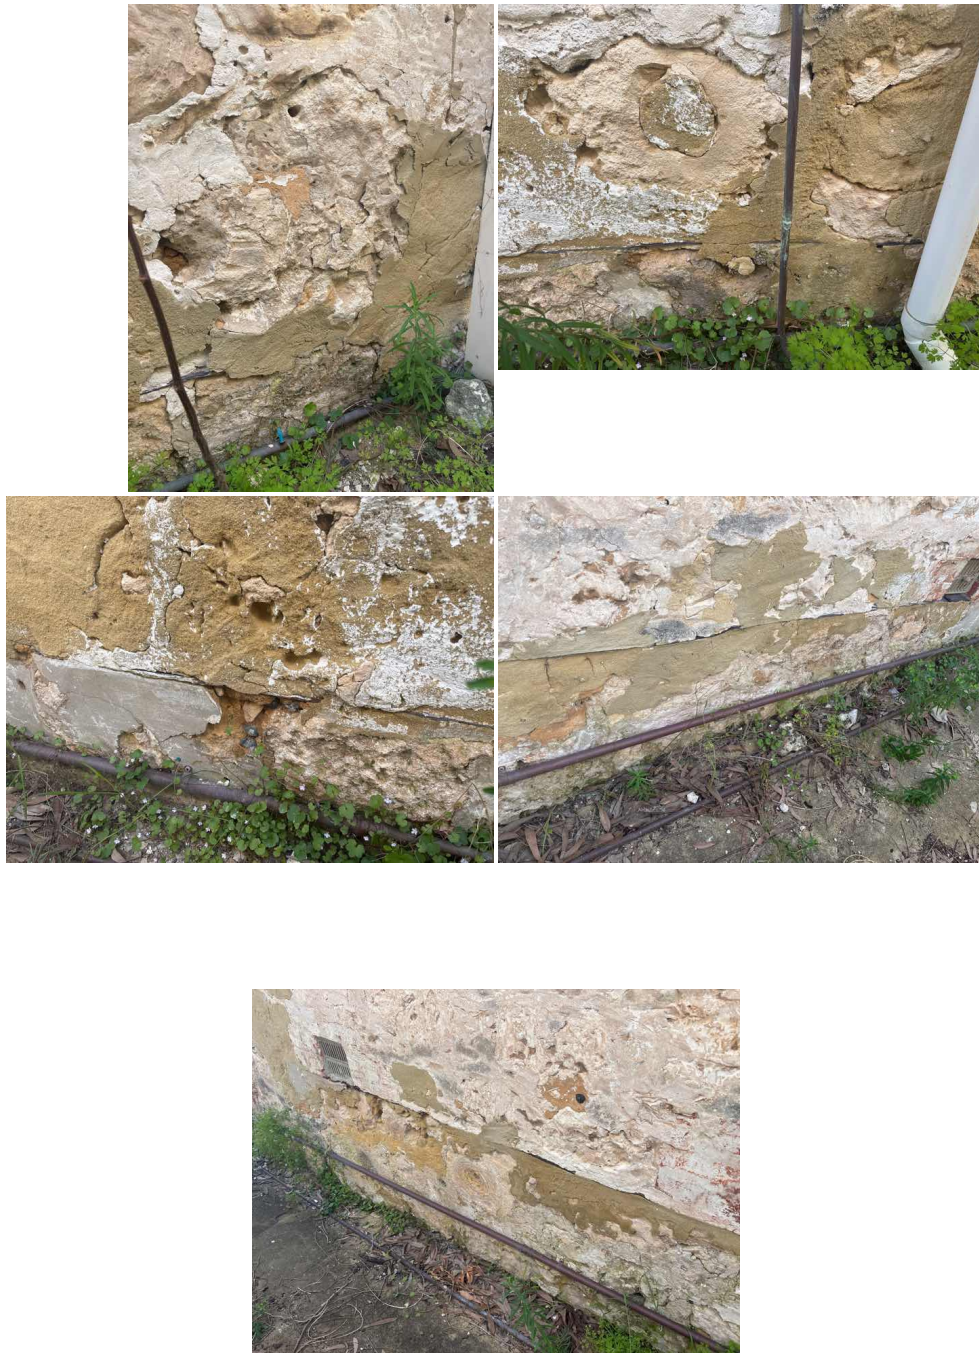
Cracking 0.5mm - 1mm

Areas of mortar / render deterioration noted.

This is age related.

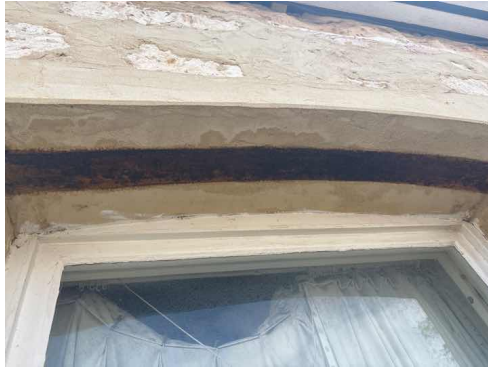
Rust observed to lintel. This may contribute to cracking in the immediate area.

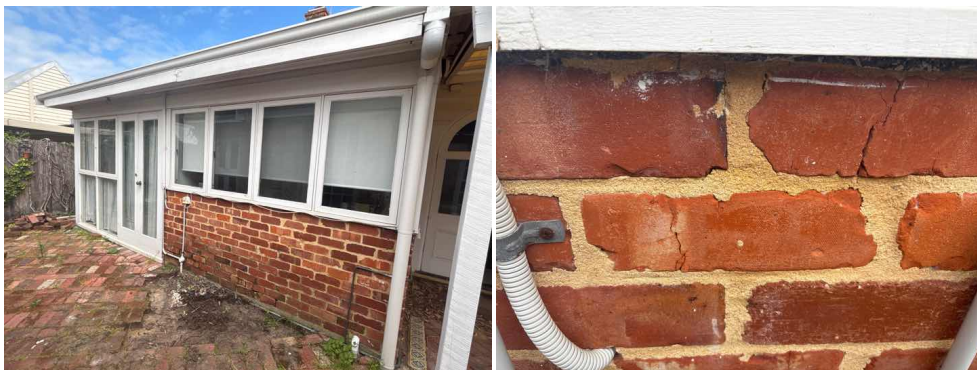
Brick cracking to areas observed.

Not considered to be of structural concern.

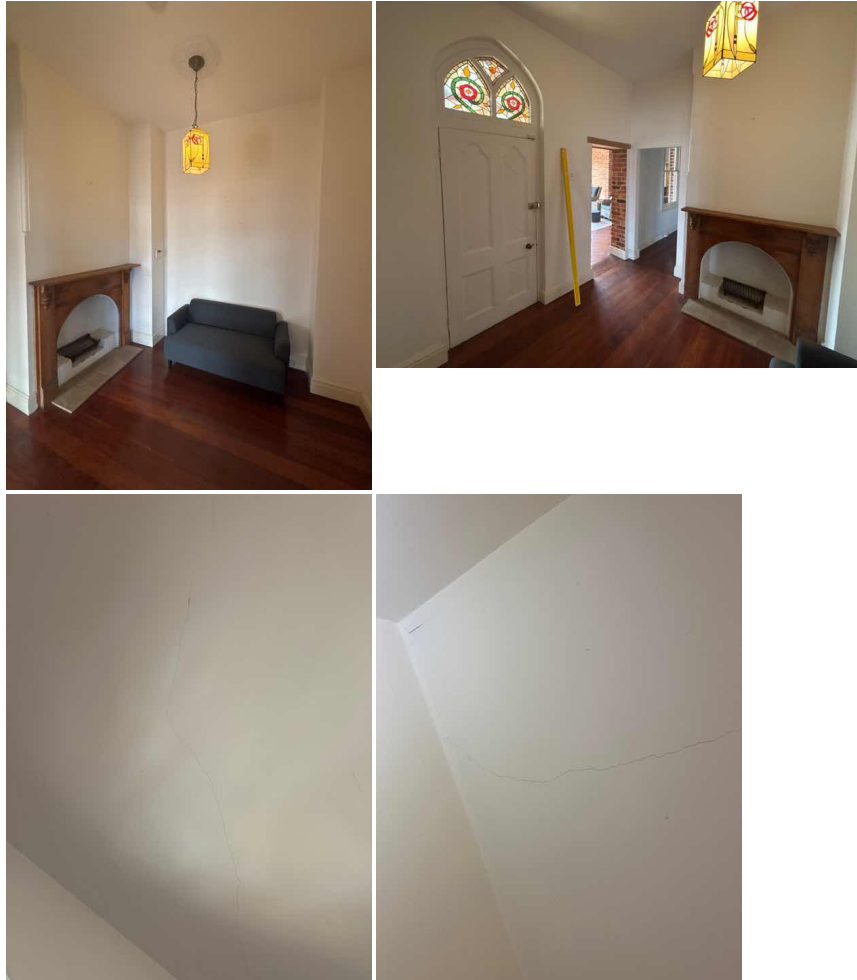
Cracking 0.01mm - 0.5mm

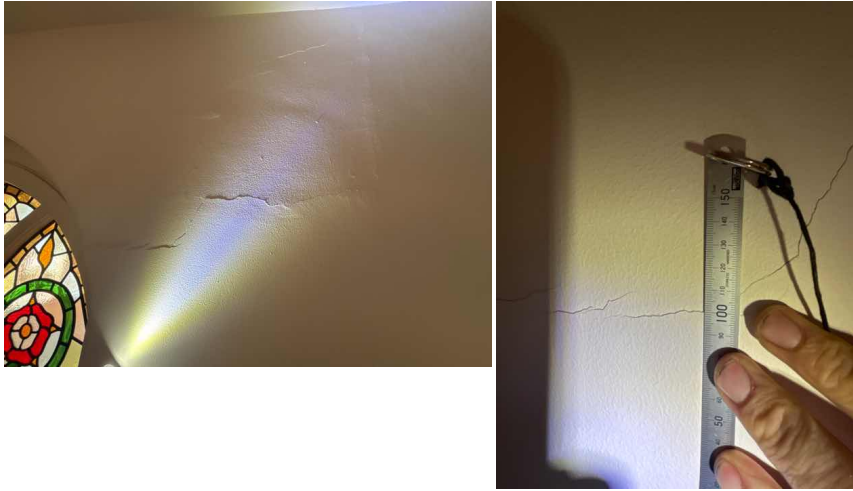
### Northern Wall

Cracking 0.01mm - 0.5mm

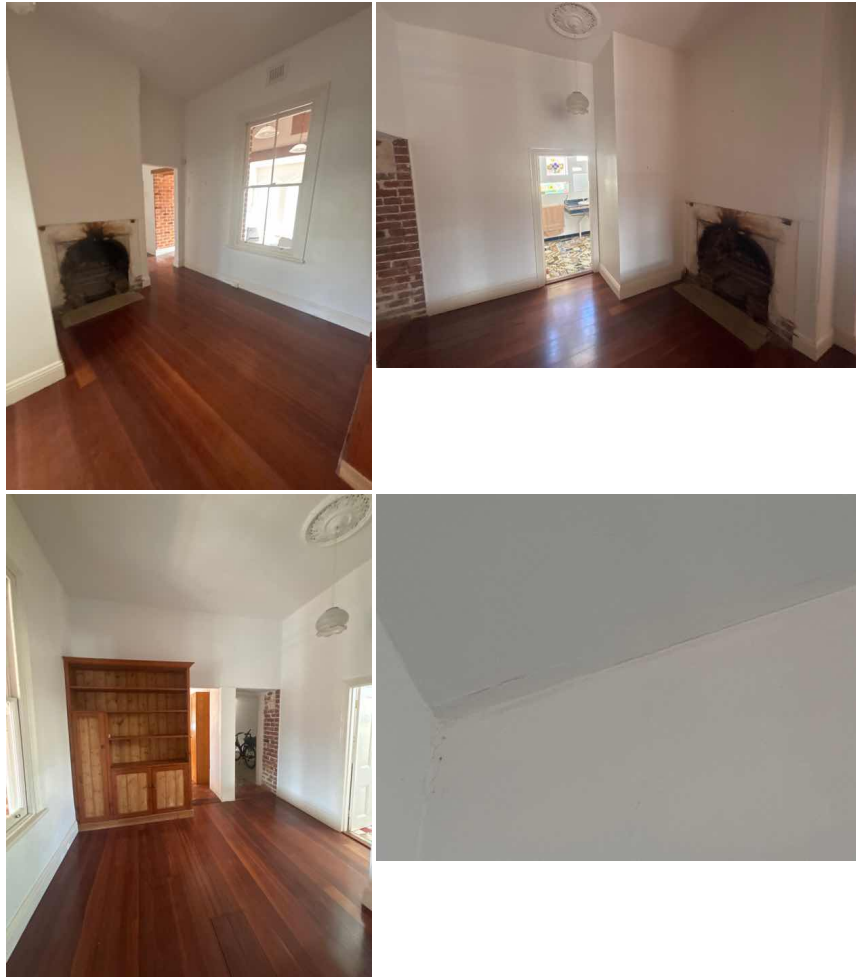
Hairline crack less than 0.01mm

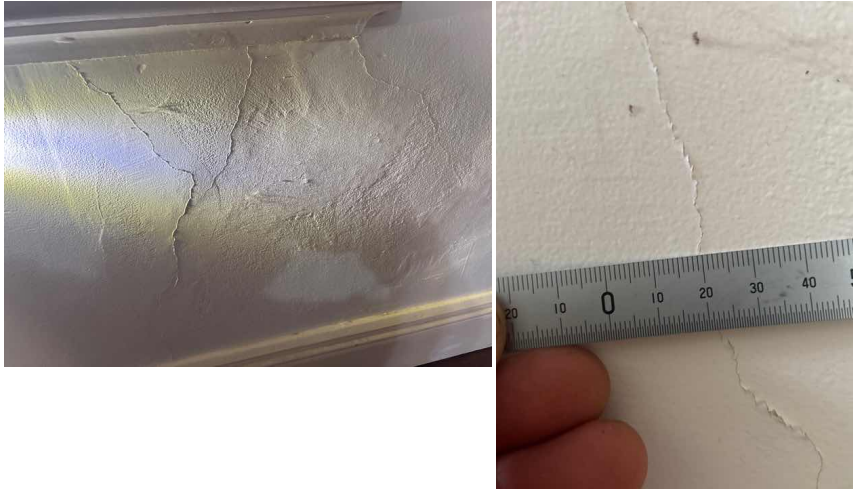
### Northern Wall

Cracking 0.01mm - 0.5mm

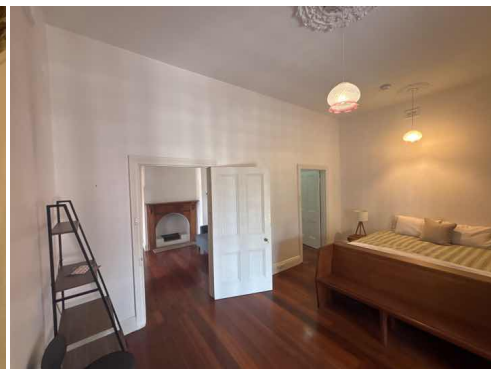
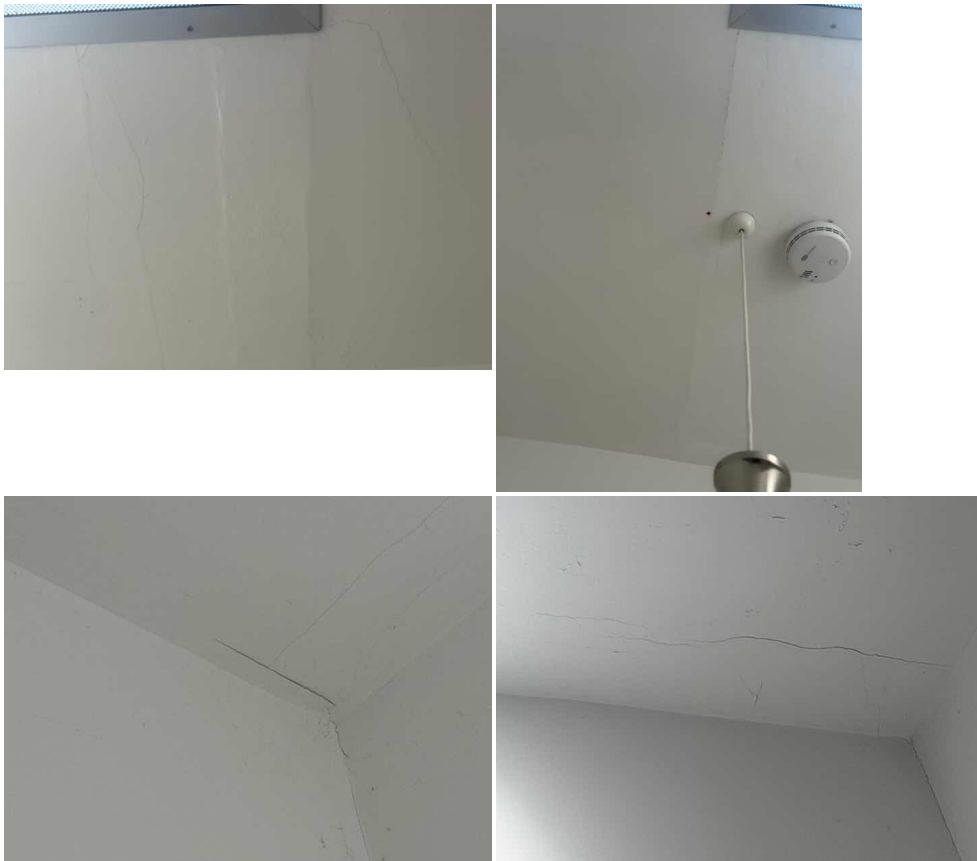
Cracking 0.01mm - 0.5mm

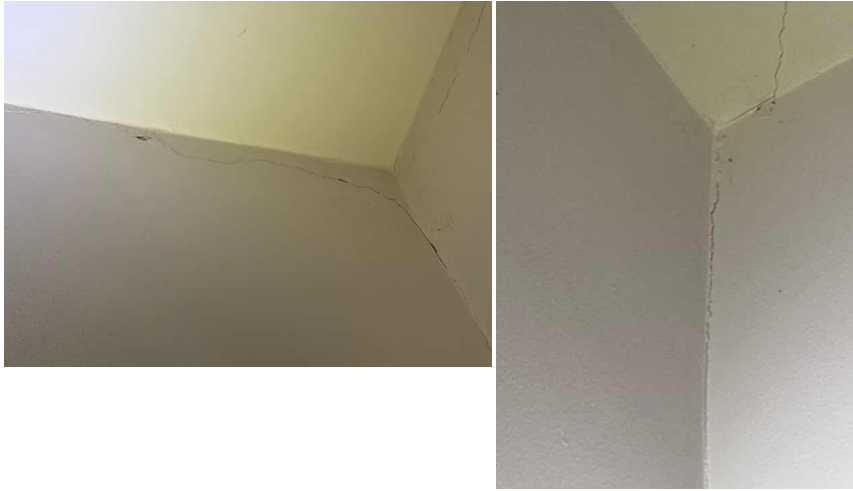
### Southern Wall

Cracking 0.5mm - 1mm

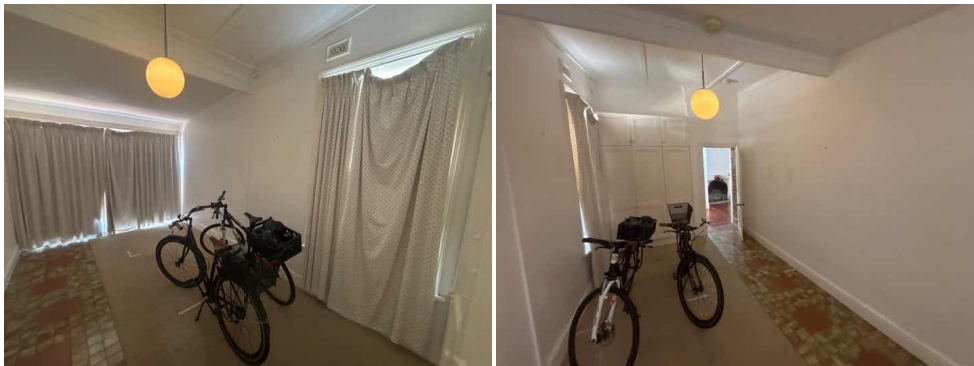
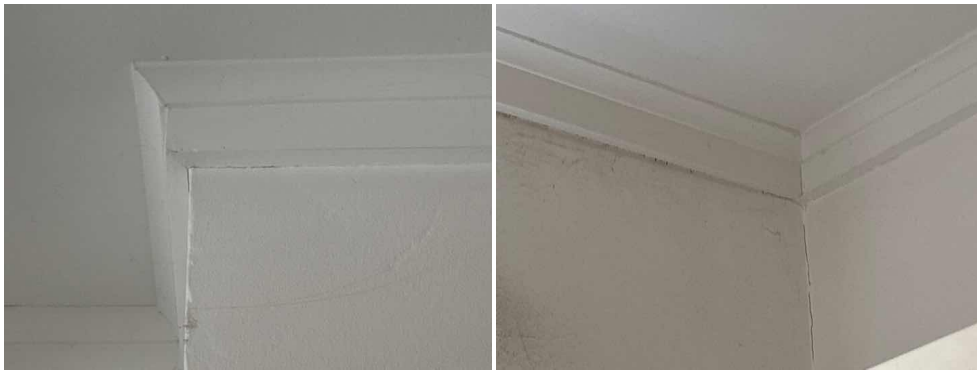
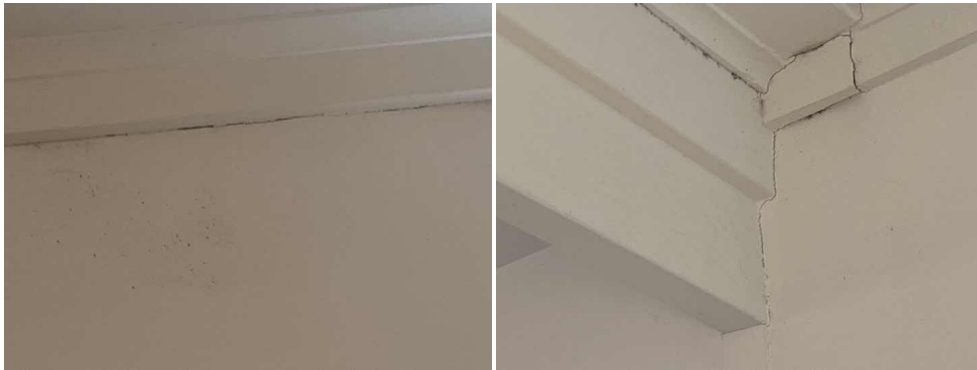
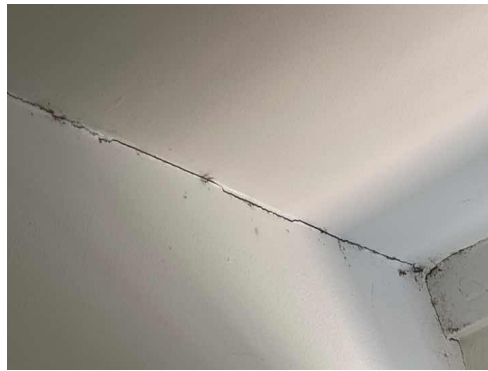
Hairline crack less than 0.01mm

Cracking 0.5mm - 1mm

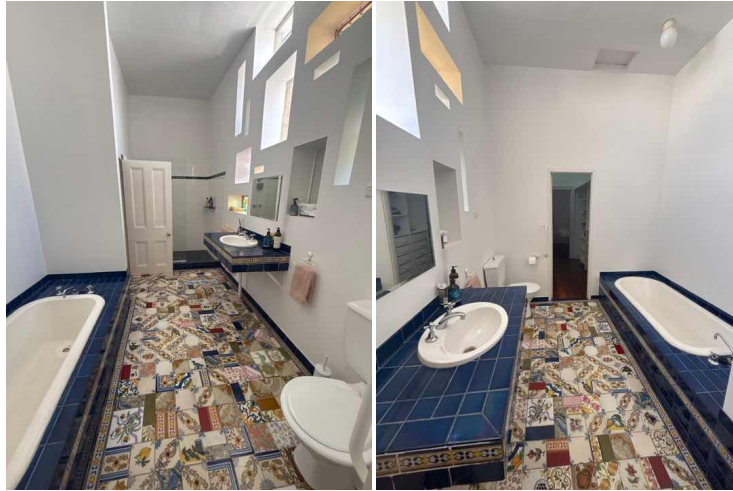
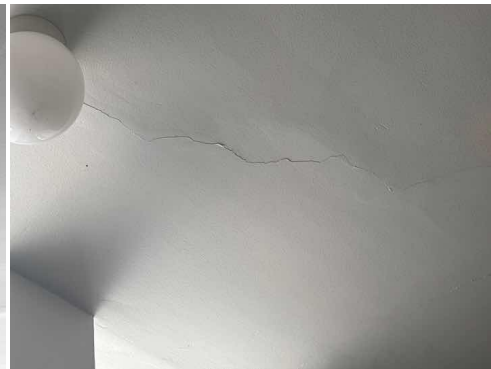
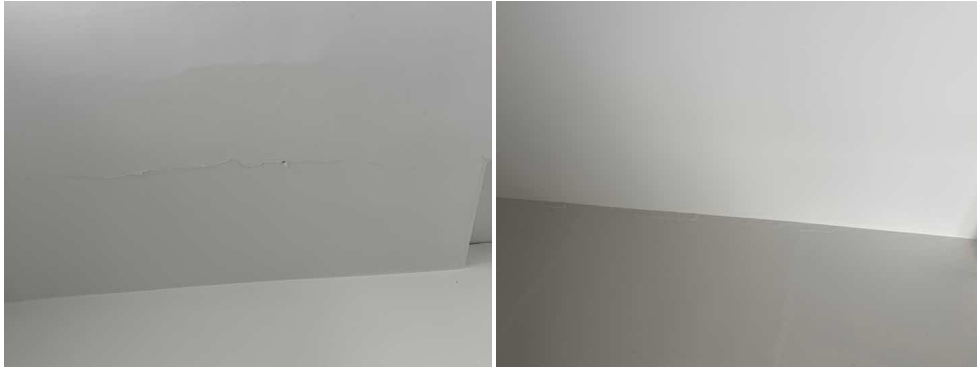
Cracking 1mm - 5mm

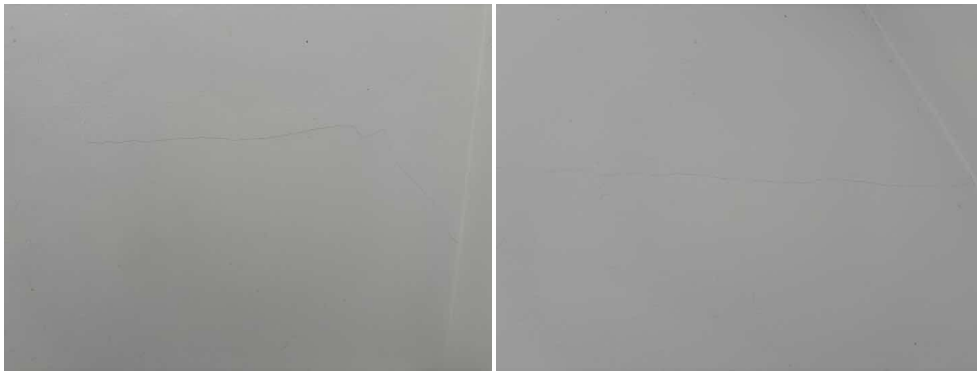
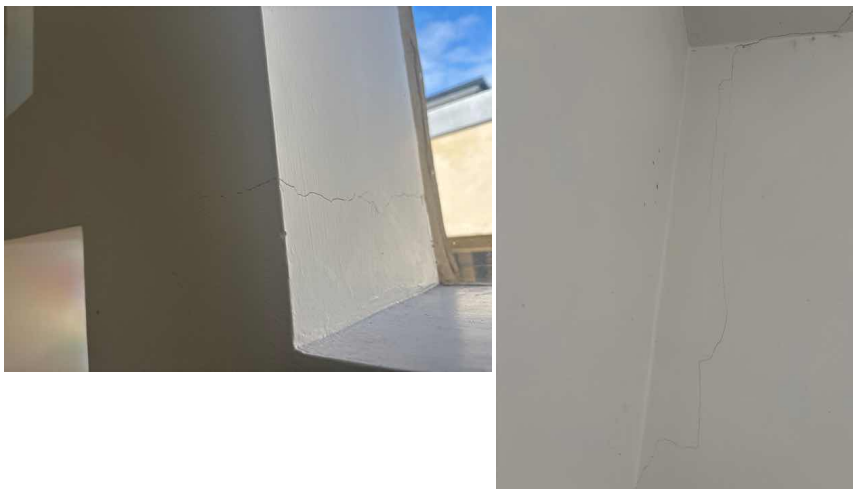
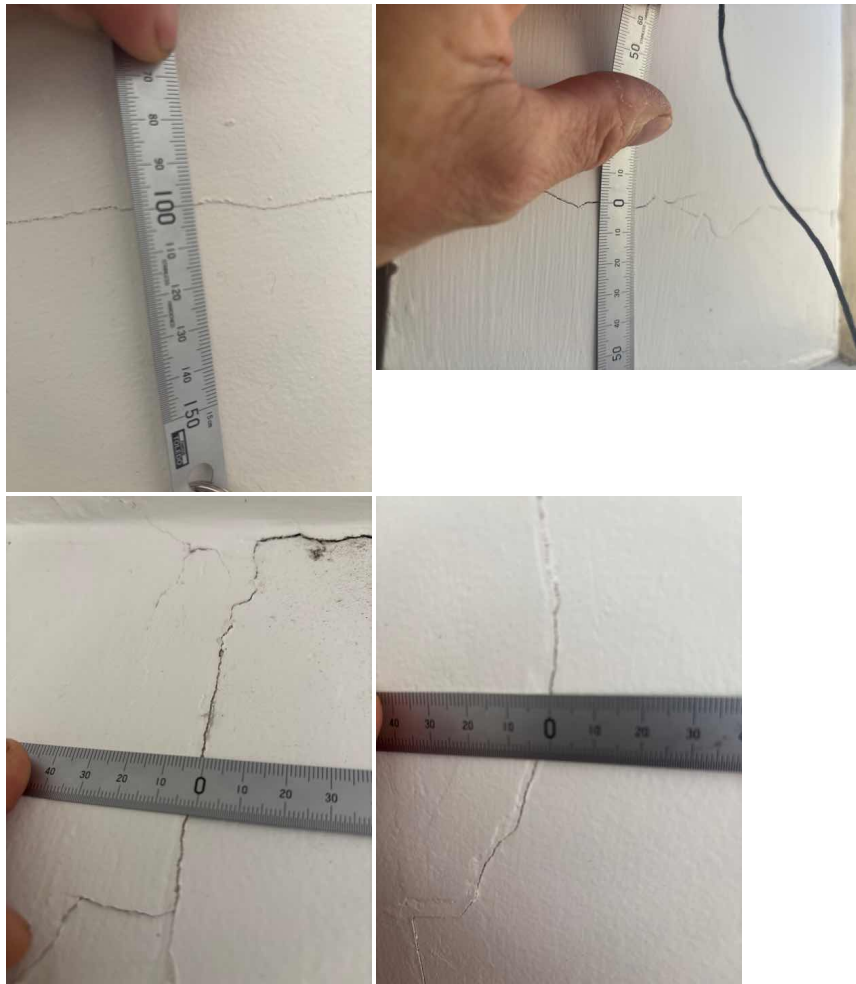
**Southern Wall**

Cracking 1mm - 5mm

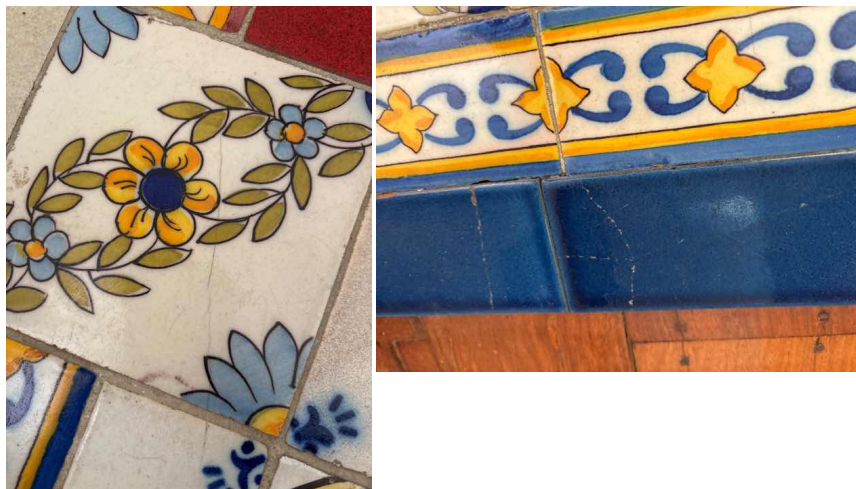
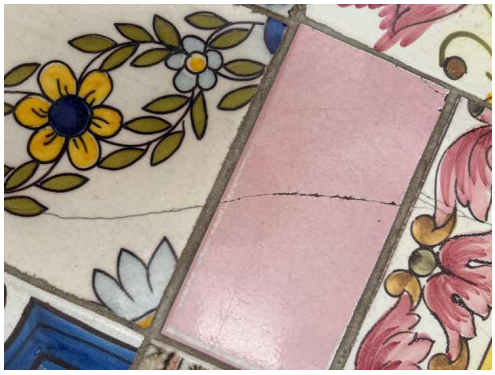
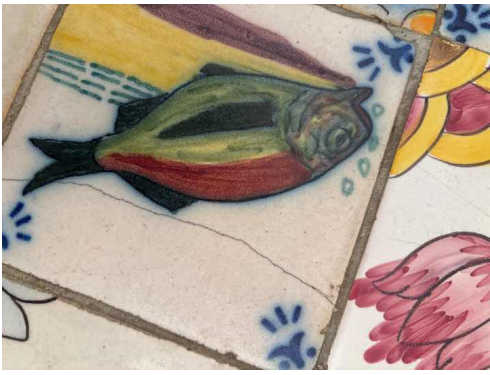
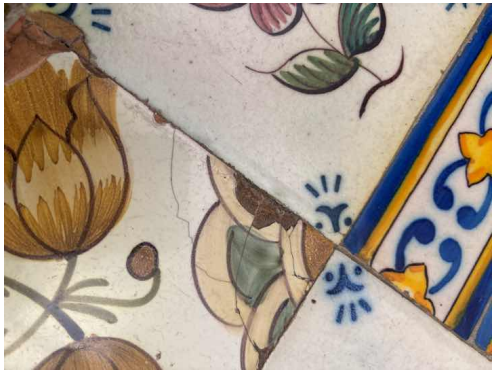
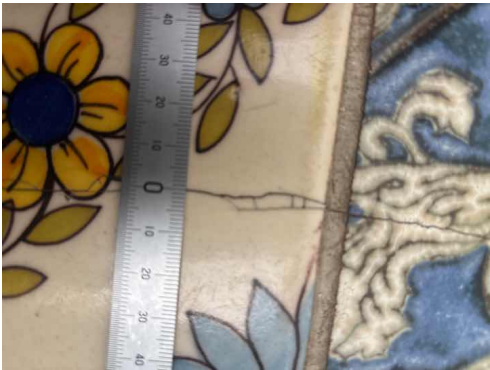
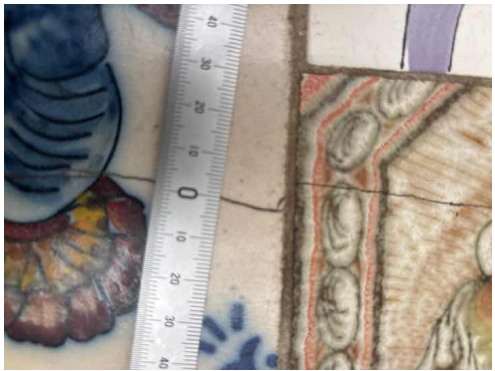
Cracking 0.01mm - 0.5mm

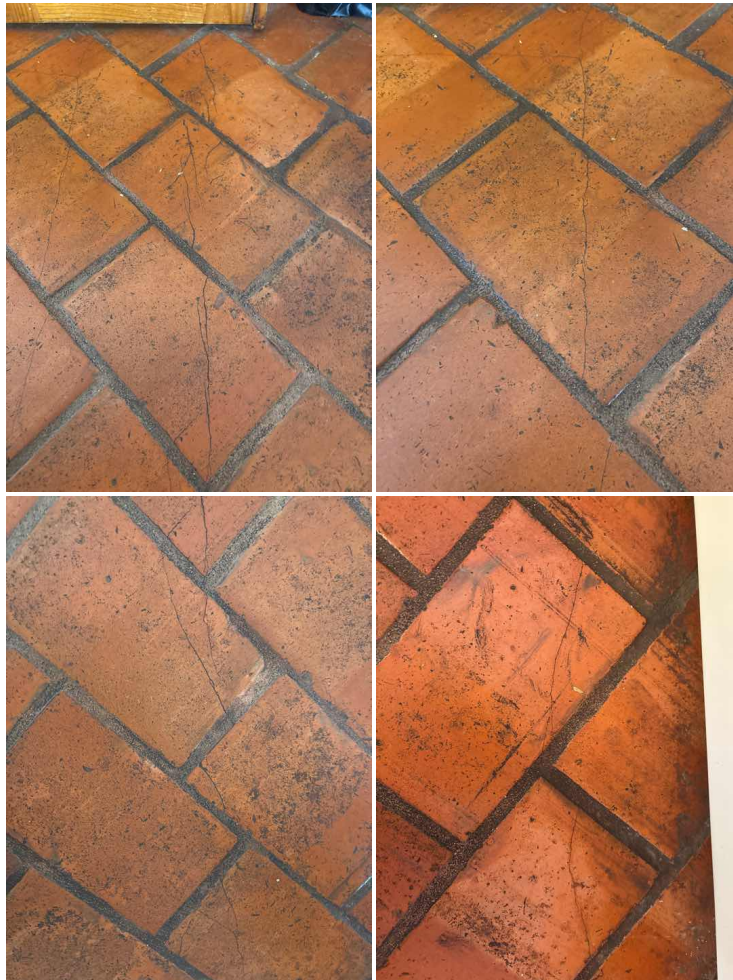
Cracking 0.5mm - 1mm

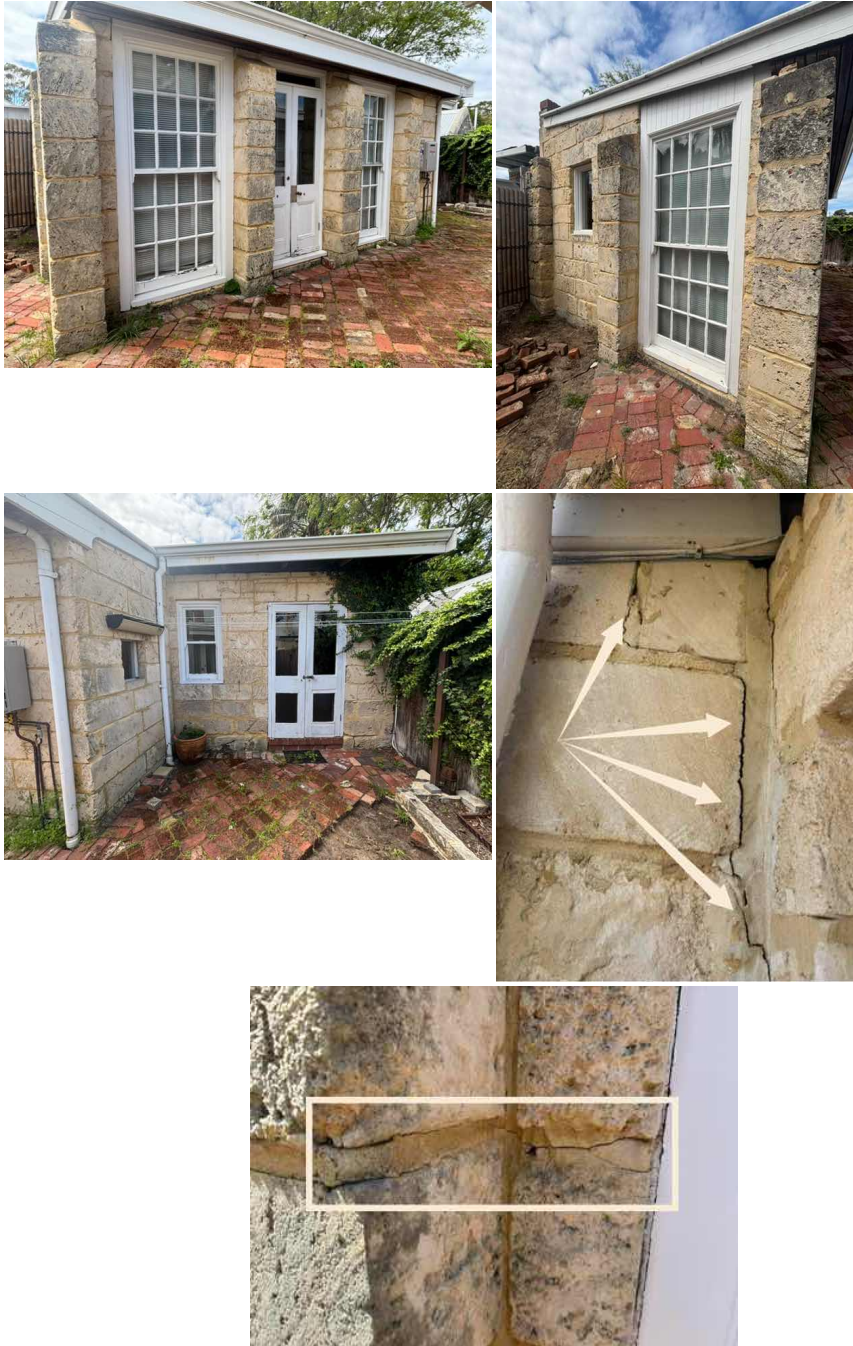
Cracking 1mm - 5mm
