# High Rise Inspection

**SURE Building Inspections**

### High Rise Apartment Inspection

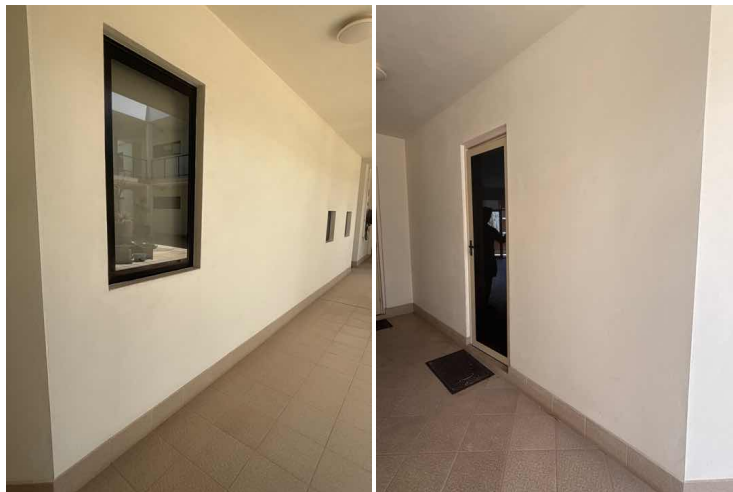
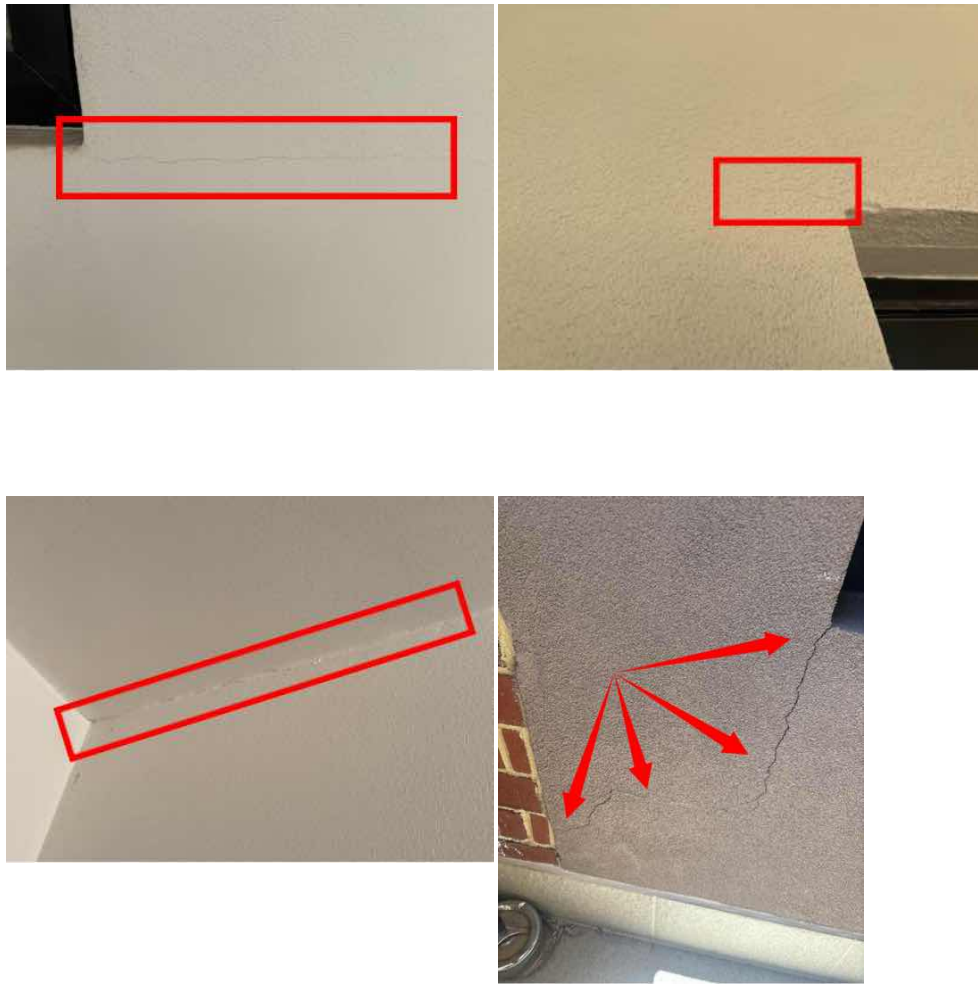
### External Wall Observations

| Section | Location | Name | Comment |
|---|---|---|---|
| EXTERIOR | External Walls | External Wall Observations | <p>Structural Minor: There appears to have been some settlement in the building which has caused some cracking to the walls. These crack/s are categorised as 0 to 2. This can also cause some doors to bind or be out of square. In the inspectors opinion these cracks are due to settlement, usually due to ground movement and subsequent movement to building materials can be expected. All cracks should be monitored and if cracks increase in size, further investigation should be carried out by a structural engineer. Engage a bricklayer to repair.</p> <p>For clarification on the category of cracks with a damage category of 0 to 2, please refer to Cracking of Building Elements in Section 2D of the Terms and Conditions of this report.</p> |

**Structural Minor:** There appears to have been some settlement in the building which has caused some cracking to the walls. These crack/s are categorised as 0 to 2. This can also cause some doors to bind or be out of square. In the inspectors opinion these cracks are due to settlement, usually due to ground movement and subsequent movement to building materials can be expected. All cracks should be monitored and if cracks increase in size, further investigation should be carried out by a structural engineer. Engage a bricklayer to repair.

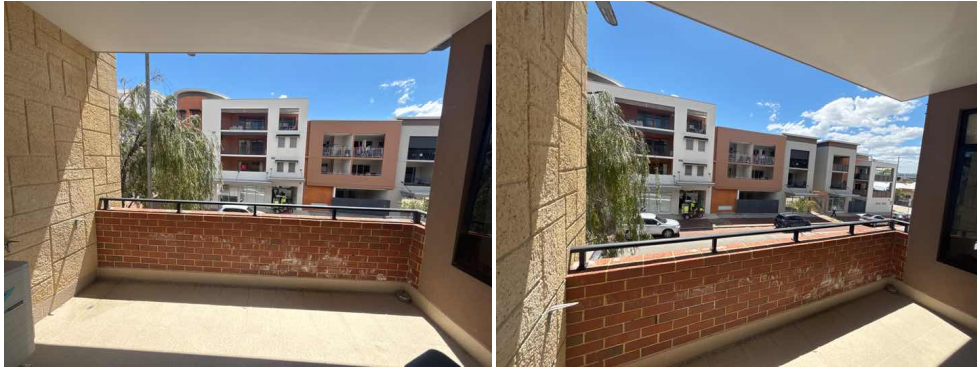
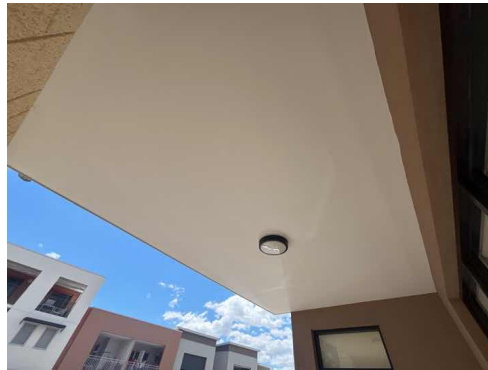
### Ceiling Lining Observations

**Maintenance:** Ceiling Lining join crack observed. Engage a painter for repairs.

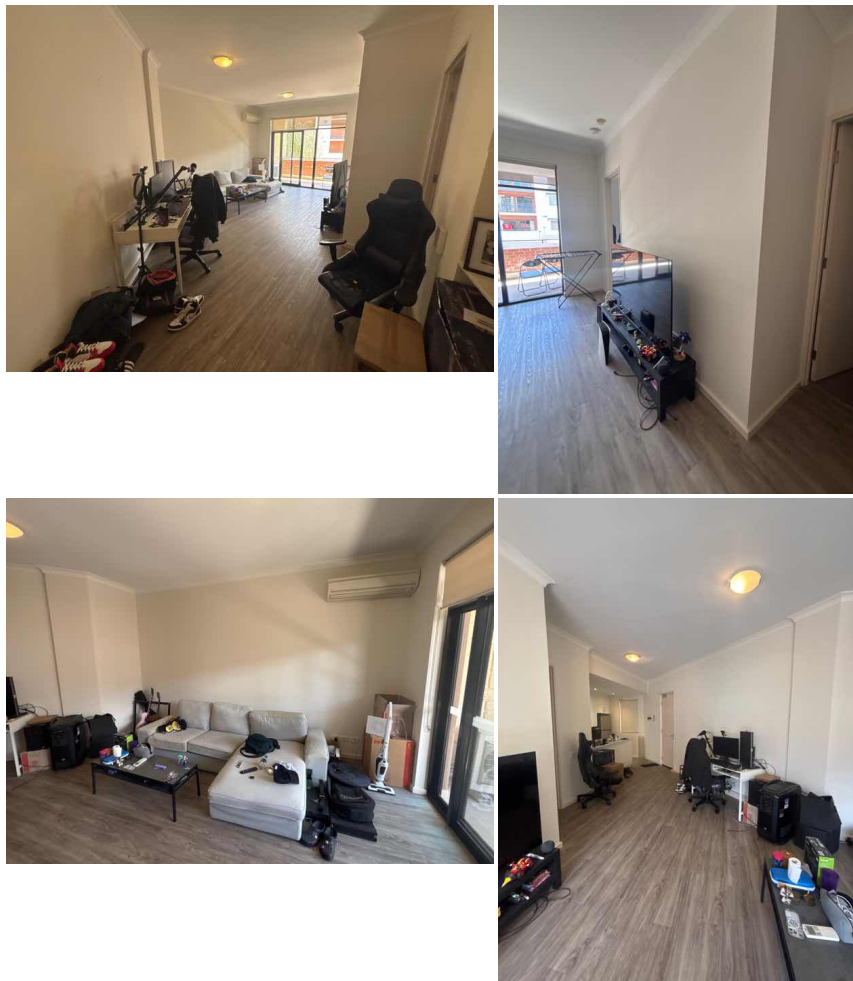
### **Ceiling Observations**

**Maintenance:** Typical marks/scuffs observed to areas of ceiling linings.

Recommendation - Engage a painter for repairs.

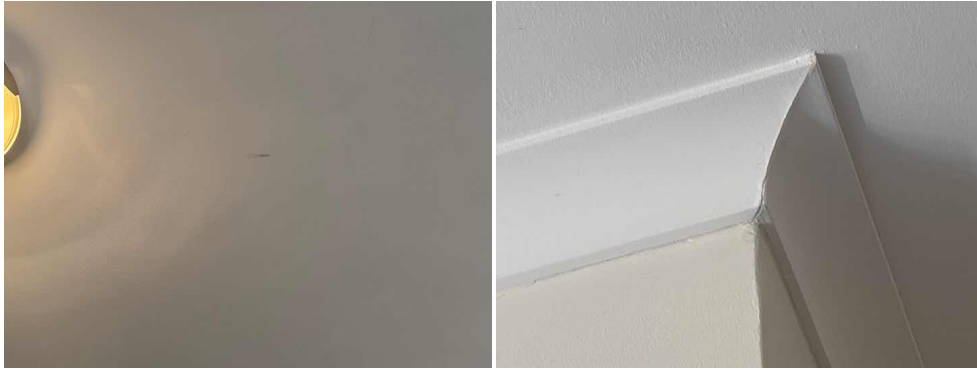
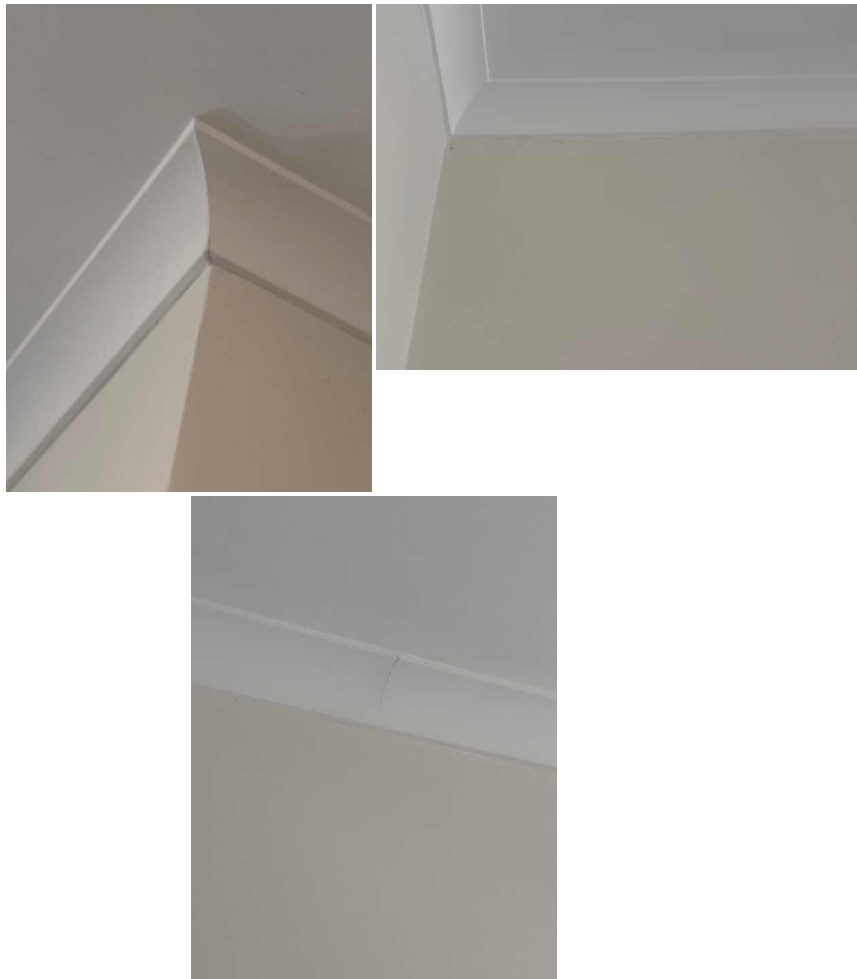
## Walls Observations

**Maintenance:** General scuffs and marks to walls. Recommendation: Engage a painter for repairs.

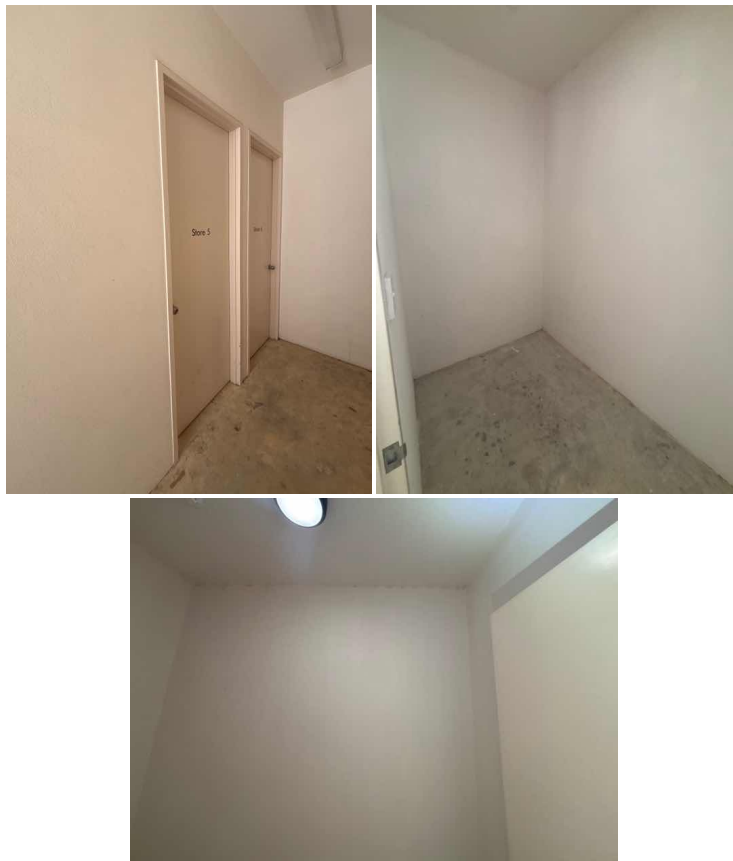
## Walls Observations

| Section | Location | Name | Comment |
|---|---|---|---|
| INTERIORS | Store Room | Walls Observations | <p>Structural Minor: There appears to have been some settlement in the building which has caused some cracking to the walls. These crack/s are categorised as 0 to 2. This can also cause some doors to bind or be out of square. In the inspectors opinion these cracks are due to settlement, usually due to ground movement and subsequent movement to building materials can be expected. All cracks should be monitored and if cracks increase in size, further investigation should be carried out by a structural engineer. Recommendation: Engage a painter to patch and paint.</p> <p>For clarification on the category of cracks with a damage category of 0 to 2, please refer to Cracking of Building Elements in Section 2D of the Terms and Conditions of this report.</p> |

**Structural Minor:** There appears to have been some settlement in the building which has caused some cracking to the walls. These crack/s are categorised as 0 to 2. This can also cause some doors to bind or be out of square. In the inspectors opinion these cracks are due to settlement, usually due to ground movement and subsequent movement to building materials can be expected. All cracks should be monitored and if cracks increase in size, further investigation should be carried out by a structural engineer. Recommendation: Engage a painter to patch and paint.

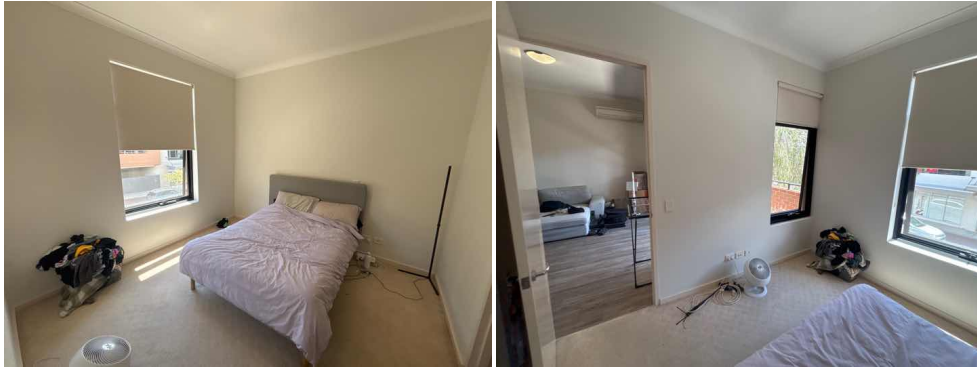
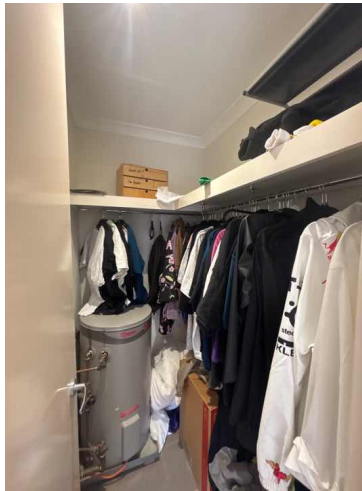
### Ceiling Observations

**Maintenance:** Ceiling/cornice join crack/s observed. Recommendation: Engage a painter for repairs.

**Maintenance:** Typical marks/scuffs observed to areas of ceiling linings.

Recommendation - Engage a painter for repairs.

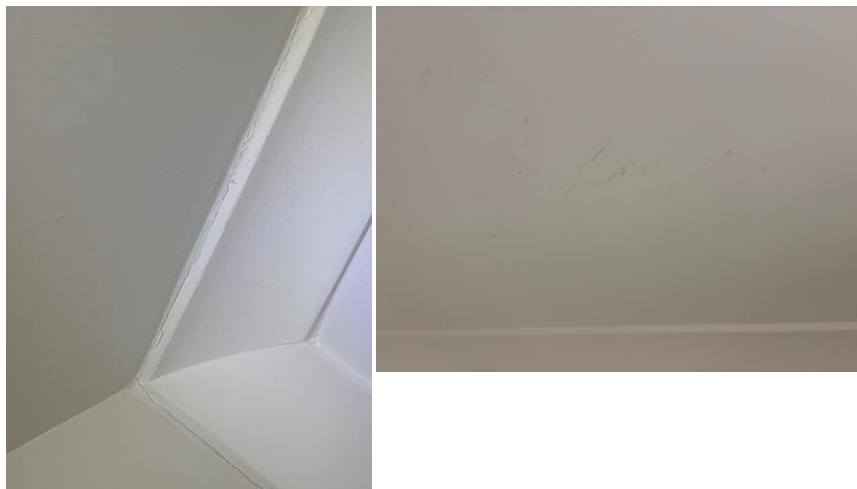
## Walls Observations

| Section | Location | Name | Comment |
|---|---|---|---|
| INTERIORS | Bedroom | Walls Observations | <p>Structural Minor: There appears to have been some settlement in the building which has caused some cracking to the walls. These crack/s are categorised as 0 to 2. This can also cause some doors to bind or be out of square. In the inspectors opinion these cracks are due to settlement, usually due to ground movement and subsequent movement to building materials can be expected. All cracks should be monitored and if cracks increase in size, further investigation should be carried out by a structural engineer. Recommendation: Engage a painter to patch and paint.</p> <p>For clarification on the category of cracks with a damage category of 0 to 2, please refer to Cracking of Building Elements in Section 2D of the Terms and Conditions of this report.</p> |

**Structural Minor:** There appears to have been some settlement in the building which has caused some cracking to the walls. These crack/s are categorised as 0 to 2. This can also cause some doors to bind or be out of square. In the inspectors opinion these cracks are due to settlement, usually due to ground movement and subsequent movement to building materials can be expected. All cracks should be monitored and if cracks increase in size, further investigation should be carried out by a structural engineer. Recommendation: Engage a painter to patch and paint.

**Maintenance:** General scuffs and marks to walls. Recommendation: Engage a painter for repairs.

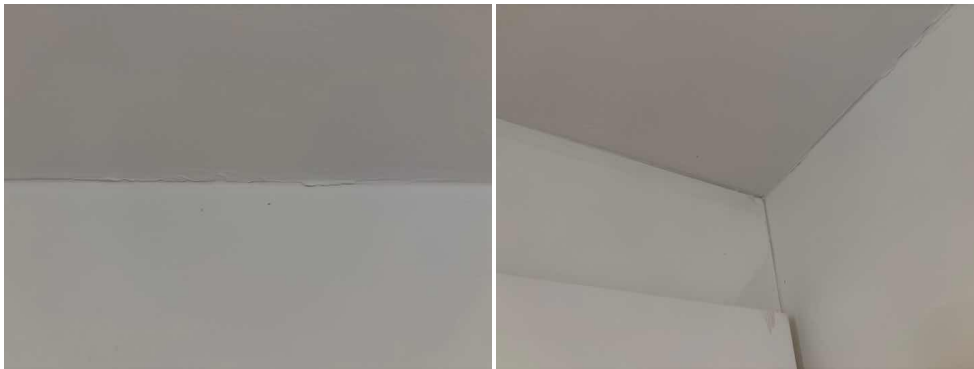
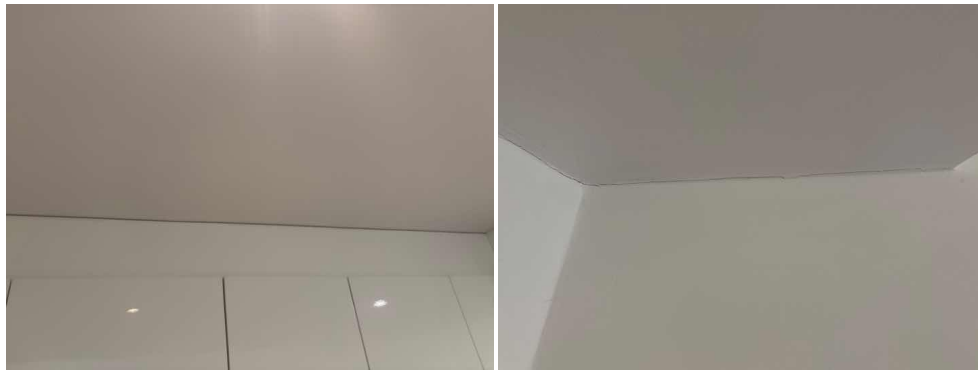
## Walls Observations

| KITCHEN & LAUNDRY | Kitchen | Walls<br>Observations | <p>Structural Minor: There appears to have been some settlement in the building which has caused some cracking to the walls. These crack/s are categorised as 0 to 2. This can also cause some doors to bind or be out of square. In the inspectors opinion these cracks are due to settlement, usually due to ground movement and subsequent movement to building materials can be expected. All cracks should be monitored and if cracks increase in size, further investigation should be carried out by a structural engineer. Engage a painter to patch and paint.</p> <p>For clarification on the category of cracks with a damage category of 0 to 2, please refer to Cracking of Building Elements in Section 2D of the Terms and Conditions of this report.</p> |

**Structural Minor:** There appears to have been some settlement in the building which has caused some cracking to the walls. These crack/s are categorised as 0 to 2. This can also cause some doors to bind or be out of square. In the inspectors opinion these cracks are due to settlement, usually due to ground movement and subsequent movement to building materials can be expected. All cracks should be monitored and if cracks increase in size, further investigation should be carried out by a structural engineer. Engage a painter to patch and paint.

**Maintenance:** General scuffs and marks to walls. Recommendation: Engage a painter for repairs.

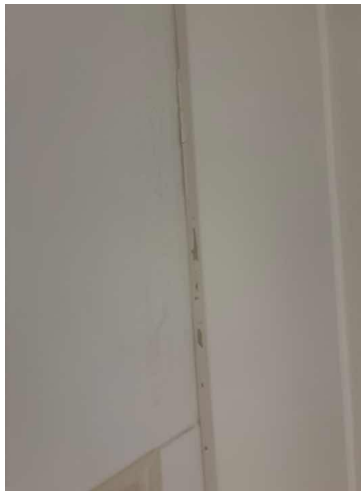
### Cabinet Observations

**Maintenance:** Typical wear observed to cabinetry components. Serviceable condition.
