# Inspection Report

## SURE Services Group Pty Ltd

### Insurance Event Inspection

## Insurance Event Summary

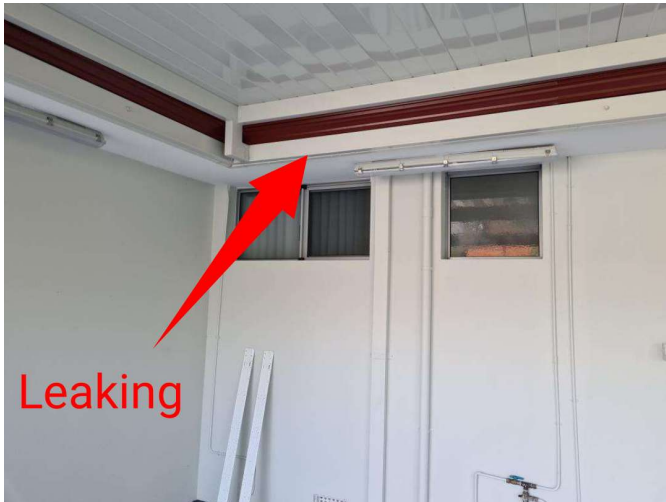
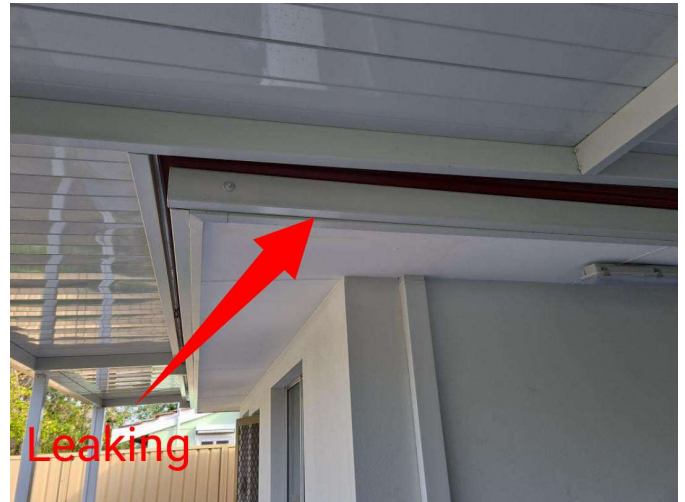
Owner has reported that when it is raining there is leaking from the roof in two locations in the patio area.

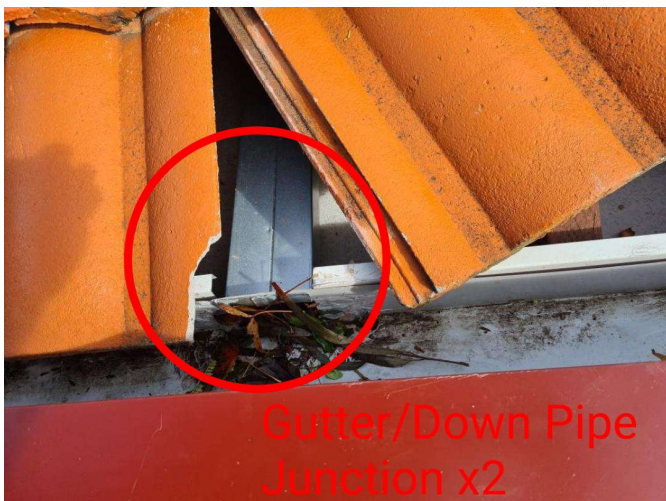
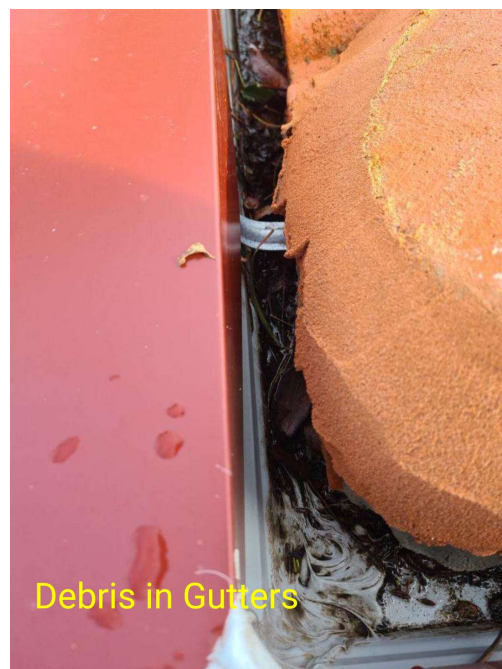
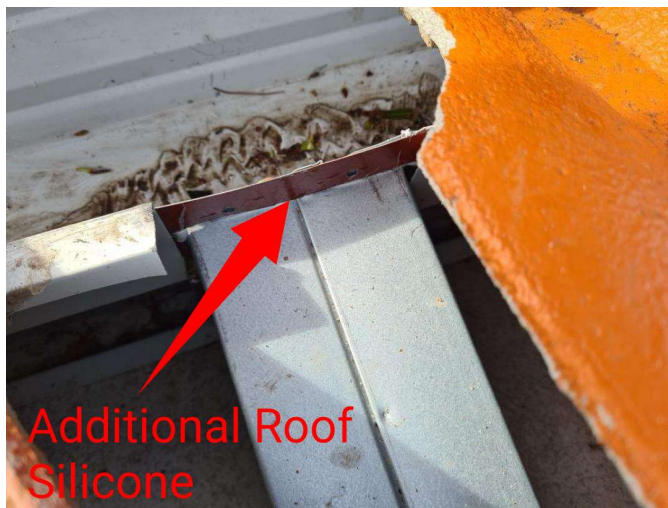
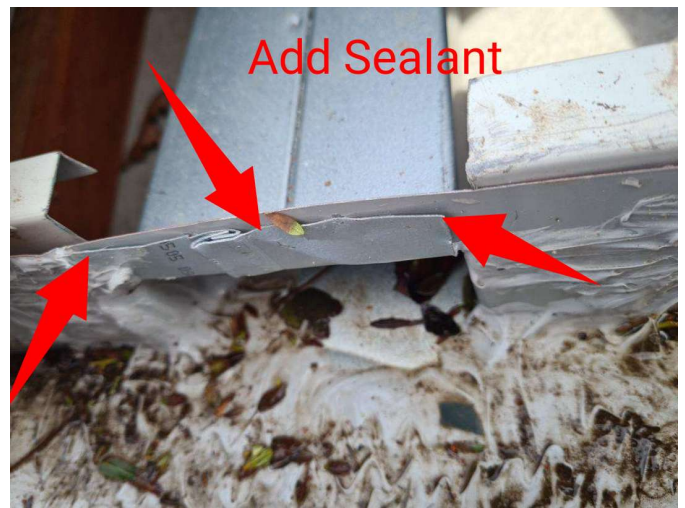
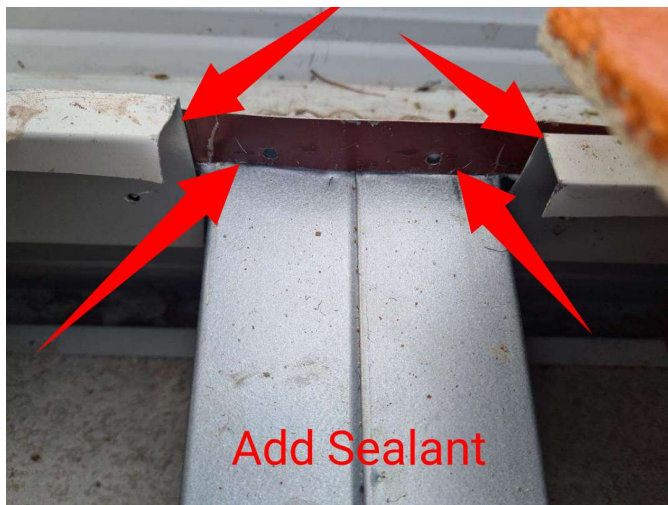
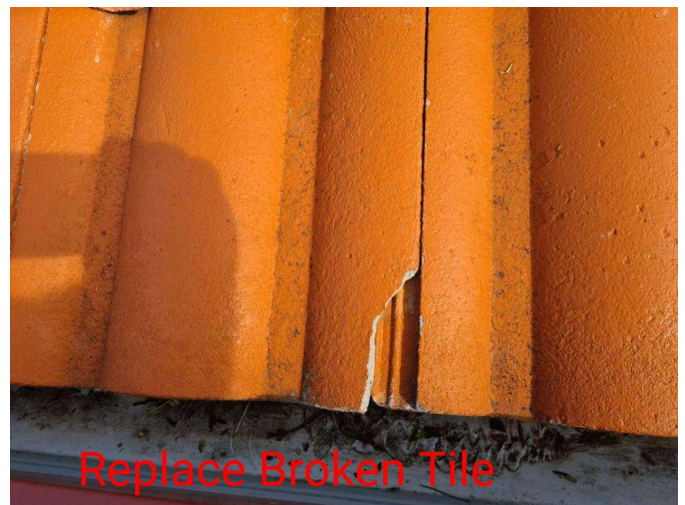
At the downpipe gutter junction the sealant needs to be added to seal the gutters to full their full height.

1. Tiles need to be lifted to gain access to the junction areas to both downpipes.
  2. Seal the downpipe/gutter junction so that sealant is water proofing the gutters to their full height.
  3. Keep debris from collecting in gutters with the installation of gutter guards or regular maintenance and cleaning.
- Replace broken title.

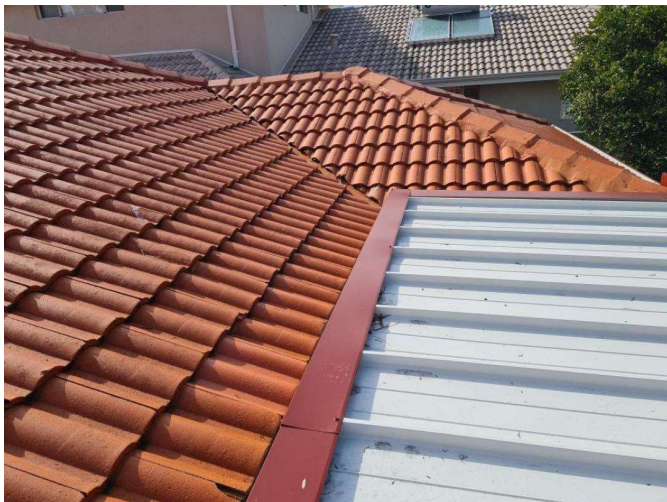
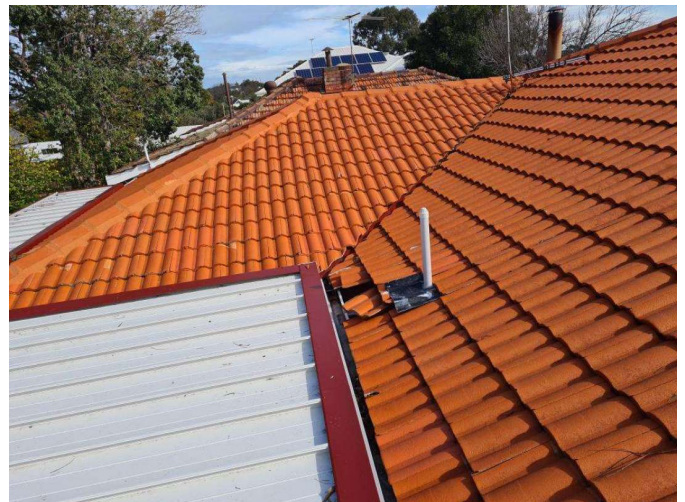
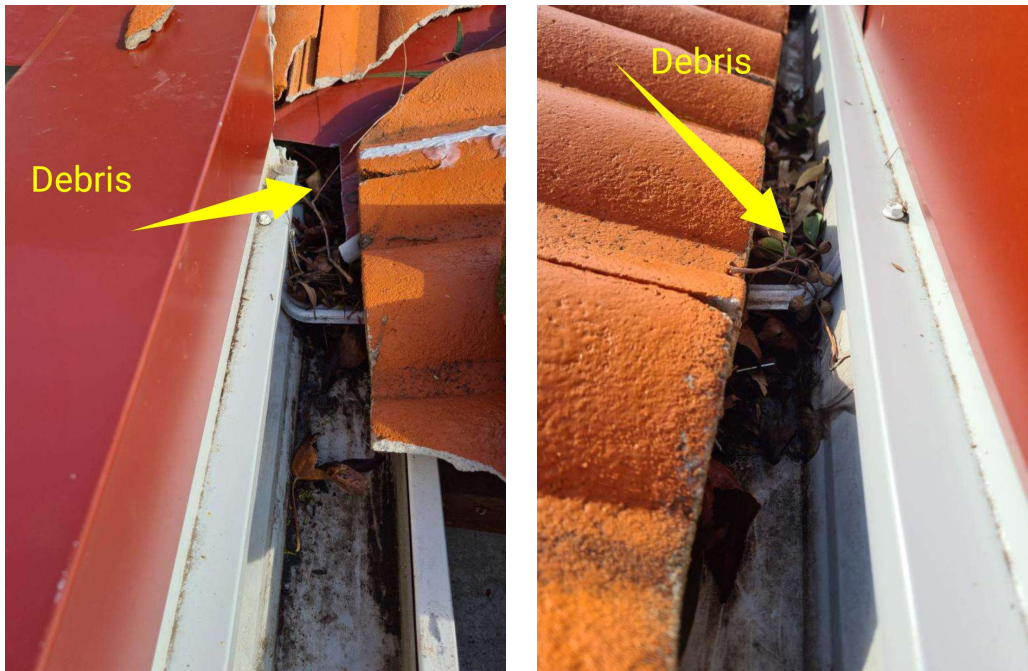
Modifying the gutters to 'box' style may help with the distribution of the water in the area where the current gutters are unable to cope.

The installation of gutter guards would ensure gutters are kept clear of debris from nearby trees.

Engage with a roofing specialist for advice and installation of an upgrade to the current setup.
