# Invasive Inspection

**SURE Building Inspections**

### Comprehensive Building and Timber Pest Inspection

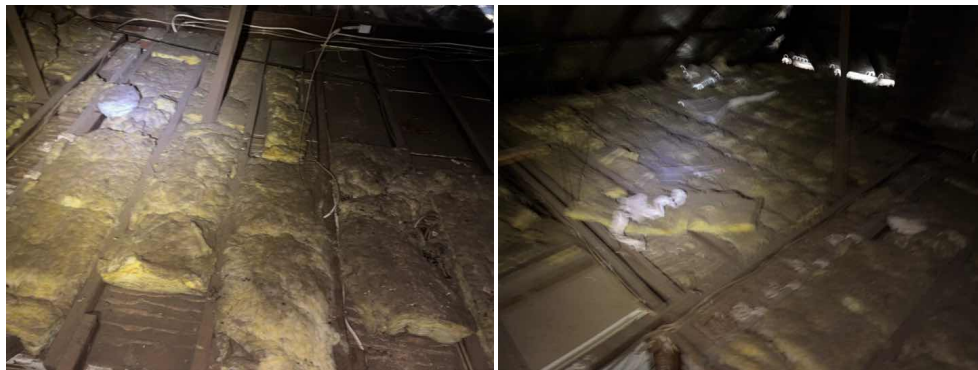
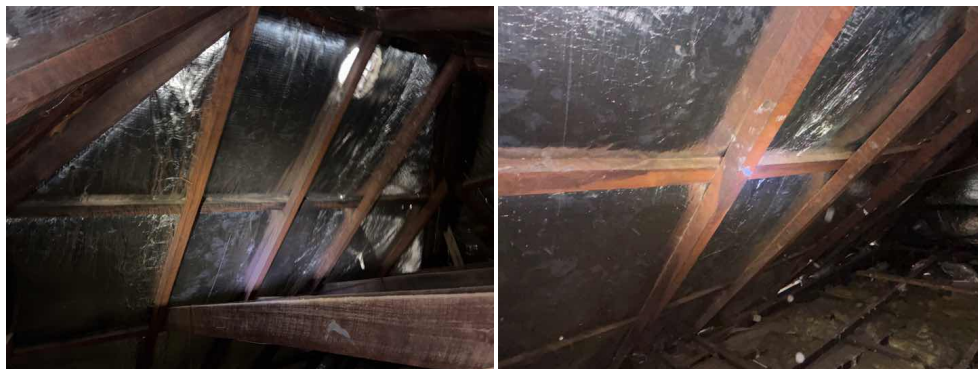
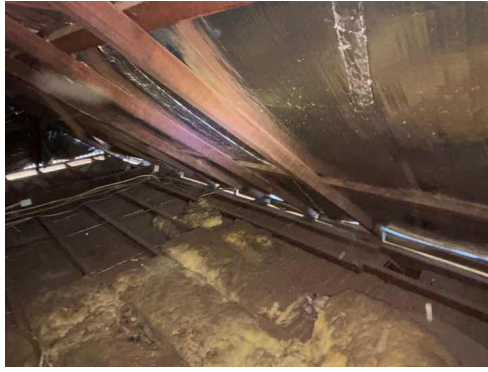
**Maintenance:** Framing timbers are aged. Recommendation: Maintain a regular inspection routine and engage a carpenter to complete maintenance as required.

**Maintenance:** Sections of the roof framing do not comply with today's standards (note the property was built prior to standards implementation). Recommendation: Engage a carpenter for maintenance work if desired.

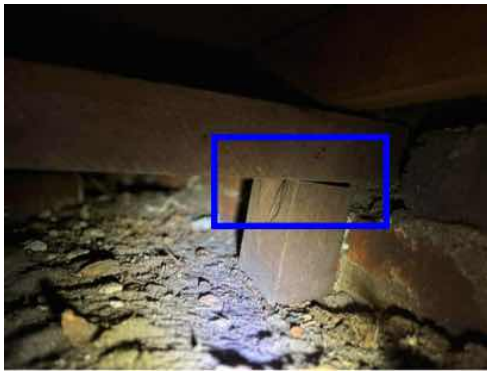
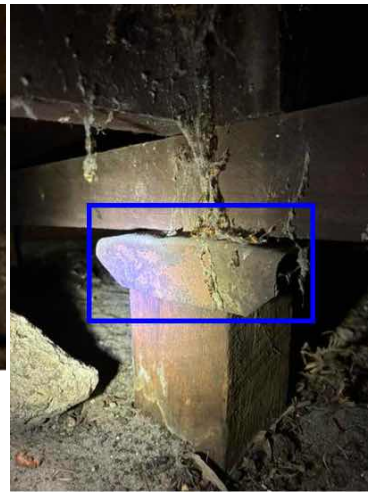
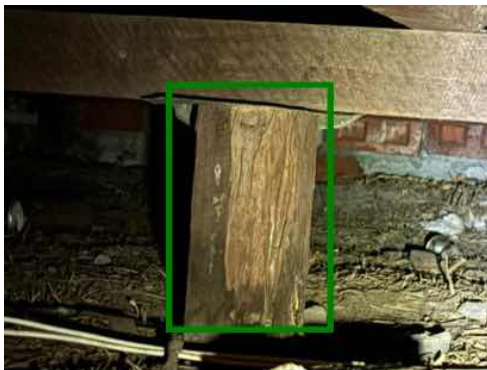
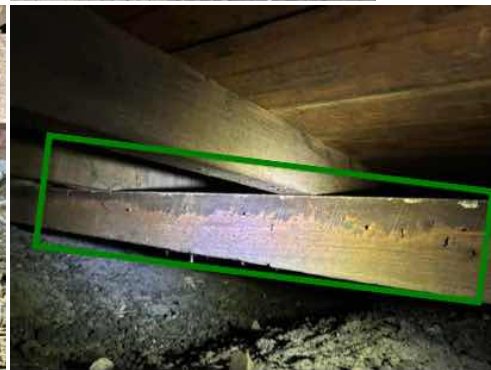
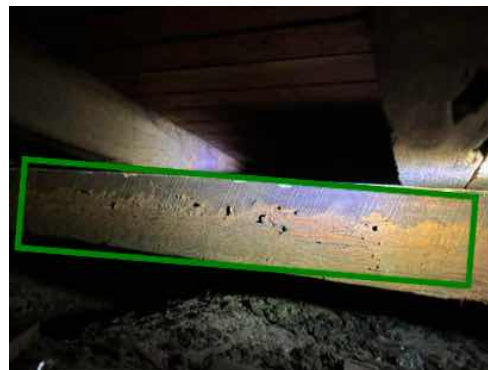
## Piers And Foundation Walls

**Structural Major:** Evidence of major subsidence (sinking) was noted to the footings. Recommendation: Engage a re-stumping company/contractor to complete repair works.

**Maintenance:** Ant caps are not installed to sections of stumps. The purpose of ant capping is to prevent concealed termite entry by forcing the termites to build mud tunnels around the visible sections of the ant capping enabling detection during a pest inspection. Ant caps will not prevent the entry of termites to a structure however, correctly fitted ant caps will assist in early detection. Recommendation: Engage a carpenter to repair.

**Maintenance:** Corroded ant capping observed. Ant capping is not designed to prevent termite entry but to force the termites to reveal themselves by means of mud packing. Rusted, missing or defective ant capping will allow the termites to enter the building undetected. Recommendation: Engage a carpenter to repair.

**Maintenance:** Termite damage noted. Recommendation: Engage a carpenter for repair or replacement of affected sections.

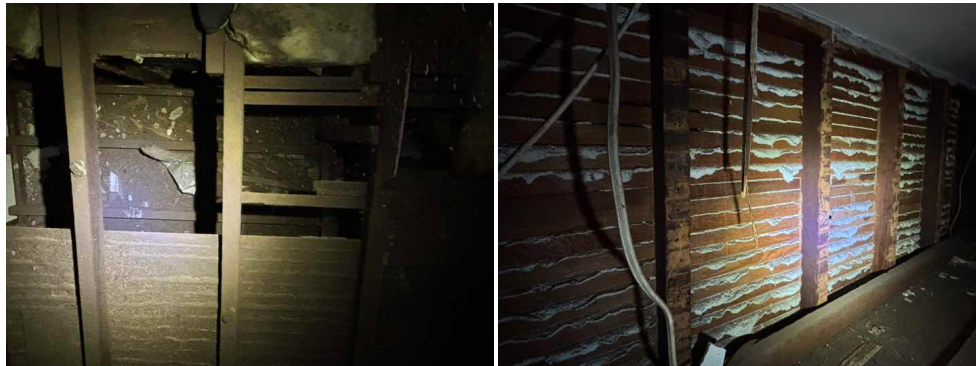
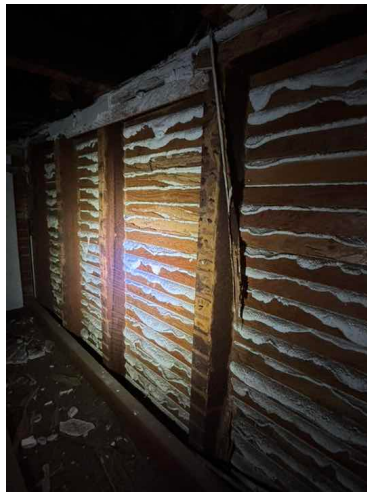
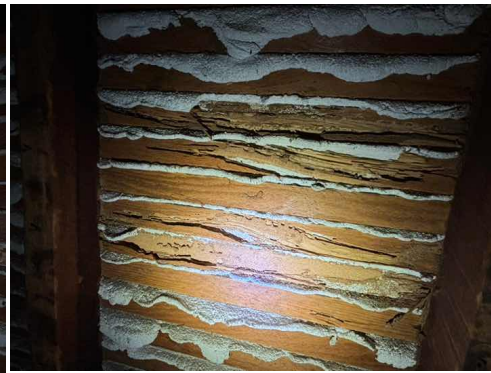
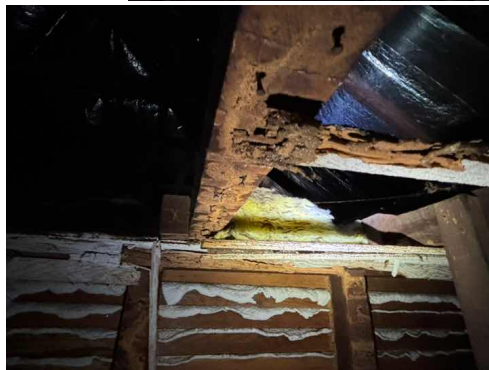
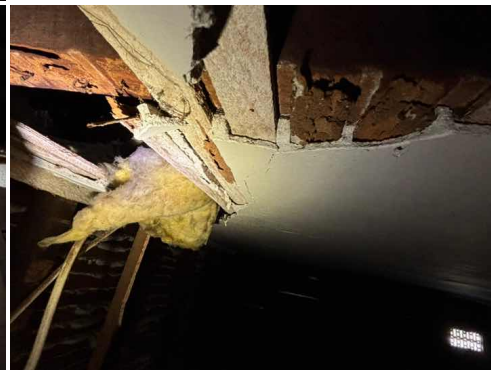
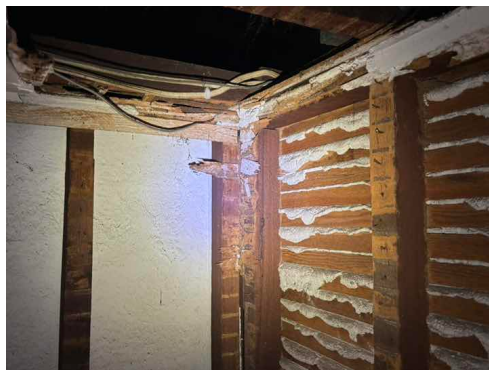
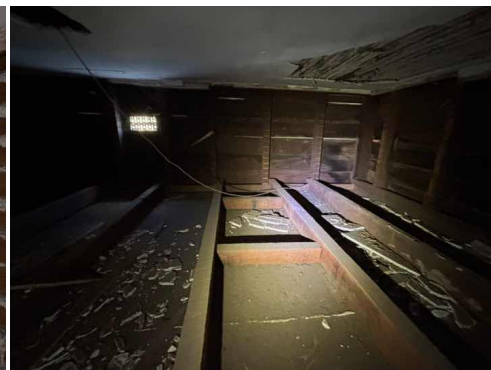
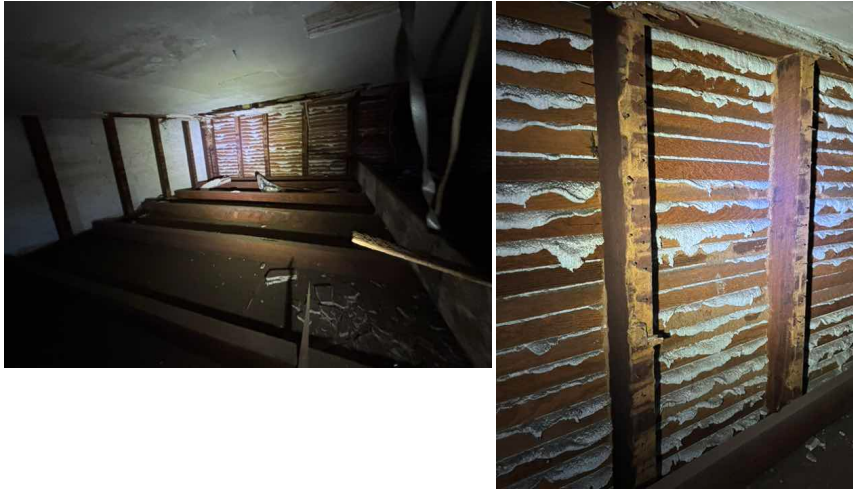
### Apparent Concealment of Possible Defects

**Maintenance:** Termite damage noted to wall. Recommendation: Engage a carpenter for repair or replacement of affected sections - See concealment section of the report for further information.

Possible attempts to conceal defects were noticed.

Ceiling linings to the second bedroom and kitchen area have been lowered. It appears this may have been undertaken to conceal historical termite damage observed in section/s of wall linings.
