# Roof Frame Inspection

**SURE Building Inspections**

### Roof Frame Inspection Report

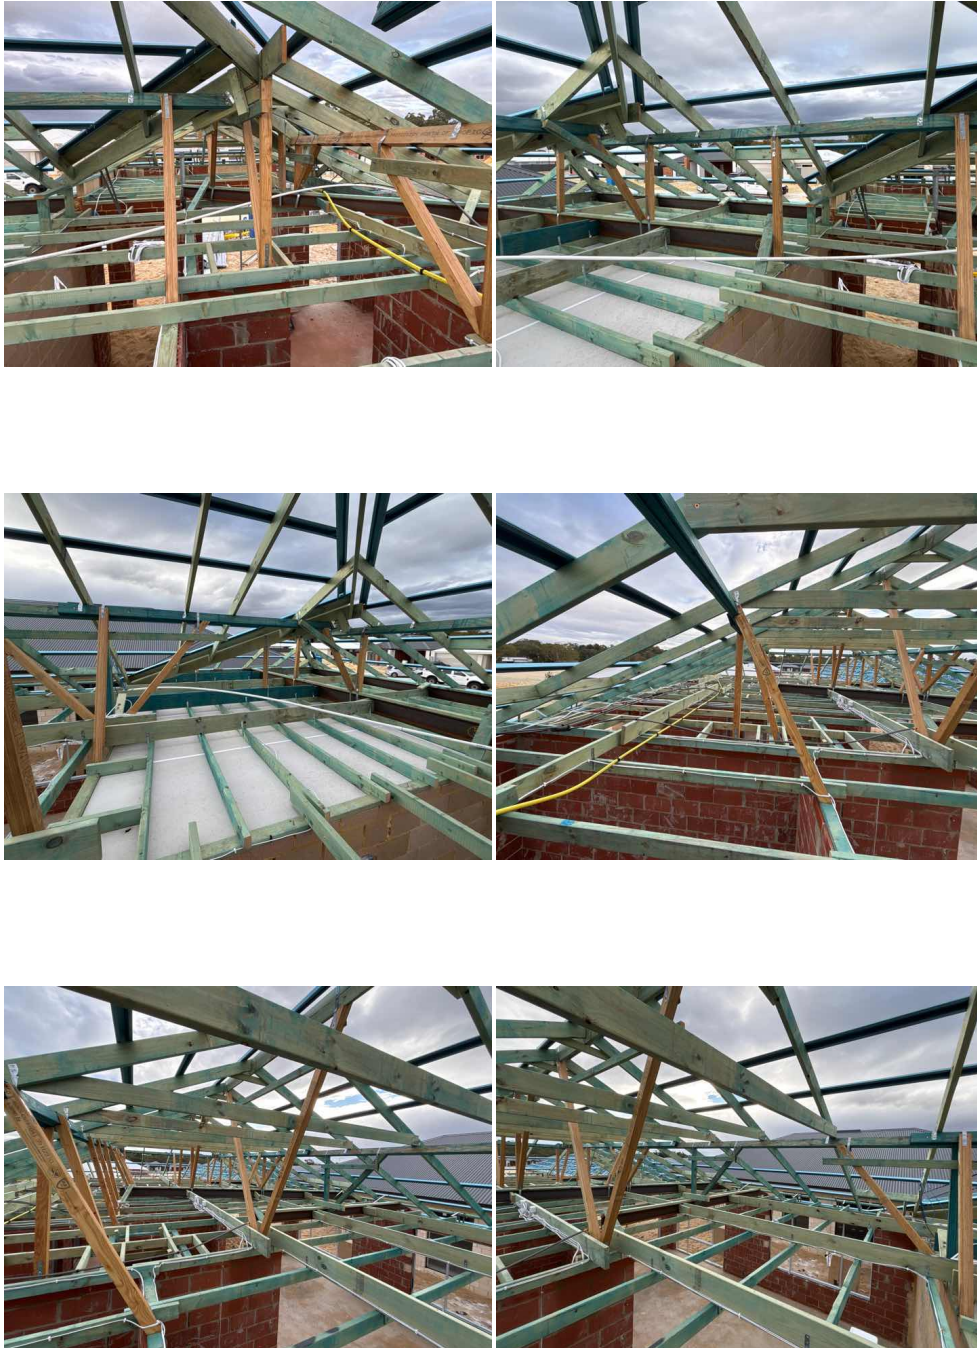
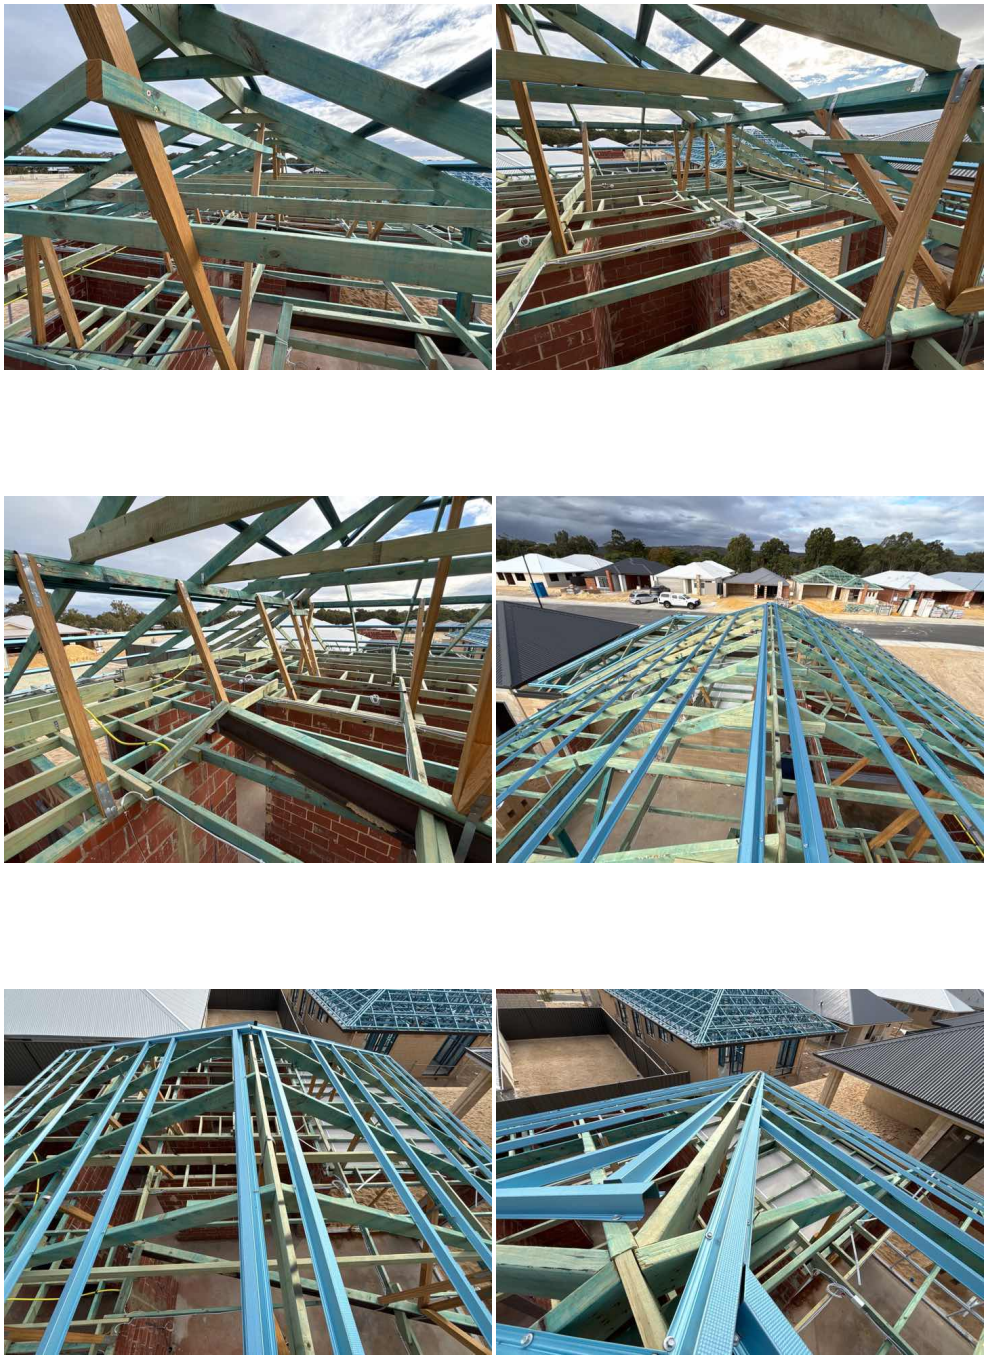
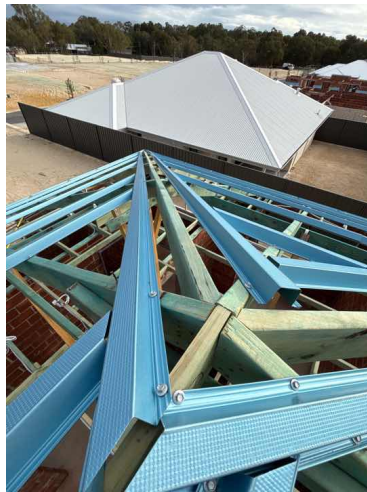
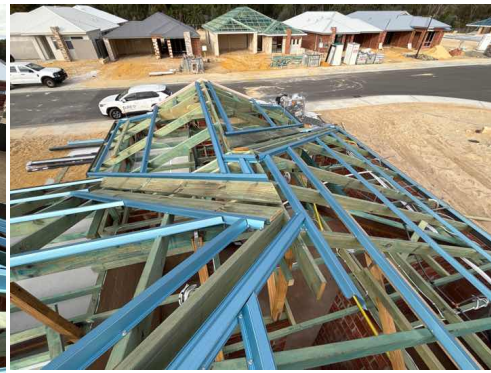
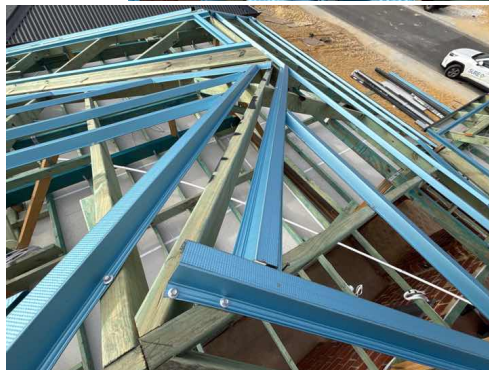
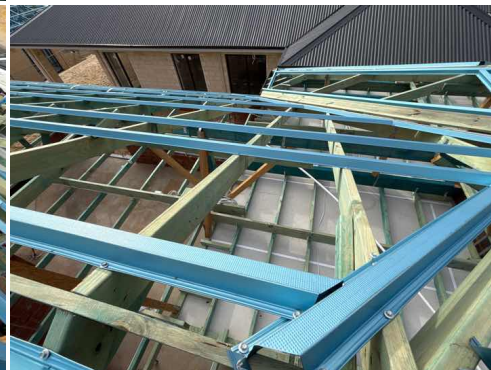
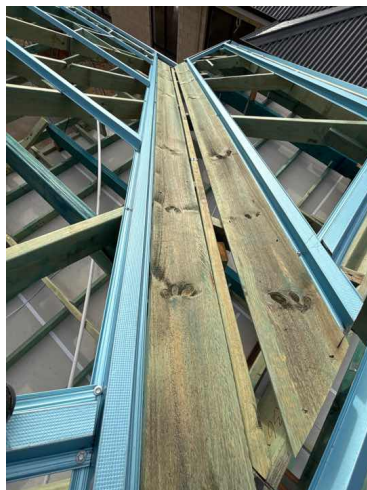
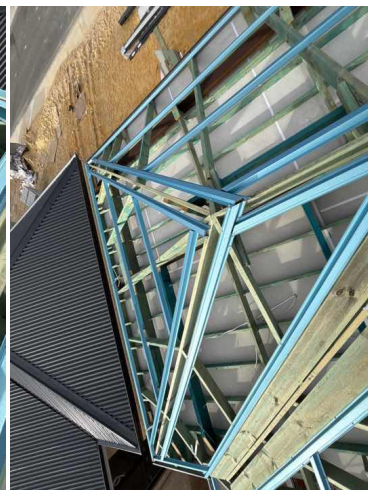
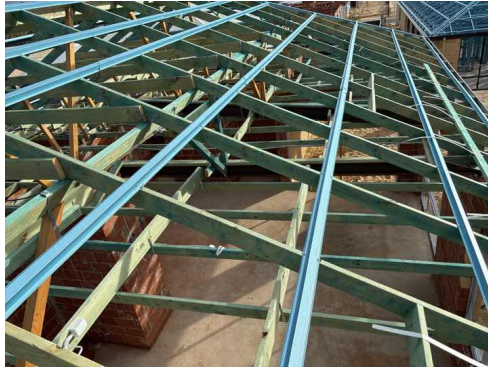
The material used for construction is timber.

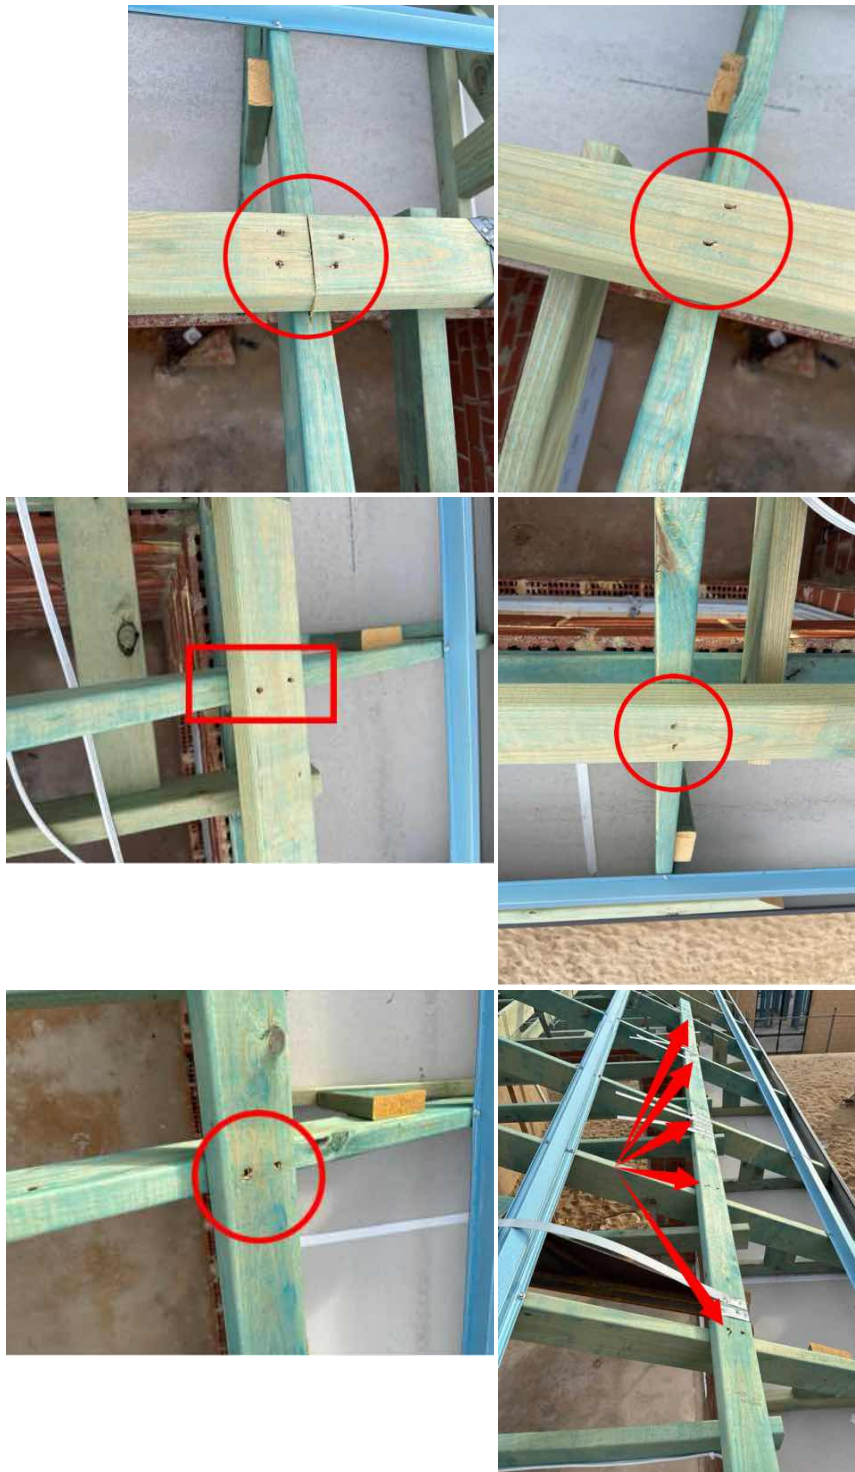
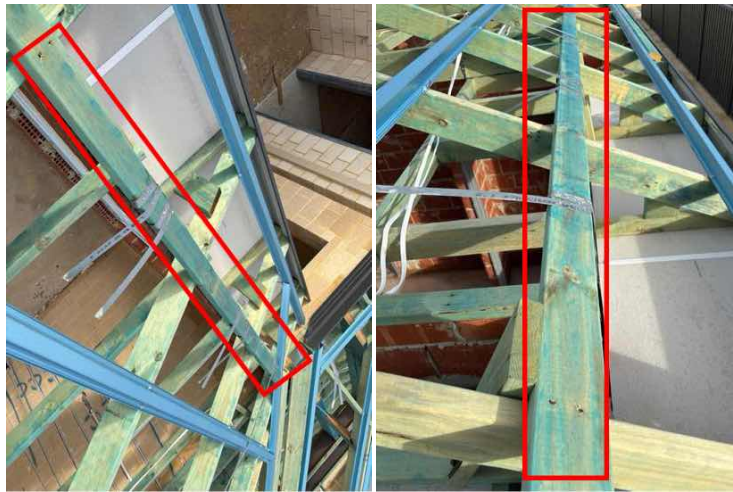
**Incomplete and not in accordance with AS1684.2 requirements.**

Timber tie down batten require type 17 14 -10 x 75mm bugle screw fixings to be installed.

Recommendation - Advise Builder

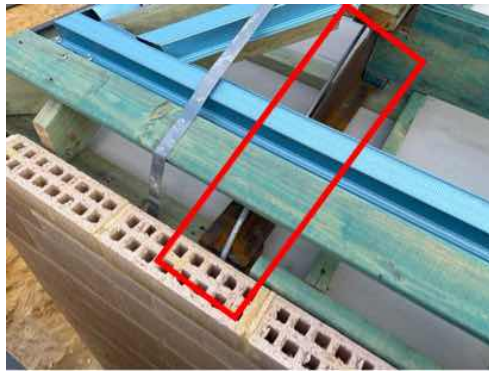
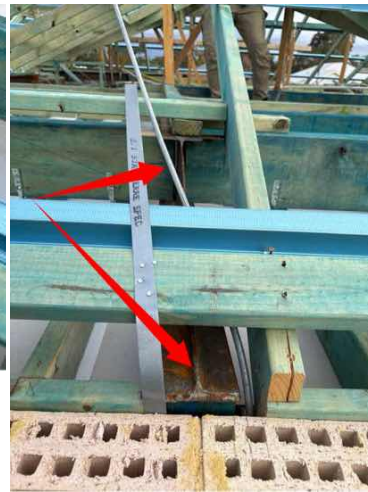
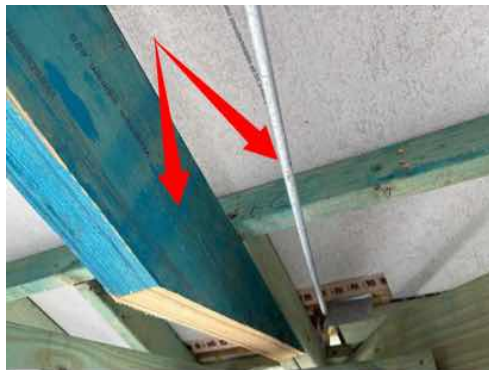
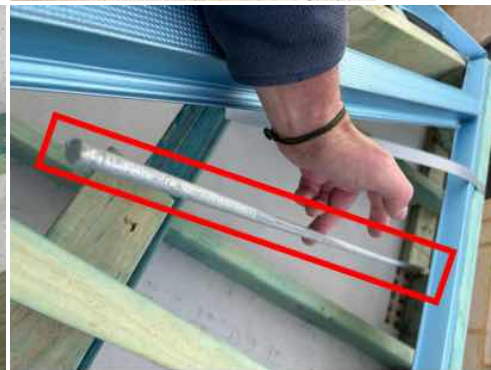
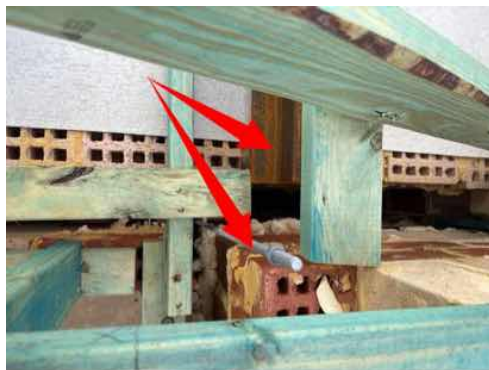
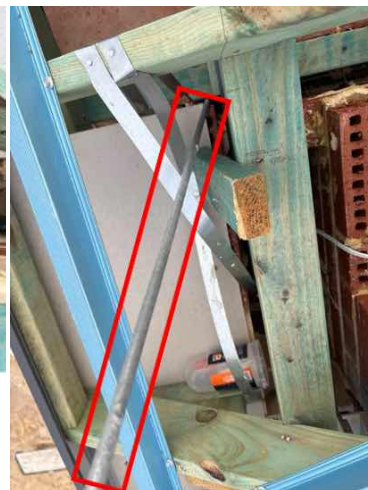
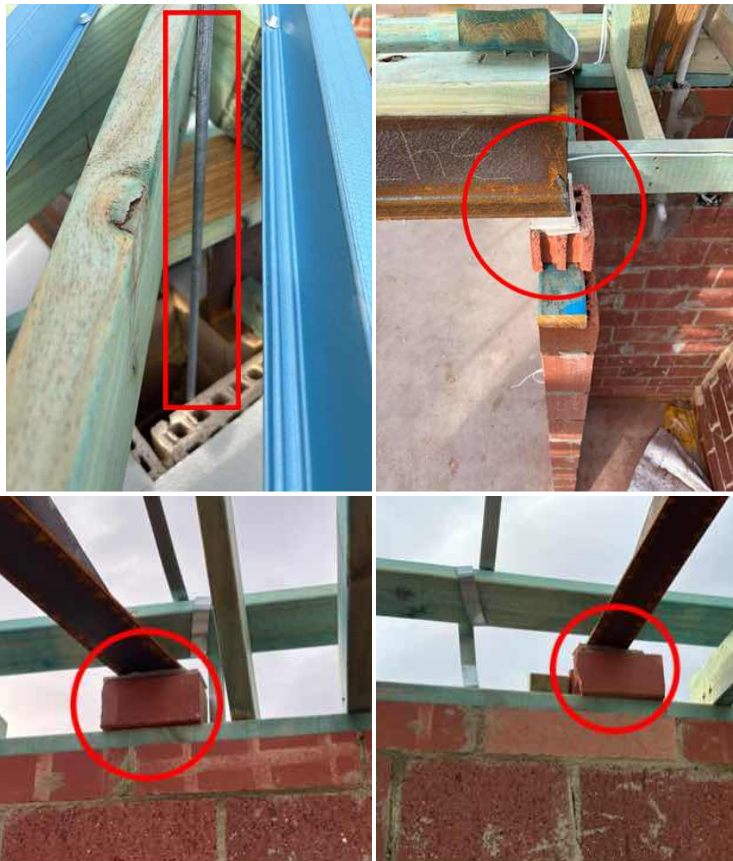
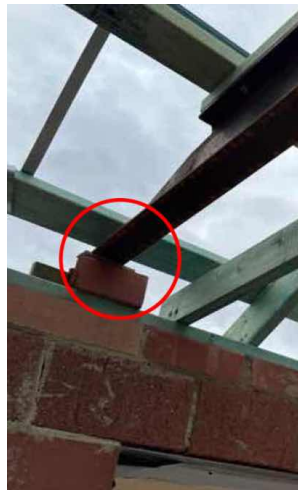
**Incomplete and not in accordance with AS1684 requirements.**

Tie down rods installed but not connected to load bearing steel / LVL timbers.

Tie down rods not connected to steel or LVL load bearing beams on Garage Northern wall, Porch Northern Wall, Southern wall and Alfresco Column. Advise builder for rectification prior to installation of roof sheeting.

Centre load bearing steel beam not adequately bearing. Advise builder to rectify.

Steel structural beams in throughout seem to be packed / secured temporarily - Client concern. Clarification required.

Recommendation - Advise builder to secure to wall plate.
