# Structural Inspection

**SURE Building Inspections**

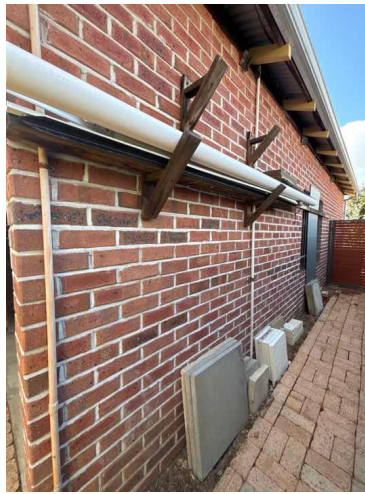
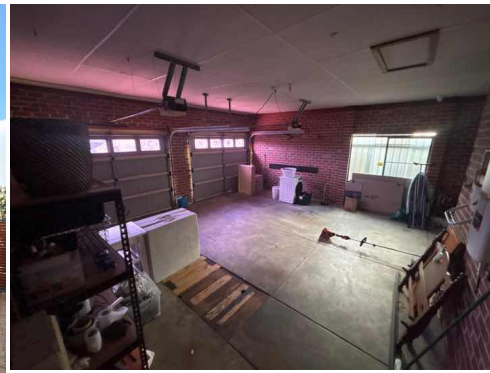
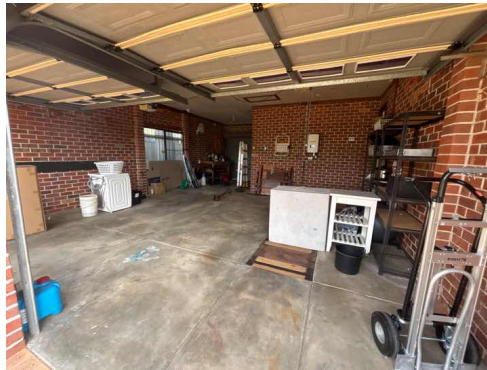
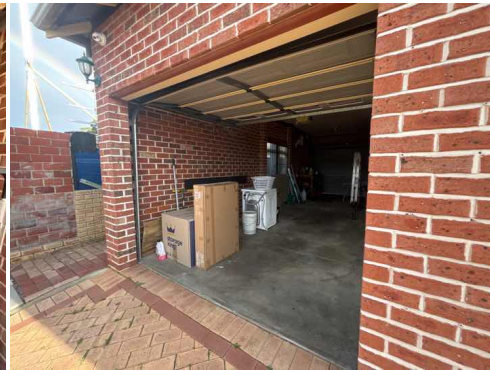
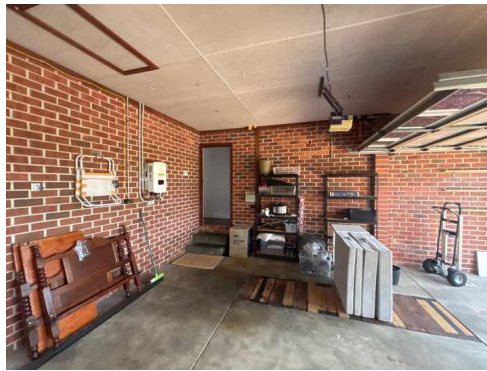
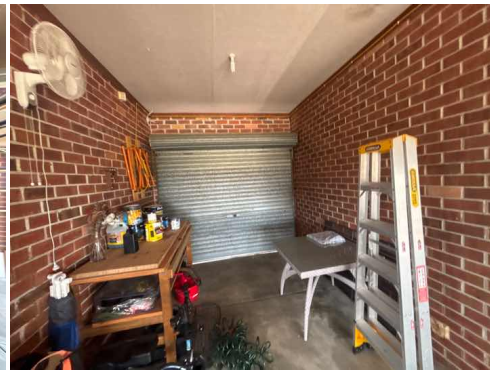
#1. **Structural Minor:** There appears to have been some settlement in the building which has caused some cracking to the walls. These crack/s are categorised as 0 to 2. This can also cause some doors to bind or be out of square. In the inspectors opinion these cracks are due to settlement, usually due to ground movement and subsequent movement to building materials can be expected. All cracks should be monitored and if cracks increase in size, further investigation should be carried out by a structural engineer. Engage a bricklayer to repair.

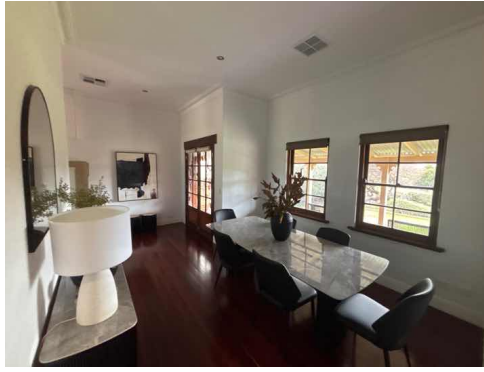
#3. **Structural Minor:** There appears to have been some settlement in the building which has caused some cracking to the walls. These crack/s are categorised as 0 to 2. This can also cause some doors to bind or be out of square. In the inspectors opinion these cracks are due to settlement, usually due to ground movement and subsequent movement to building materials can be expected. All cracks should be monitored and if cracks increase in size, further investigation should be carried out by a structural engineer. Recommendation: Engage a painter to patch and paint.

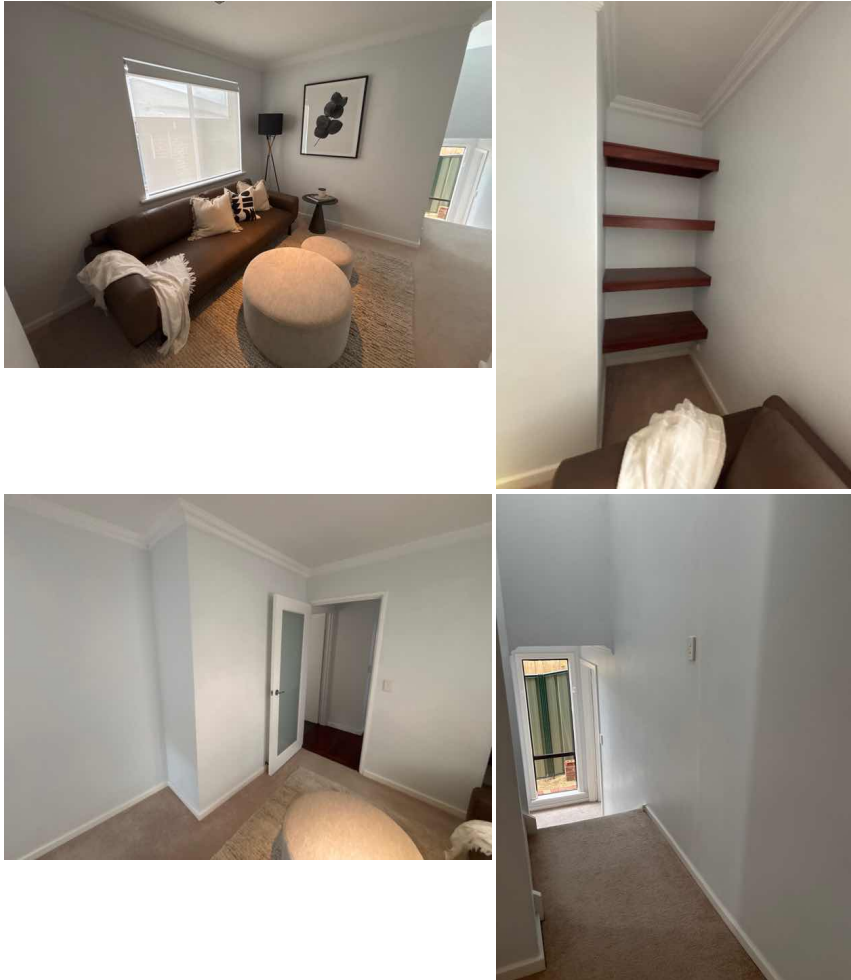
#4. **Structural Minor:** There appears to have been some settlement in the building which has caused some cracking to the walls. These crack/s are categorised as 0 to 2. This can also cause some doors to bind or be out of square. In the inspectors opinion these cracks are due to settlement, usually due to ground movement and subsequent movement to building materials can be expected. All cracks should be monitored and if cracks increase in size, further investigation should be carried out by a structural engineer. Recommendation: Engage a painter to patch and paint.

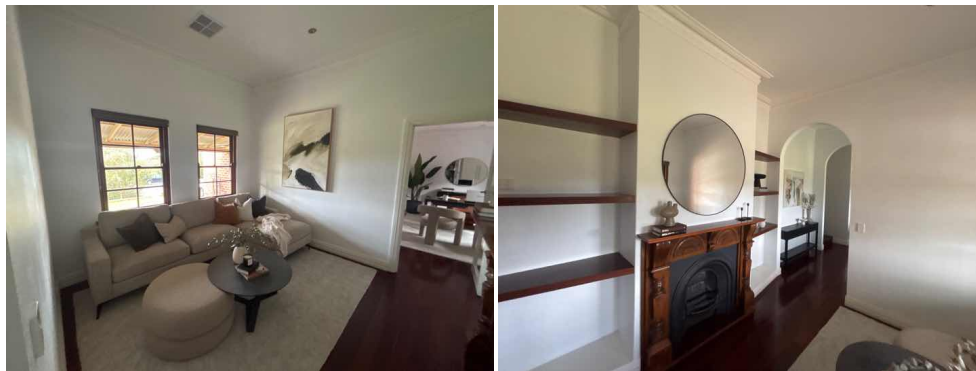
#5. **Structural Minor:** There appears to have been some settlement in the building which has caused some cracking to the walls. These crack/s are categorised as 0 to 2. This can also cause some doors to bind or be out of square. In the inspectors opinion these cracks are due to settlement, usually due to ground movement and subsequent movement to building materials can be expected. All cracks should be monitored and if cracks increase in size, further investigation should be carried out by a structural engineer. Recommendation: Engage a painter to patch and paint.

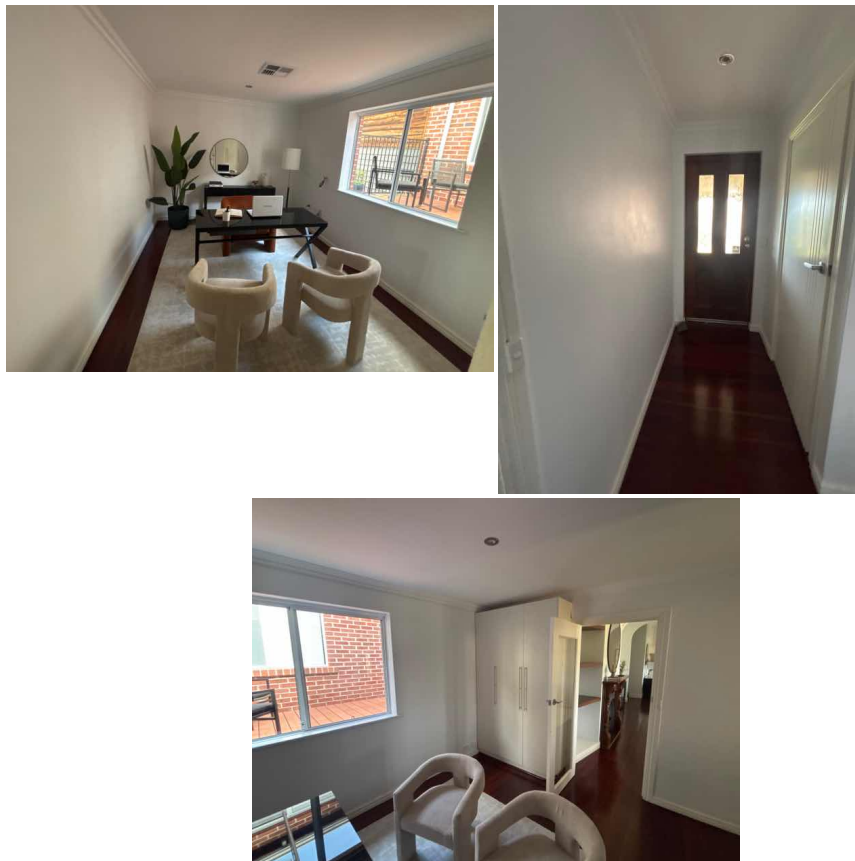
#6. **Structural Minor:** There appears to have been some settlement in the building which has caused some cracking to the walls. These crack/s are categorised as 0 to 2. This can also cause some doors to bind or be out of square. In the inspectors opinion these cracks are due to settlement, usually due to ground movement and subsequent movement to building materials can be expected. All cracks should be monitored and if cracks increase in size, further investigation should be carried out by a structural engineer. Recommendation: Engage a painter to patch and paint.

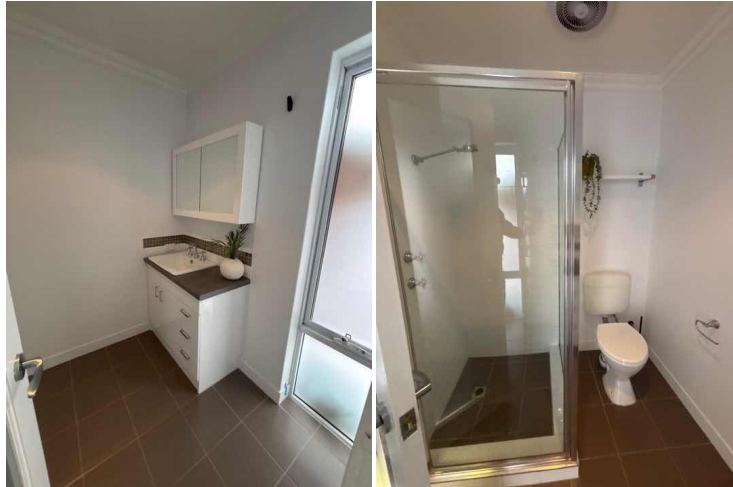
#8. **Structural Minor:** There appears to have been some settlement in the building which has caused some cracking to the walls. These crack/s are categorised as 0 to 2. This can also cause some doors to bind or be out of square. In the inspectors opinion these cracks are due to settlement, usually due to ground movement and subsequent movement to building materials can be expected. All cracks should be monitored and if cracks increase in size, further investigation should be carried out by a structural engineer. Engage a painter to patch and paint.

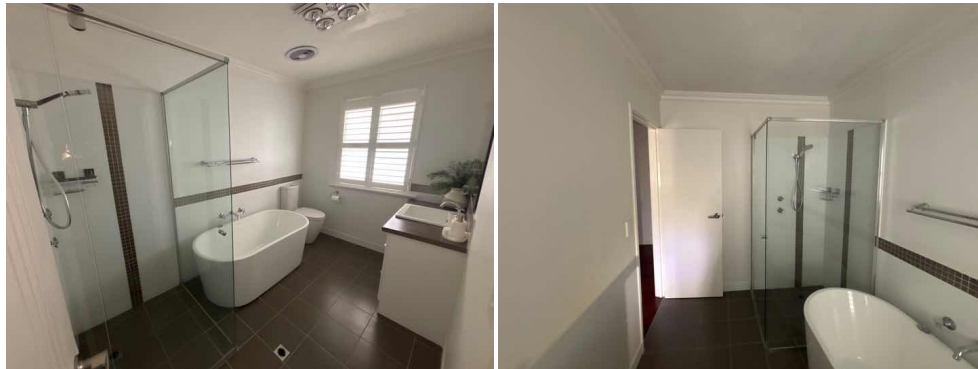
#9. **Structural Minor:** There appears to have been some settlement in the building which has caused some cracking to the walls. These crack/s are categorised as 0 to 2. This can also cause some doors to bind or be out of square. In the inspectors opinion these cracks are due to settlement, usually due to ground movement and subsequent movement to building materials can be expected. All cracks should be monitored and if cracks increase in size, further investigation should be carried out by a structural engineer. Engage a painter to patch and paint.

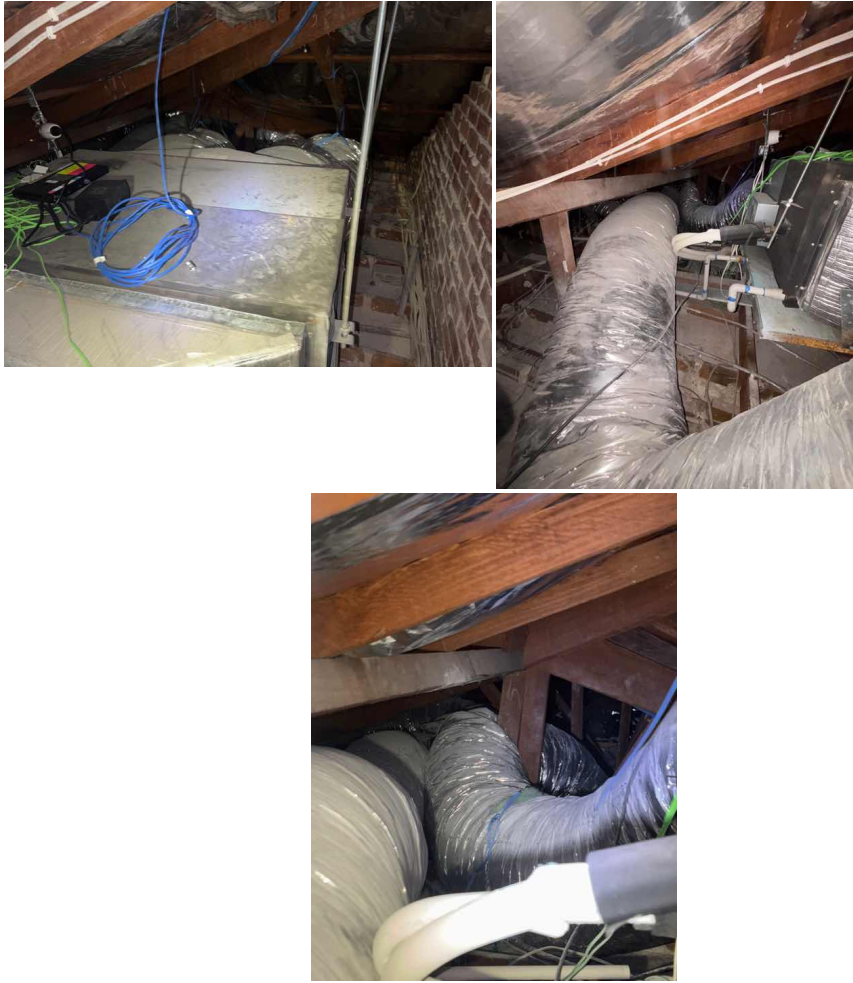
#10. **Structural Major:** Struts observed to be installed flush to underpurlin are missing straps at top and bottom junction connections. This form of timber joint connection is not inline with current compliance requirements and would have been considered non-compliant tie down methods at time of build. Recommendation: Engage a carpenter to install strapping / multi clips to all strutting Timbers as to comply with AS1684.1 & 2.

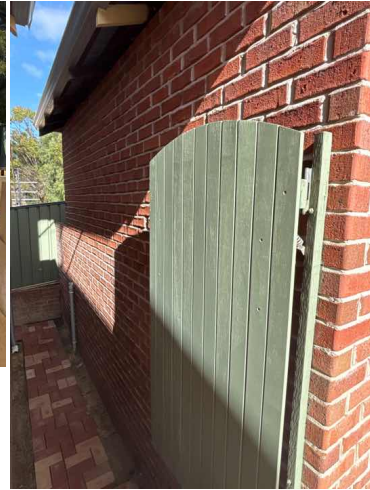
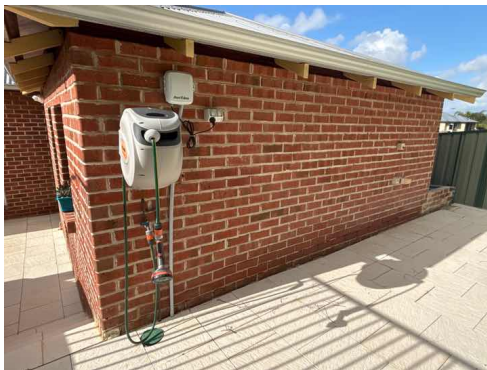
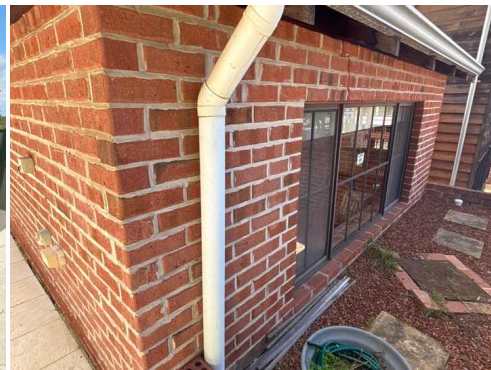
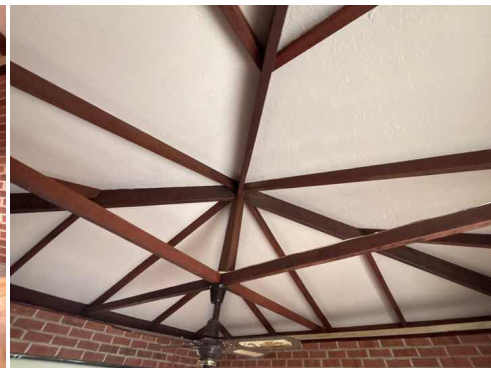
#11. **Structural Minor:** There appears to have been some settlement in the building which has caused some cracking to the walls. These crack/s are categorised as 0 to 2. This can also cause some doors to bind or be out of square. In the inspectors opinion these cracks are due to settlement, usually due to ground movement and subsequent movement to building materials can be expected. All cracks should be monitored and if cracks increase in size, further investigation should be carried out by a structural engineer. Engage a bricklayer to repair.

#12. **Structural Minor:** Mortar between the brickwork is eroded. Recommendation: Engage a bricklayer for repairs.

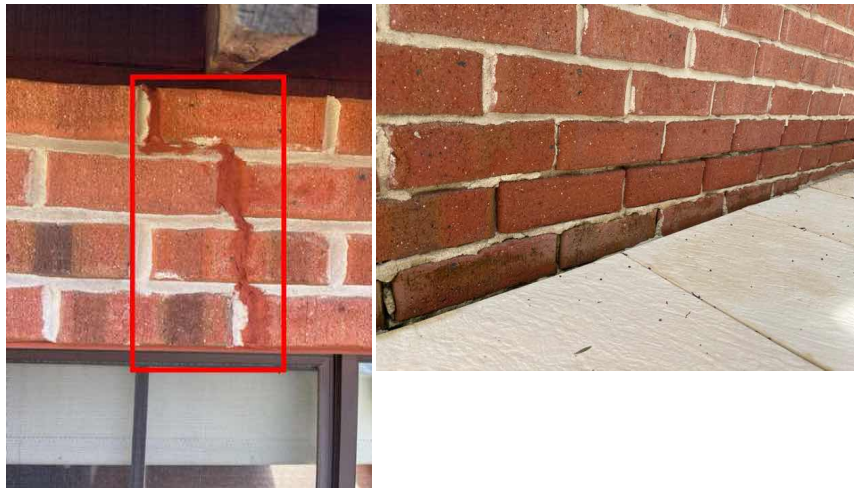
#13. **Structural Minor:** There appears to have been some settlement in the building which has caused some cracking to the walls. These crack/s are categorised as 0 to 2. This can also cause some doors to bind or be out of square. In the inspectors opinion these cracks are due to settlement, usually due to ground movement and subsequent movement to building materials can be expected. All cracks should be monitored and if cracks increase in size, further investigation should be carried out by a structural engineer. Engage a bricklayer to repair.
