# Timber Pest Inspection

**SURE Building Inspections**

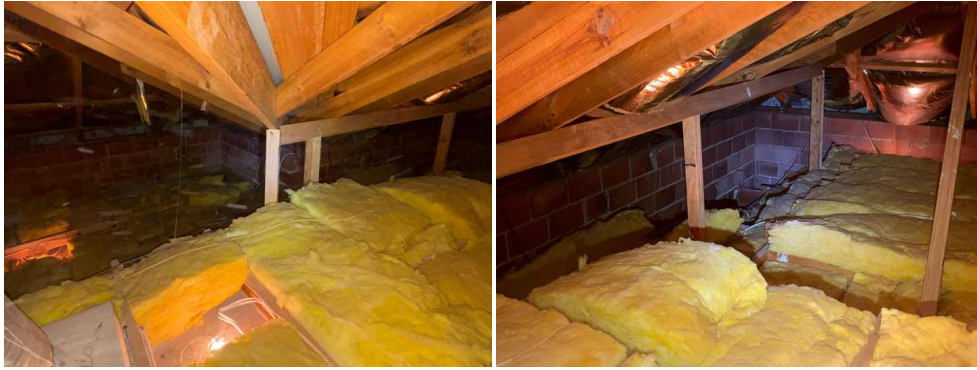
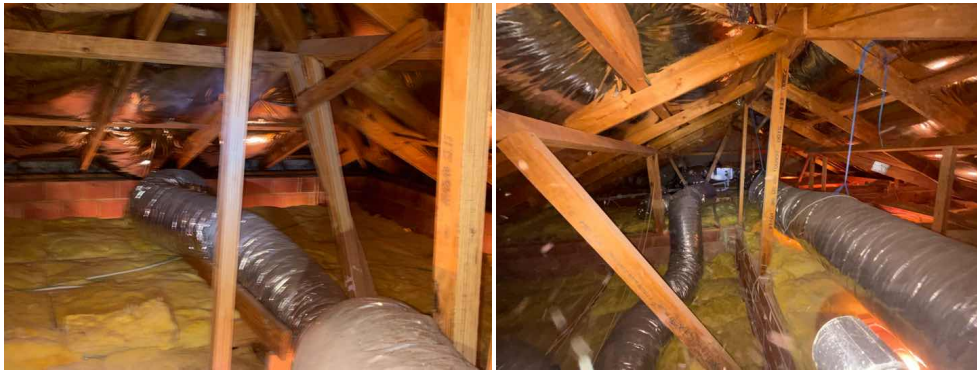
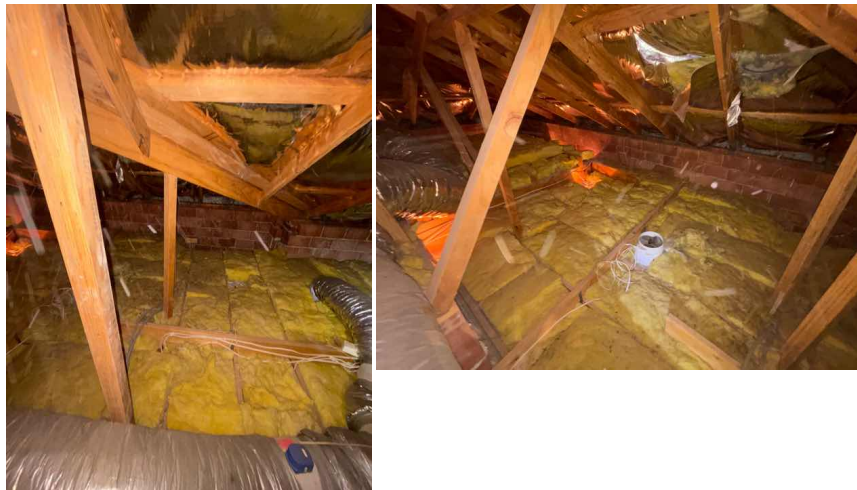
The slab edge was not exposed, restricting a full inspection for weeps and pest ingress. The slab edge should be exposed so that a thorough inspection can be conducted.

Storage/vehicles restricted full visual inspection on the garage.

Inaccessible roof void sections due to access limitations and or insulation and ducting.

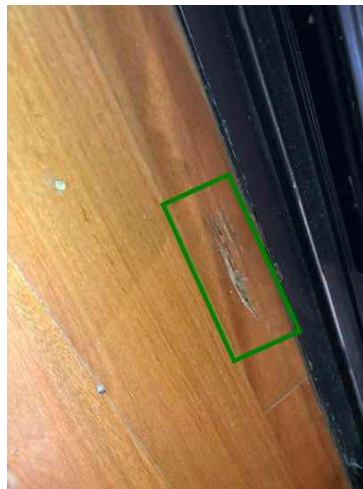
Yes, termite damage was identified during the visual inspection in the following areas:

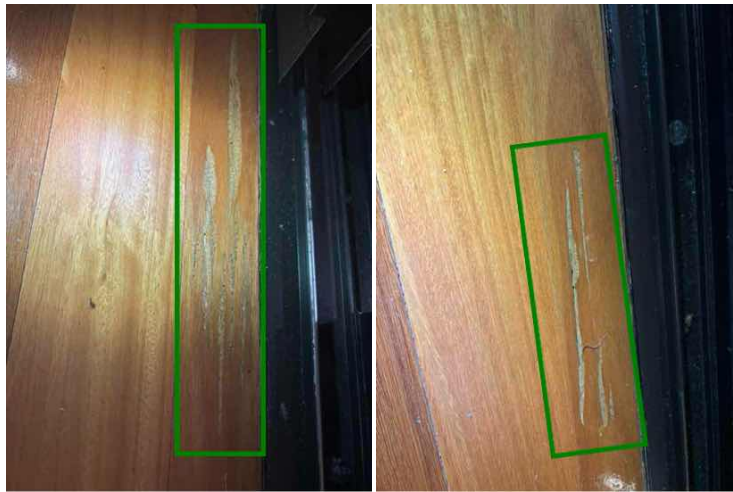
#### **Location of Workings or Damage to Building**

**Timber Pest:** Termite damage/workings observed in floor boards. Recommendation: Engage a pest control technician to implement a termite site management plan.

The identified damage is localised to a smaller area of the property.

There is no safety risk as a result of the identified termite damage.

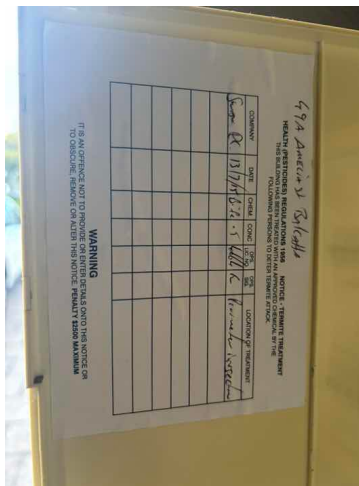
A durable notice was found in the meter-box during the inspection.

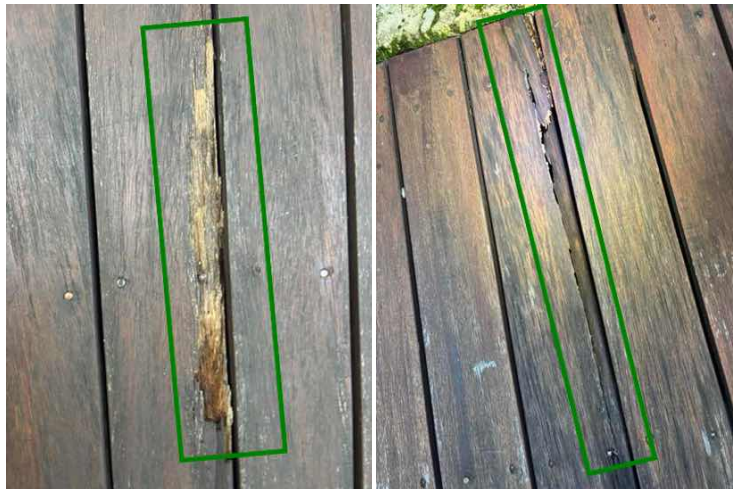
### Location of Workings or Damage to Site

**Timber Pest:** Fungi decay (rot) observed in deck. Recommendation: Engage a carpenter to repair.

The extent of rot damage is considered to be high.

Yes, A minor trip hazard is present - The safety hazard due to fungi decay (Rot) is considered to be minor.

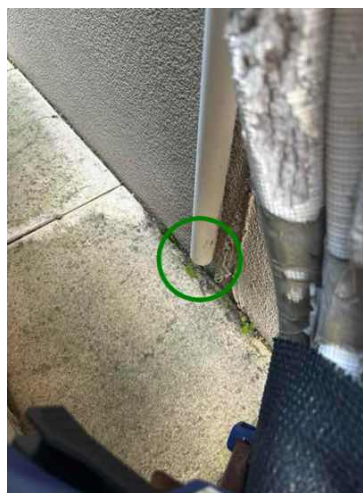
No. Airconditioning overflow should be diverted away from the building perimeter or into a drain.

Air conditioner overflow requires diverting to drain. This provides conducive conditions for termite infestation.

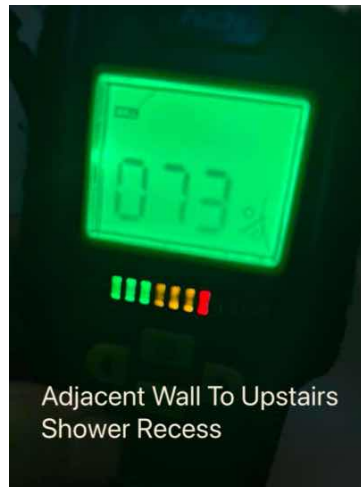
At the time of the inspection moisture readings were high.

High moisture readings can be caused by any one of the following: Poor ventilation, ineffective drainage, leaking pipes, leaking roofs, defective flashing or by concealed termite activity. The areas of high moisture should be investigated by way of an invasive inspection and a building expert engaged to determine the full extent of damage and the estimated cost of repairs.
