# 6 Month Warranty Inspection

**SURE Building Inspections**

### Building Maintenance Inspection

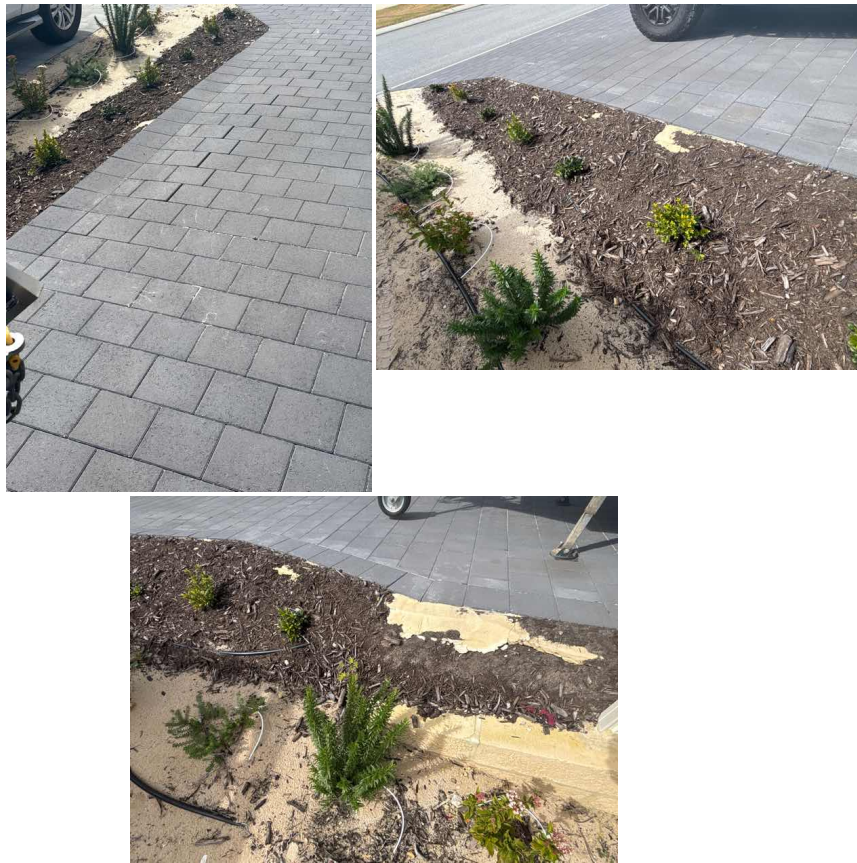
#1. **Maintenance:** Driveway edging has started to collapse where there is insufficient retaining system in place.

Recommendation: Engage a landscaper for repair.

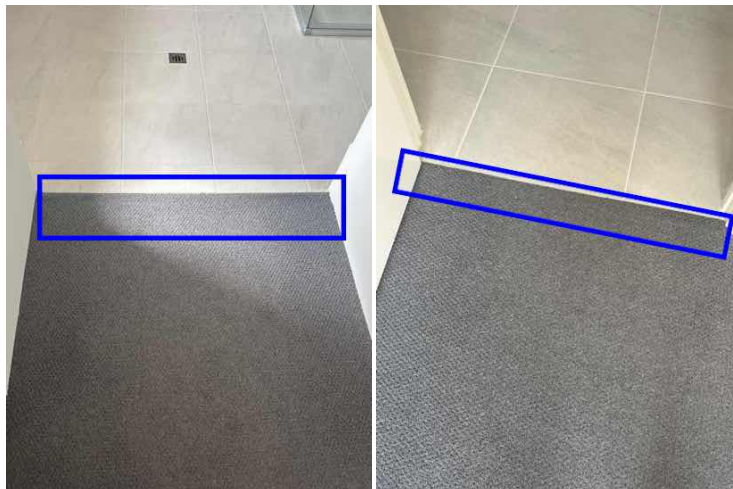
#2. **Maintenance:** Carpet grippers protruding through carpet across threshold.

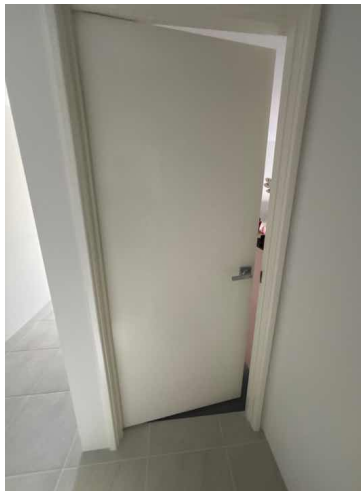
#3. **Maintenance:** Binding when opened and closed. Recommendation: Engage a carpenter to repair.

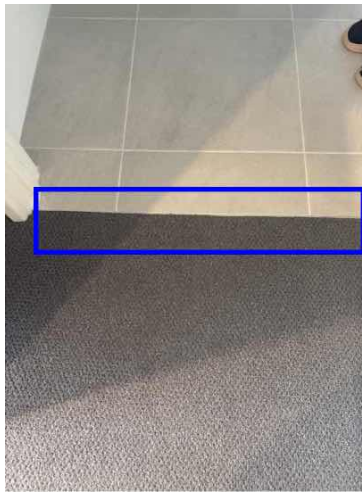
#4. **Maintenance:** Carpet grippers protruding through carpet across threshold.

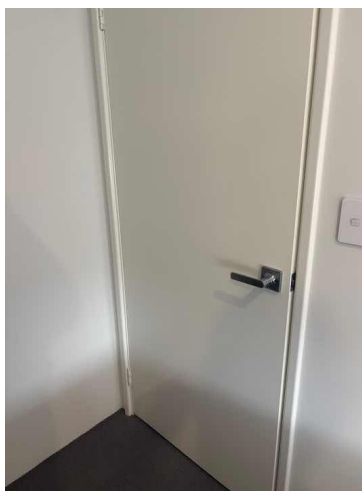
#5. **Maintenance:** Binding when opened and closed. Recommendation: Engage a carpenter to repair.

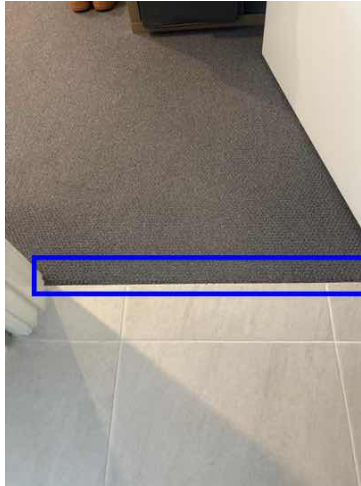
#6. **Maintenance:** Carpet grippers protruding through carpet across threshold.

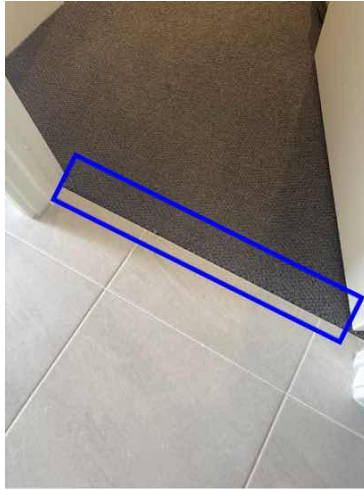
#7. **Maintenance:** Carpet grippers protruding through carpet across threshold.

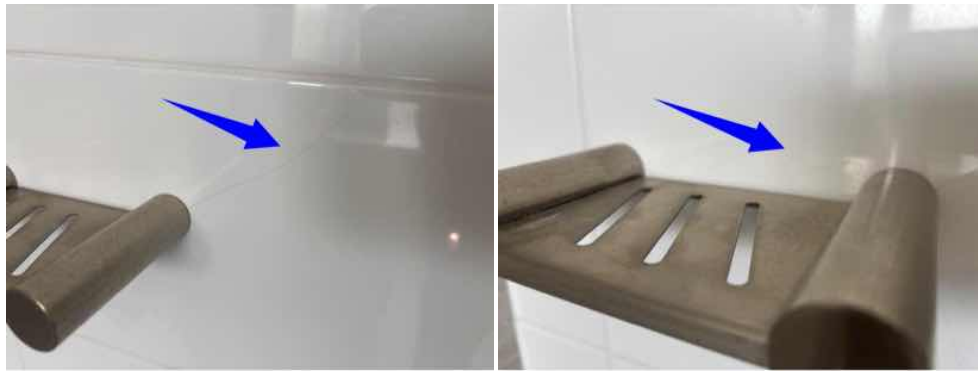
#8. **Maintenance:** Cracked tile/s noted. Recommendation: Engage a tiler for repairs.

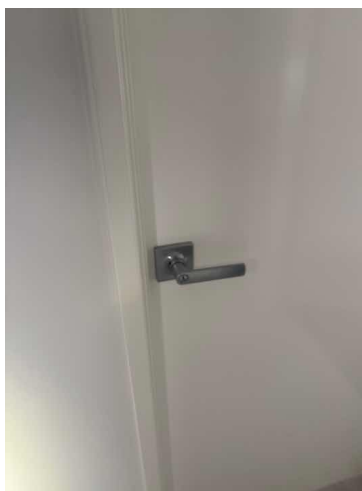
#9. **Maintenance:** Binding when opened and closed. Recommendation: Engage a carpenter to repair.
