# Combined Inspection

**SURE Building Inspections**

### Combined Structural and Timber Pest Inspection

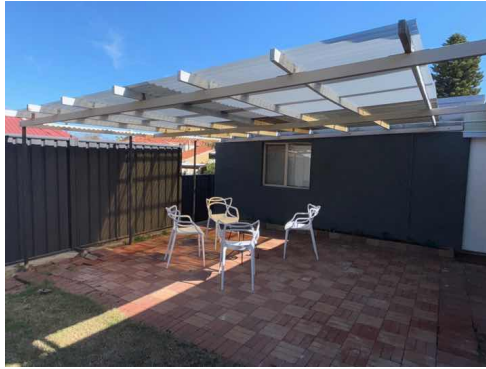
| Section | Location | Name | Comment |
|---|---|---|---|
| PERGOLA/S | Pergola Findings Rear | Frame Observations | 3. Structural Minor: The frame is poorly supported due to inadequate installation of posts, bearers and joists. Recommendation: Engage a carpenter for repairs. |

1. **Structural Minor:** The frame is poorly supported due to inadequate installation of posts, bearers and joists. Recommendation: Engage a carpenter for repairs.

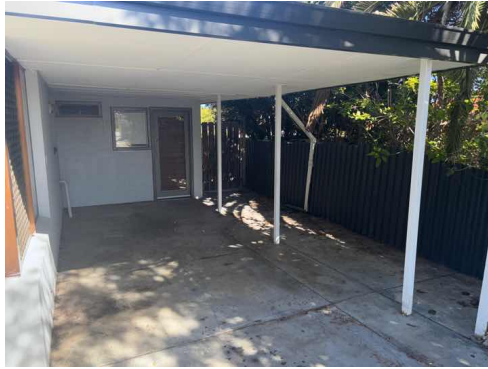
| Section | Location | Name | Comment |
|---|---|---|---|
| GARAGING | Attached Carport | Column or Post Observations | 4. Structural Minor: Post rust observed. If left unattended, overtime the post will become unstable. Recommendation: Engage a carpenter for repair. |

2. **Structural Minor:** Post rust observed. If left unattended, overtime the post will become unstable.  
Recommendation: Engage a carpenter for repair.

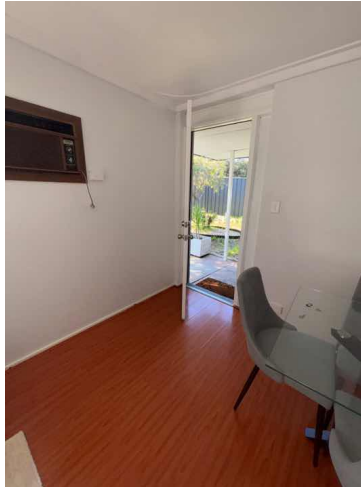
| Section | Location | Name | Comment |
|---|---|---|---|
| INTERIORS | Entry | Walls Observations | 6. Structural Minor: There appears to have been some settlement in the building which has caused some cracking to the walls. These crack/s are categorised as 0 to 2. This can also cause some doors to bind or be out of square. In the inspectors opinion these cracks are due to settlement, usually due to ground movement and subsequent movement to building materials can be expected. All cracks should be monitored and if cracks increase in size, further investigation should be carried out by a structural engineer.<br>Recommendation: Engage a painter to patch and paint. For clarification on the category of cracks with a damage category of 0 to 2, please refer to Cracking of Building Elements in Section 2G of the Terms and Conditions of this report. |

4. **Structural Minor:** There appears to have been some settlement in the building which has caused some cracking to the walls. These crack/s are categorised as 0 to 2. This can also cause some doors to bind or be out of square. In the inspectors opinion these cracks are due to settlement, usually due to ground movement and subsequent movement to building materials can be expected. All cracks should be monitored and if cracks increase in size, further investigation should be carried out by a structural engineer. Recommendation: Engage a painter to patch and paint.

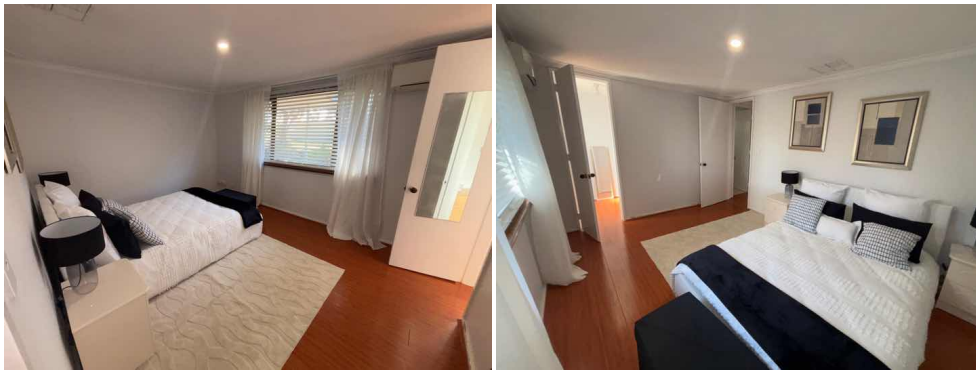
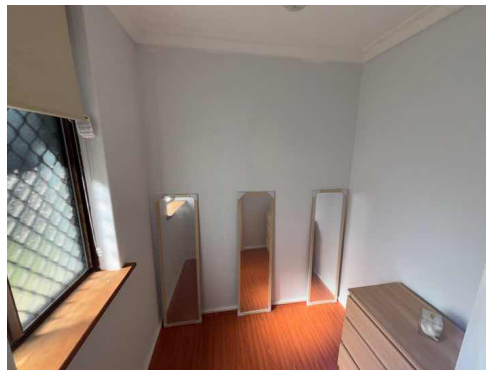
## **Bedroom 1**

| Section | Location | Name | Comment |
|---|---|---|---|
| INTERIORS | Bedroom 1 | Walls Observations | 7. Structural Minor: There appears to have been some settlement in the building which has caused some cracking to the walls. These crack/s are categorised as 0 to 2. This can also cause some doors to bind or be out of square. In the inspectors opinion these cracks are due to settlement, usually due to ground movement and subsequent movement to building materials can be expected. All cracks should be monitored and if cracks increase in size, further investigation should be carried out by a structural engineer.<br>Recommendation: Engage a painter to patch and paint. For clarification on the category of cracks with a damage category of 0 to 2, please refer to Cracking of Building Elements in Section 2G of the Terms and Conditions of this report. |

5. **Structural Minor:** There appears to have been some settlement in the building which has caused some cracking to the walls. These crack/s are categorised as 0 to 2. This can also cause some doors to bind or be out of square. In the inspectors opinion these cracks are due to settlement, usually due to ground movement and subsequent movement to building materials can be expected. All cracks should be monitored and if cracks increase in size, further investigation should be carried out by a structural engineer. Recommendation: Engage a painter to patch and paint.

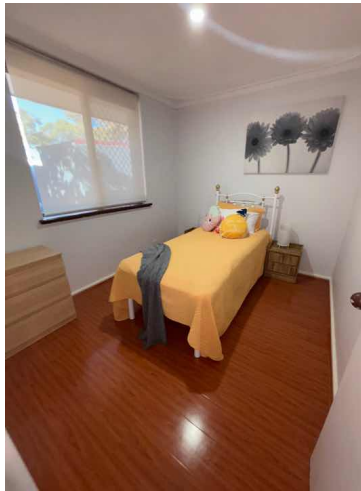
| INTERIORS | Bedroom 2 | Walls Observations | <p>8. Structural Minor: There appears to have been some settlement in the building which has caused some cracking to the walls. These crack/s are categorised as 0 to 2. This can also cause some doors to bind or be out of square. In the inspectors opinion these cracks are due to settlement, usually due to ground movement and subsequent movement to building materials can be expected. All cracks should be monitored and if cracks increase in size, further investigation should be carried out by a structural engineer.</p> <p>Recommendation: Engage a painter to patch and paint. For clarification on the category of cracks with a damage category of 0 to 2, please refer to Cracking of Building Elements in Section 2G of the Terms and Conditions of this report.</p> |

6. **Structural Minor:** There appears to have been some settlement in the building which has caused some cracking to the walls. These crack/s are categorised as 0 to 2. This can also cause some doors to bind or be out of square. In the inspectors opinion these cracks are due to settlement, usually due to ground movement and subsequent movement to building materials can be expected. All cracks should be monitored and if cracks increase in size, further investigation should be carried out by a structural engineer. Recommendation: Engage a painter to patch and paint.

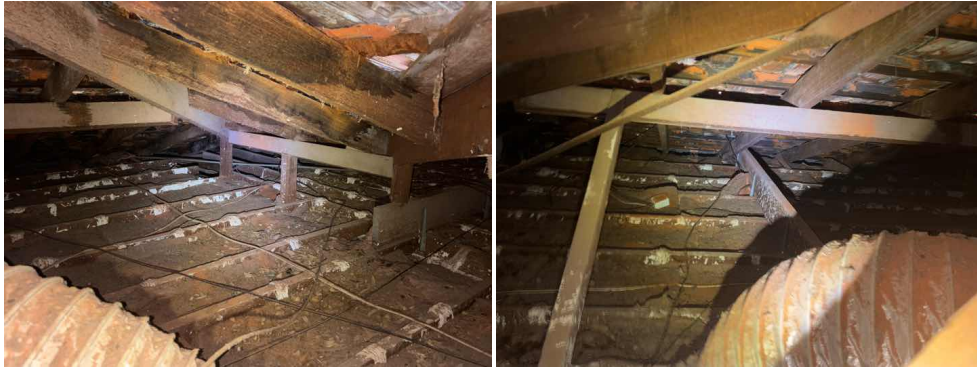
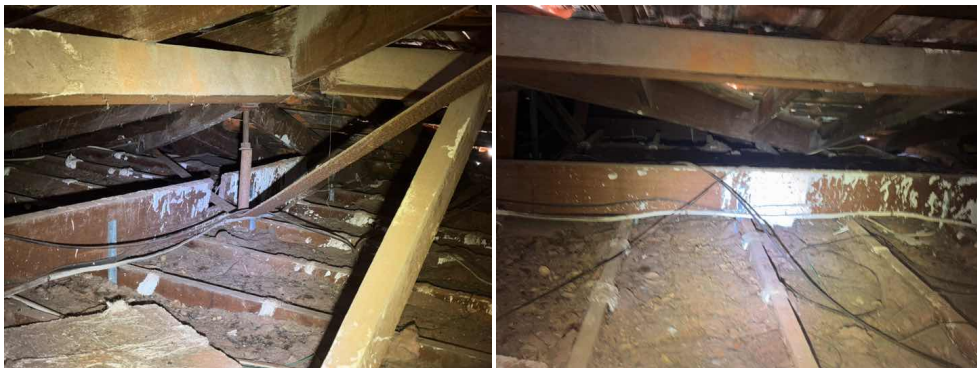
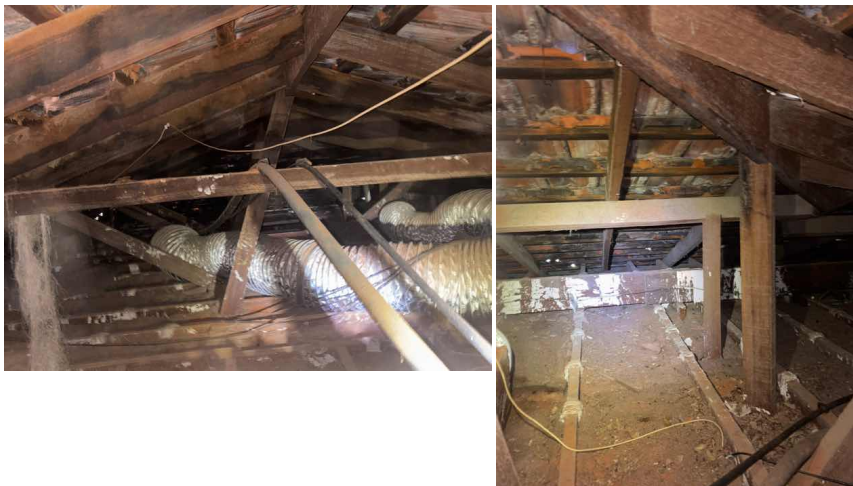
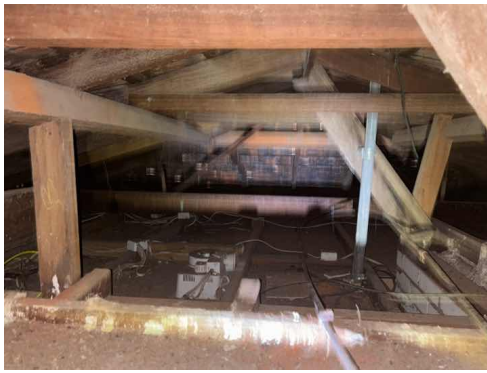
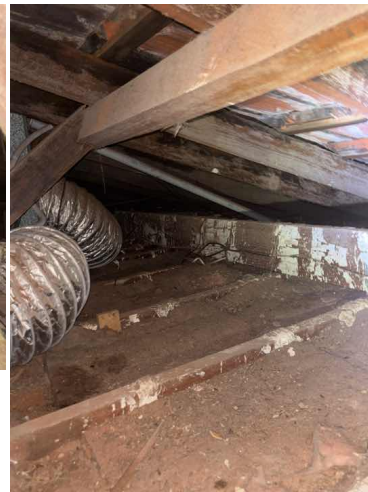
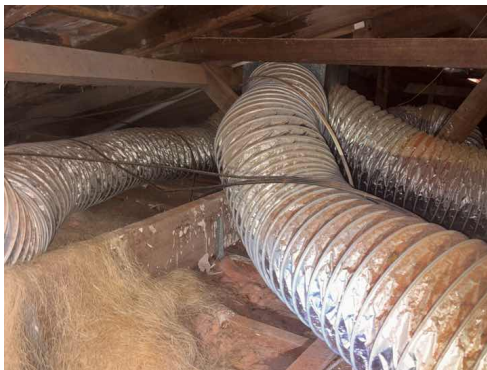
| Section | Location | Name | Comment |
|---|---|---|---|
| ROOF VOID | Roof Void Findings | Roof Framing Observations | <p>1. Structural Major: Chemical delignification observed to Structural Elements in the roof frame (rafters). It is expected that further deterioration will occur over time to such a point that reduced strength of the affected timbers is highly likely. Recommendation: Engage a structural engineer for confirmation of major defect.</p> <p>Engage a carpenter specialising in chemical Delignification for repair.</p> <p>The battens of the roof frame (North facing) are affected - non structural. The Delignification has spread into rafters on this elevation of the house to a significant degree.</p> |

Engage a carpenter specialising in chemical Delignification for repair.

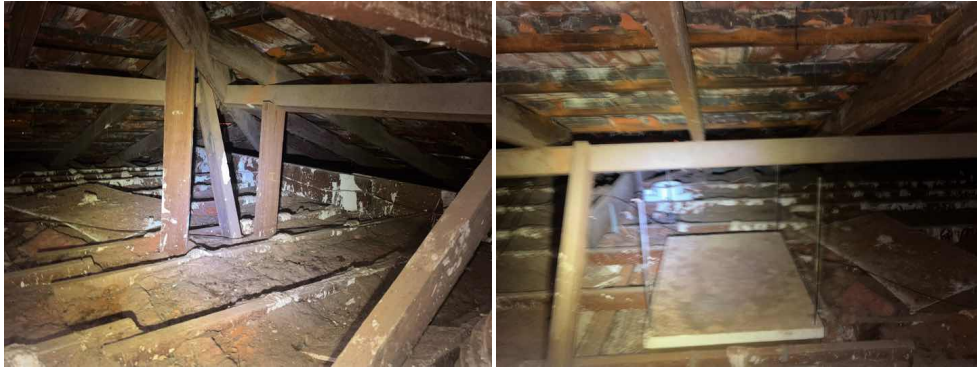
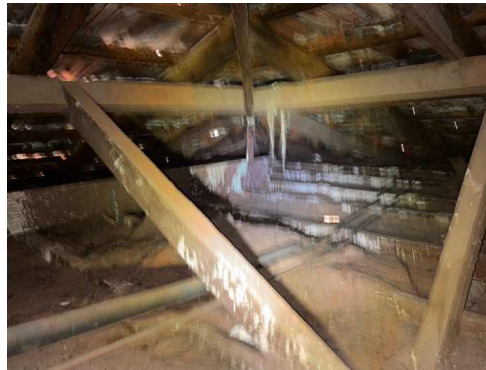
## Roof Framing Observations

7. **Structural Major:** Chemical delignification observed to Structural Elements in the roof frame (rafters). It is expected that further deterioration will occur over time to such a point that reduced strength of the affected timbers is highly likely. Recommendation: Engage a structural engineer for confirmation of major defect.

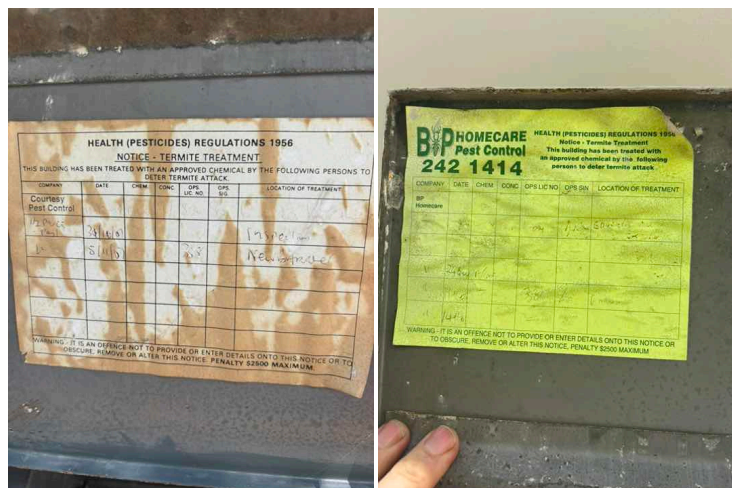
### Was a Treatment Notice Found

A durable notice was found in the meter-box during the inspection.
