# Commercial Combined

**SURE Building Inspections**

### Commercial Combined Structural and Timber Pest Inspection

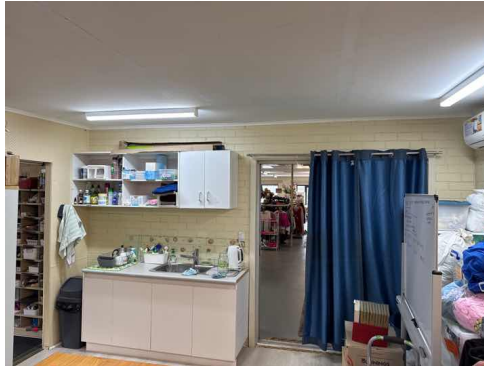
From the visible and accessible areas, the structural condition of the kitchen is serviceable for the age of the building.

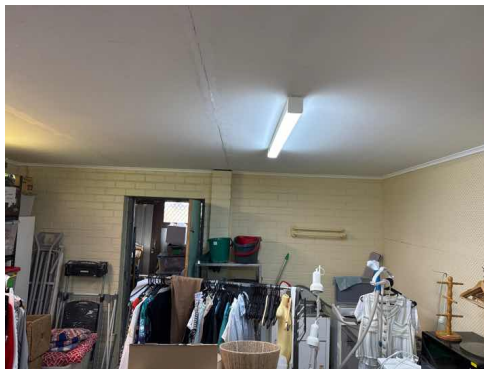
### Laundry

From the visible and accessible areas, the structural condition of the laundry is serviceable for the age of the building.

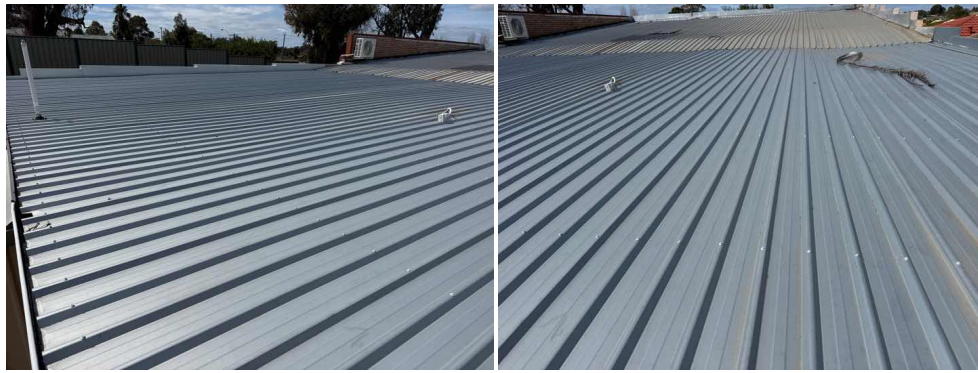
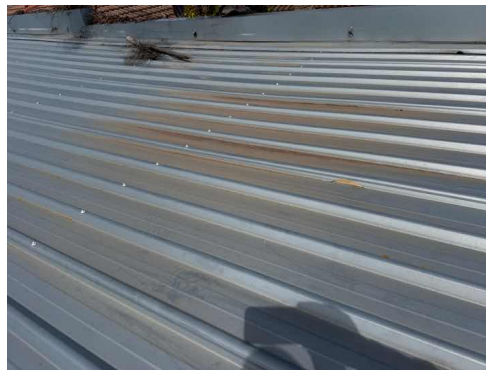
#### **Roof Cladding**

The roof is metal.
