# High Rise Inspection

**SURE Building Inspections**

### High Rise Apartment Inspection

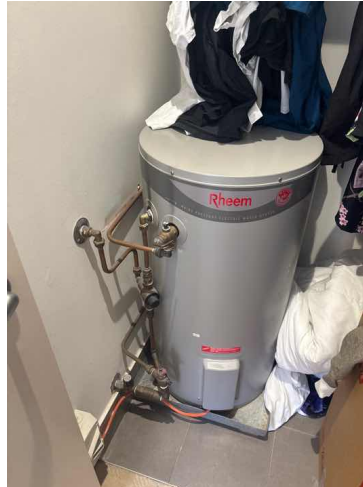
**Hot Water Unit****Hot Water Unit Observations**

The hot water system appears to be in a serviceable condition. No specific tests other than running the hot water from a tap was carried out. No determination has been made as to the suitability or adequacy of the hot water system in relation to capacity or otherwise. The hot water unit should be periodically inspected for leaks and deterioration.

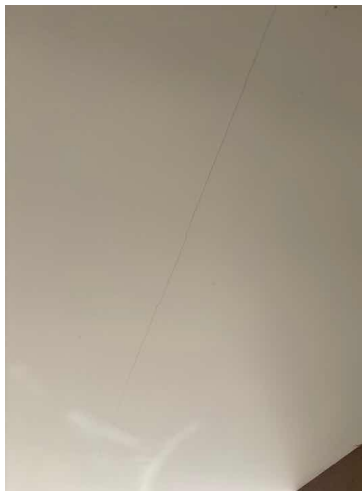
### Ceiling Lining Observations

**Maintenance:** Ceiling Lining join crack observed. Engage a painter for repairs.

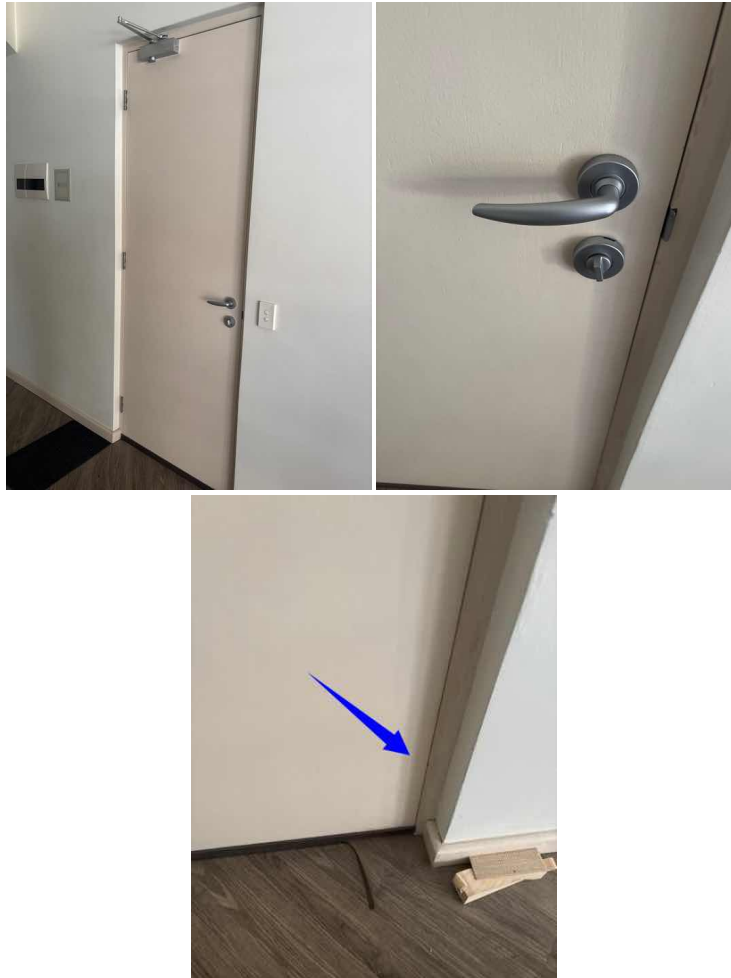
**Maintenance:** Binding when opened and closed. Recommendation: Engage a carpenter to repair.

**Maintenance:** Door handle/hardware is loose. Recommendation: Engage a handyman to repair.

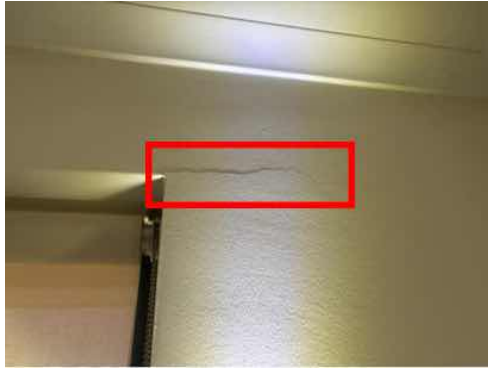
## Walls Observations

**Maintenance:** General scuffs and marks to walls. Recommendation: Engage a painter for repairs.

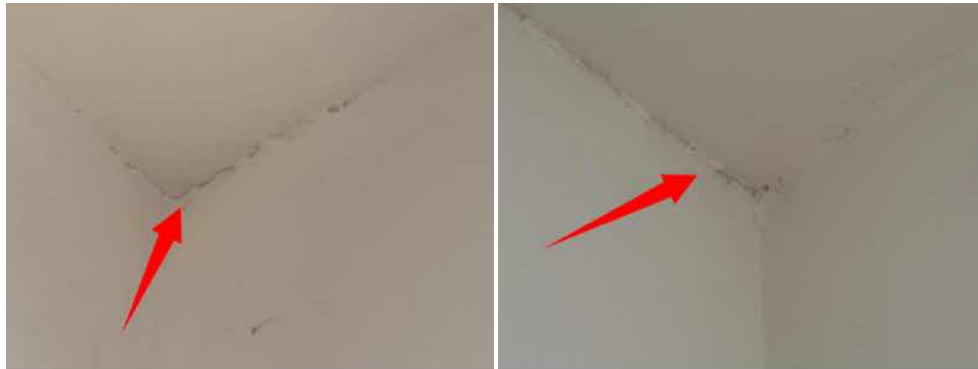
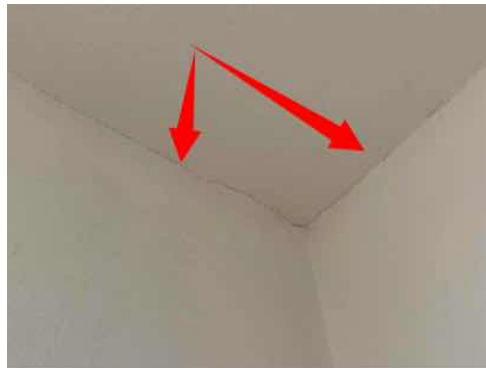
| Section | Location | Name | Comment |
|---|---|---|---|
| INTERIORS | Store Room | Walls Observations | <p>Structural Minor: There appears to have been some settlement in the building which has caused some cracking to the walls. These crack/s are categorised as 0 to 2. This can also cause some doors to bind or be out of square. In the inspectors opinion these cracks are due to settlement, usually due to ground movement and subsequent movement to building materials can be expected. All cracks should be monitored and if cracks increase in size, further investigation should be carried out by a structural engineer. Recommendation: Engage a painter to patch and paint.</p> <p>For clarification on the category of cracks with a damage category of 0 to 2, please refer to Cracking of Building Elements in Section 2D of the Terms and Conditions of this report.</p> |

**Structural Minor:** There appears to have been some settlement in the building which has caused some cracking to the walls. These crack/s are categorised as 0 to 2. This can also cause some doors to bind or be out of square. In the inspectors opinion these cracks are due to settlement, usually due to ground movement and subsequent movement to building materials can be expected. All cracks should be monitored and if cracks increase in size, further investigation should be carried out by a structural engineer. Recommendation: Engage a painter to patch and paint.

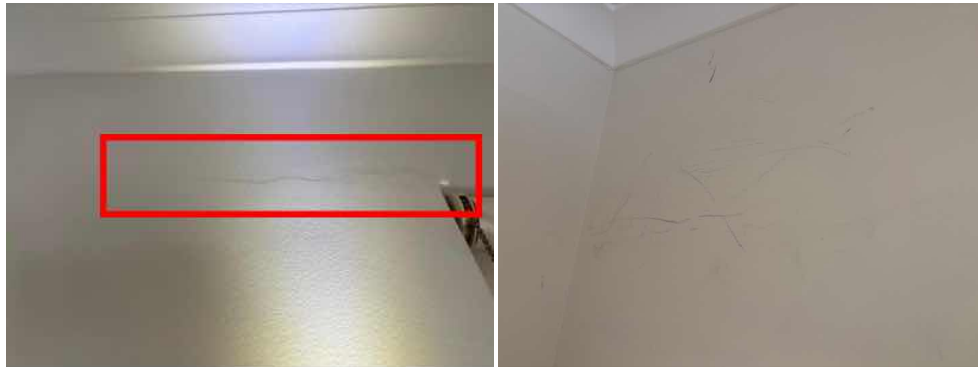
| Section | Location | Name | Comment |
|---|---|---|---|
| INTERIORS | Bedroom | Walls Observations | <p>Structural Minor: There appears to have been some settlement in the building which has caused some cracking to the walls. These crack/s are categorised as 0 to 2. This can also cause some doors to bind or be out of square. In the inspectors opinion these cracks are due to settlement, usually due to ground movement and subsequent movement to building materials can be expected. All cracks should be monitored and if cracks increase in size, further investigation should be carried out by a structural engineer. Recommendation: Engage a painter to patch and paint.</p> <p>For clarification on the category of cracks with a damage category of 0 to 2, please refer to Cracking of Building Elements in Section 2D of the Terms and Conditions of this report.</p> |

**Maintenance:** General scuffs and marks to walls. Recommendation: Engage a painter for repairs.

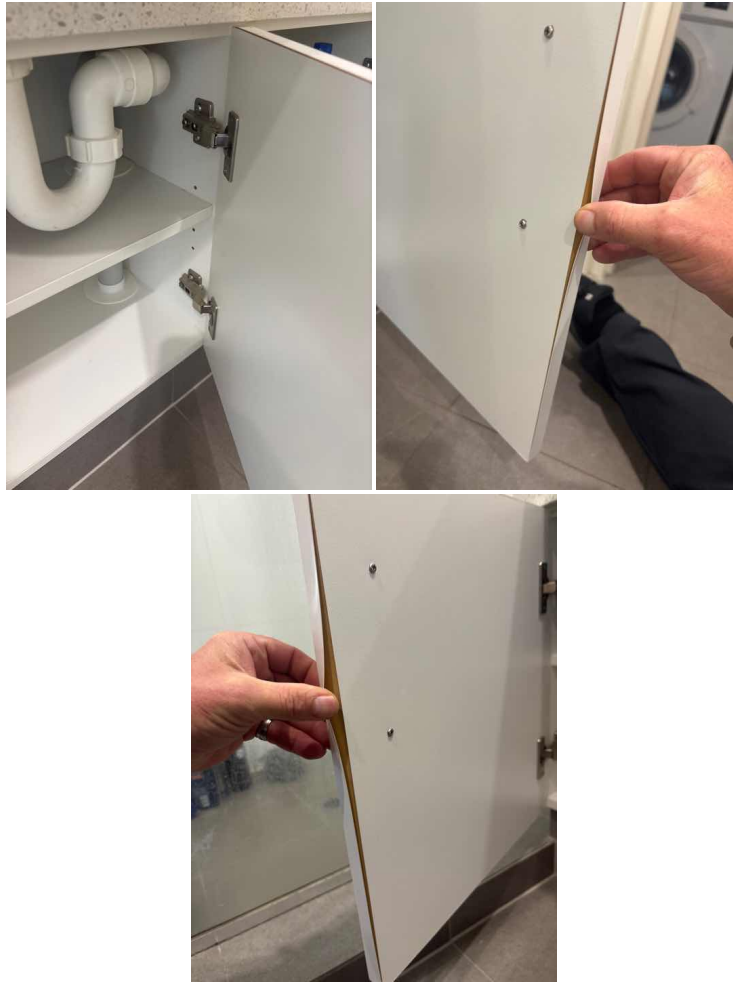
**Maintenance:** Hinges and/or drawer rollers require maintenance and adjustment. Recommendation: Engage a handyman or cabinet maker for repairs.

**Maintenance:** Typical wear observed to cabinetry components. Serviceable condition.

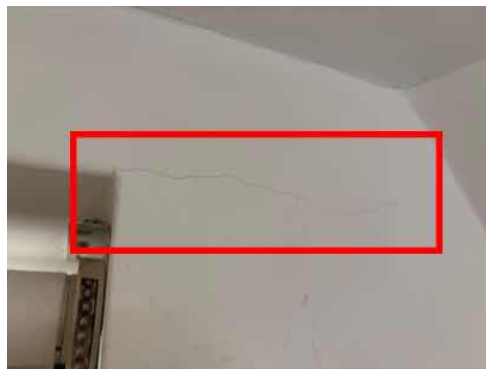
| KITCHEN & LAUNDRY | Kitchen | Walls<br>Observations | <p>Structural Minor: There appears to have been some settlement in the building which has caused some cracking to the walls. These crack/s are categorised as 0 to 2. This can also cause some doors to bind or be out of square. In the inspectors opinion these cracks are due to settlement, usually due to ground movement and subsequent movement to building materials can be expected. All cracks should be monitored and if cracks increase in size, further investigation should be carried out by a structural engineer. Engage a painter to patch and paint.</p> <p>For clarification on the category of cracks with a damage category of 0 to 2, please refer to Cracking of Building Elements in Section 2D of the Terms and Conditions of this report.</p> |

**Maintenance:** General scuffs and marks to walls. Recommendation: Engage a painter for repairs.

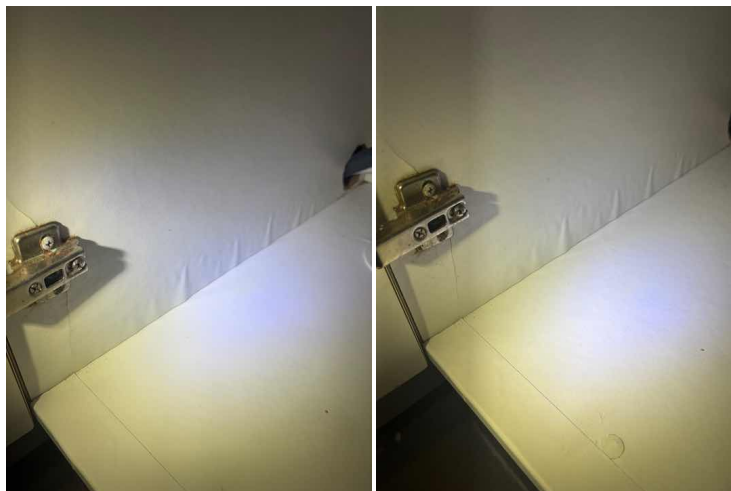
### Cabinet Observations

**Maintenance:** Typical wear observed to cabinetry components. Serviceable condition.

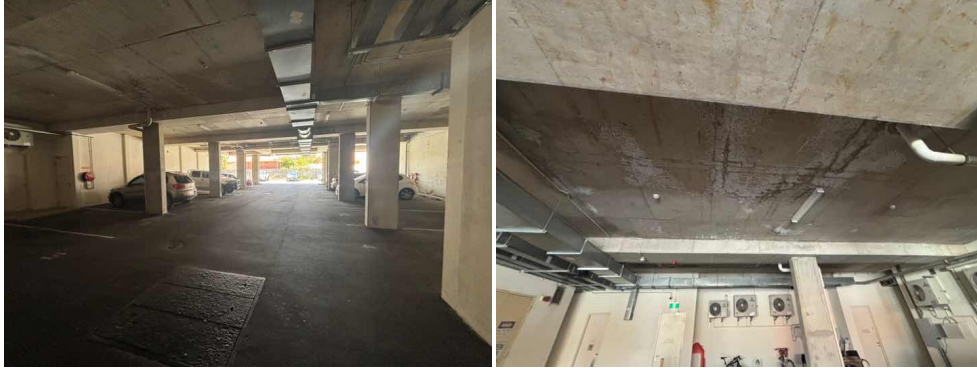
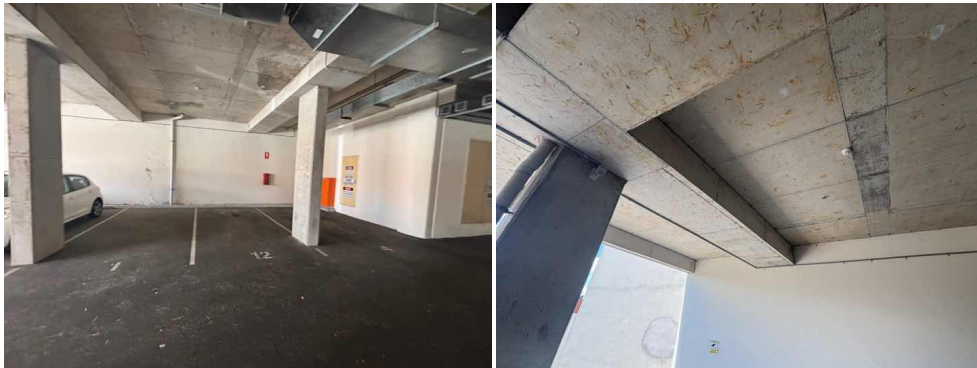
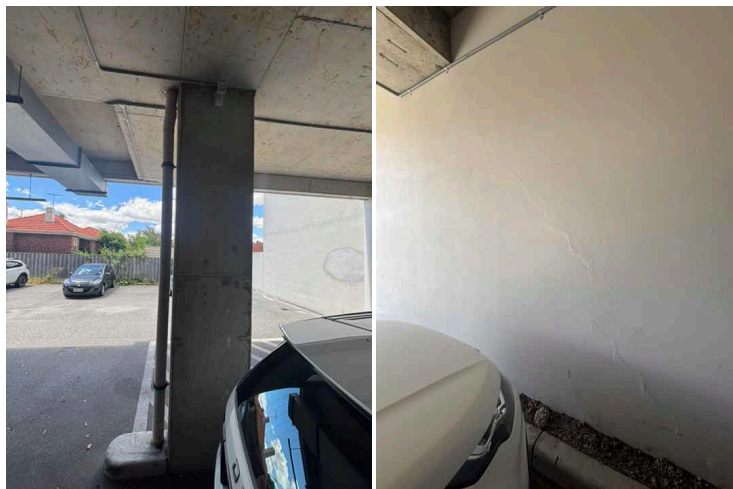
### Car Space - Common Garage

On visual inspection, the general condition of the garage is serviceable for the age of the building.
