# Invasive Inspection

**SURE Building Inspections**

### Comprehensive Building and Timber Pest Inspection

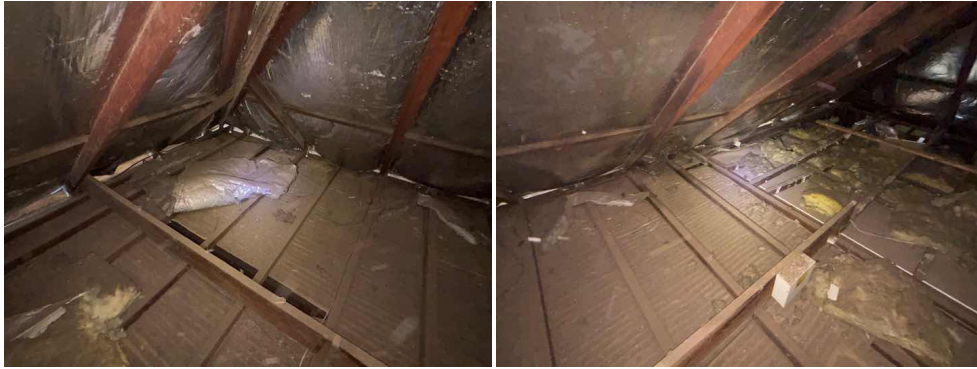
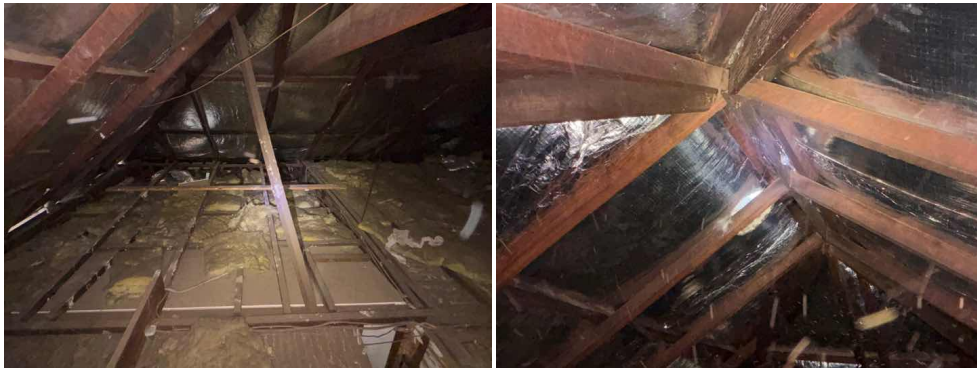
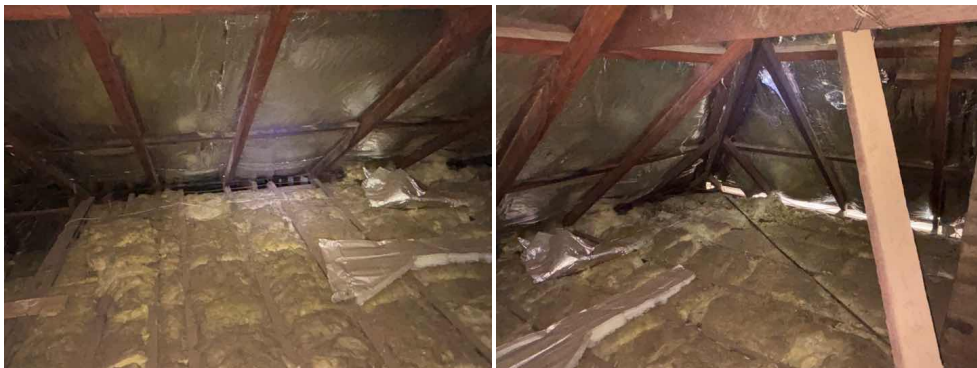
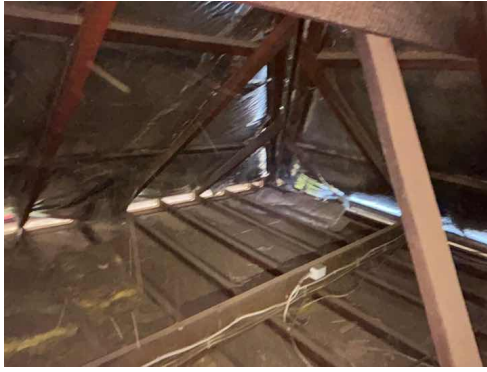
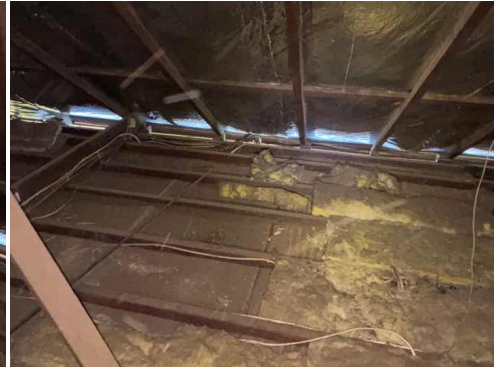
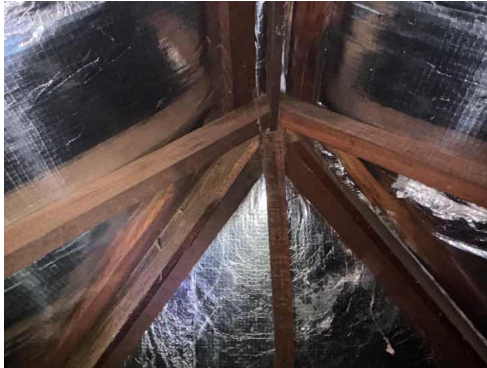
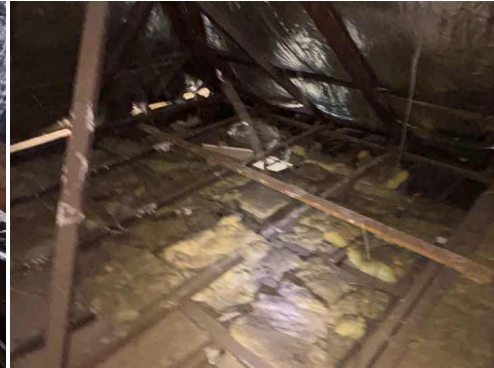
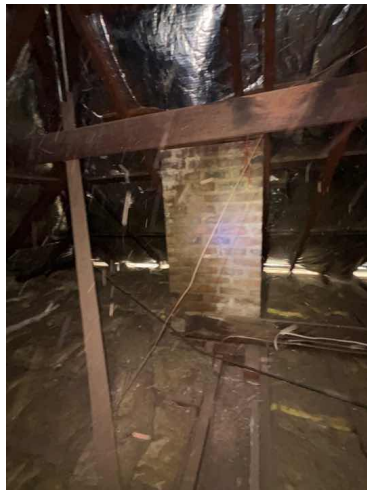
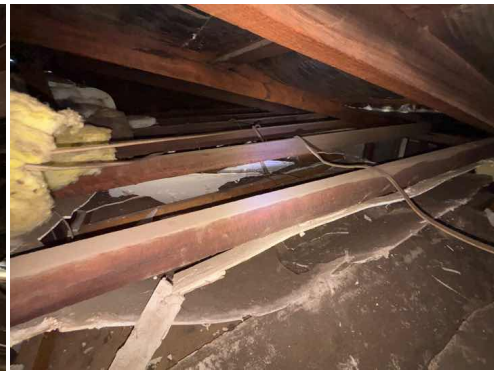
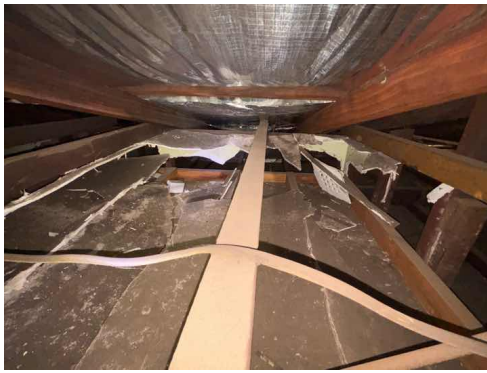
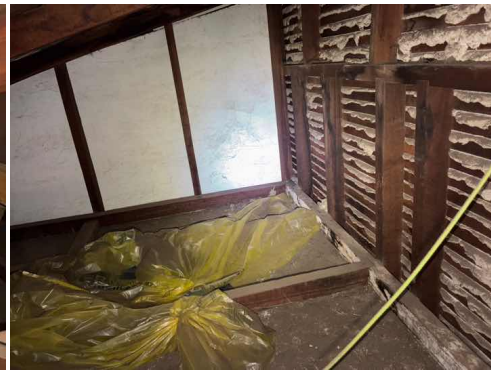
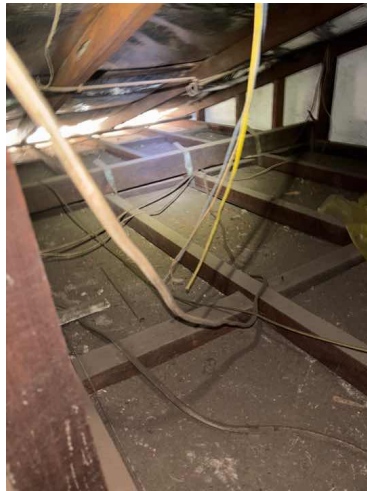
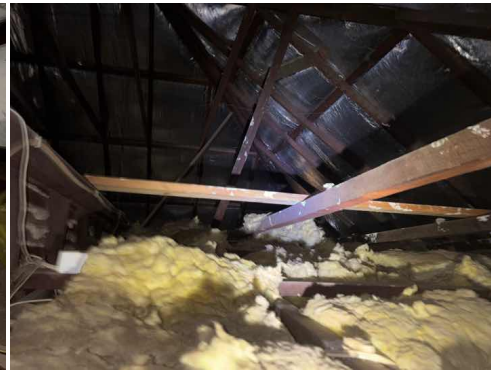
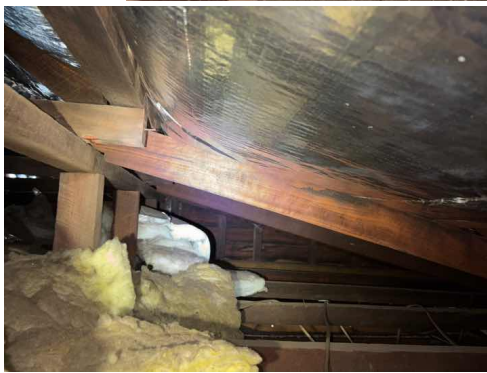
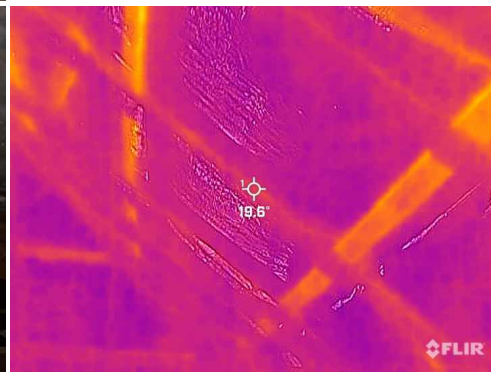
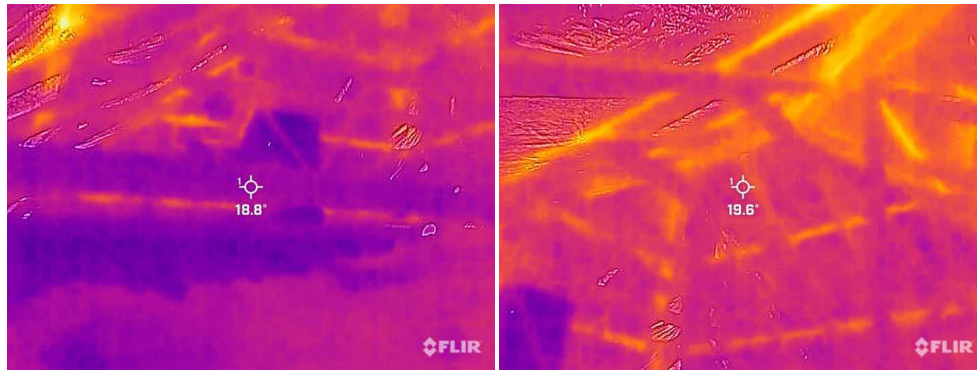
## Roof Framing Observations

**Maintenance:** Framing timbers are aged. Recommendation: Maintain a regular inspection routine and engage a carpenter to complete maintenance as required.

**Maintenance:** Sections of the roof framing do not comply with today's standards (note the property was built prior to standards implementation). Recommendation: Engage a carpenter for maintenance work if desired.

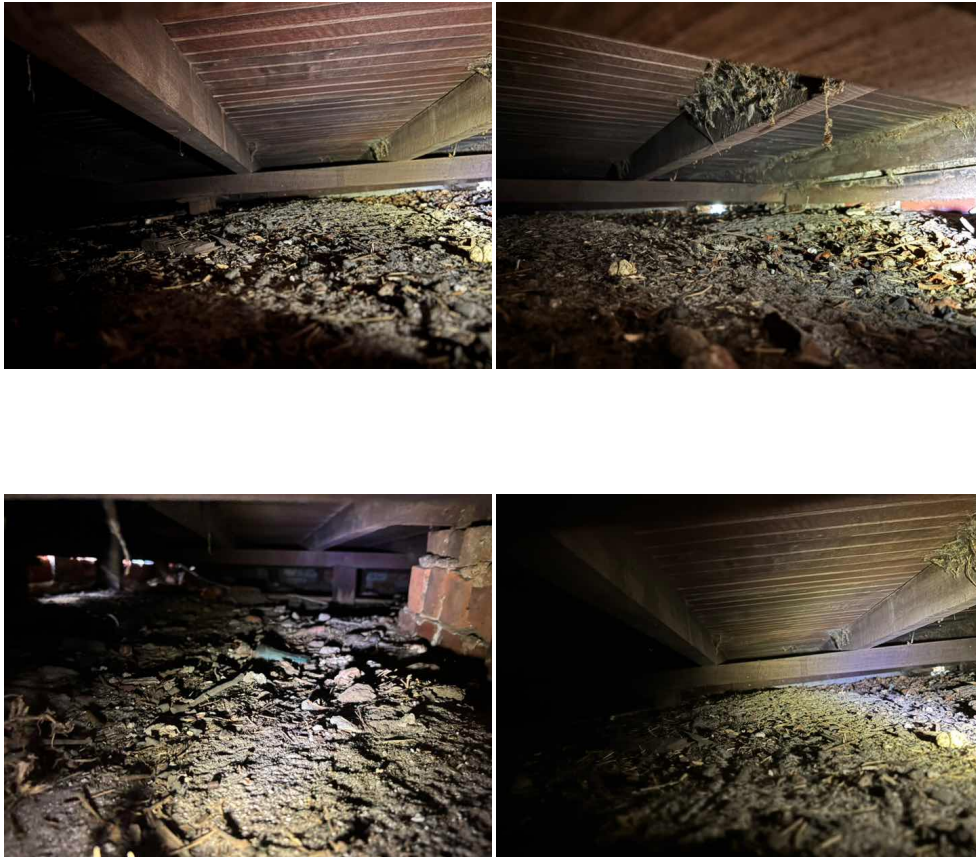
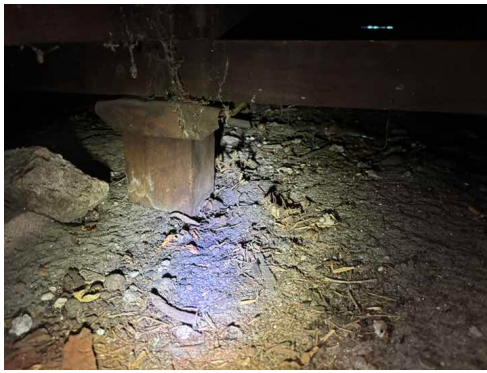
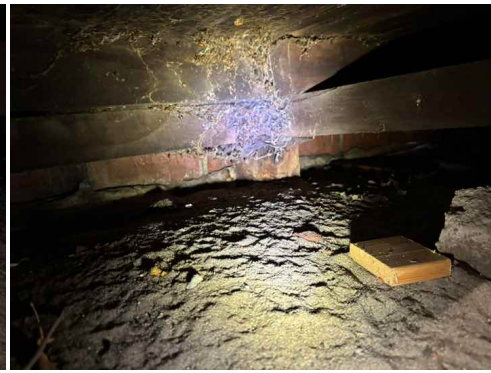
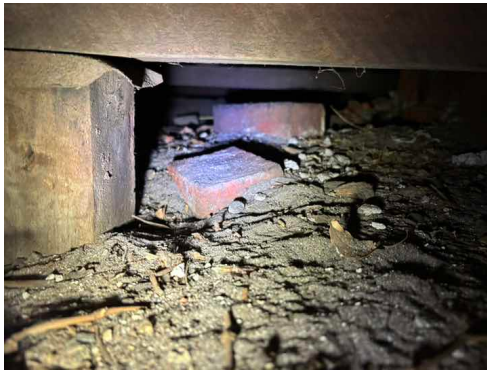
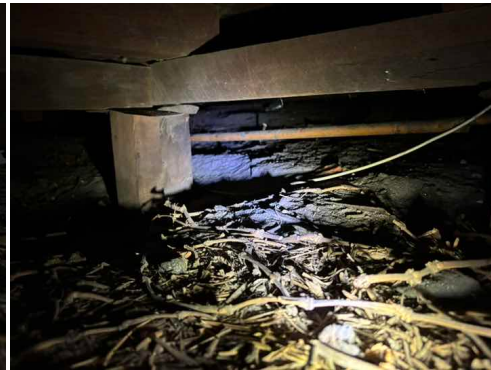
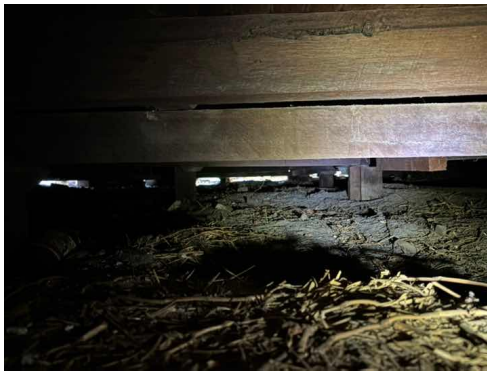
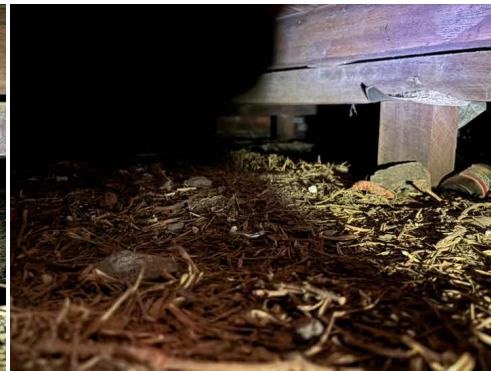
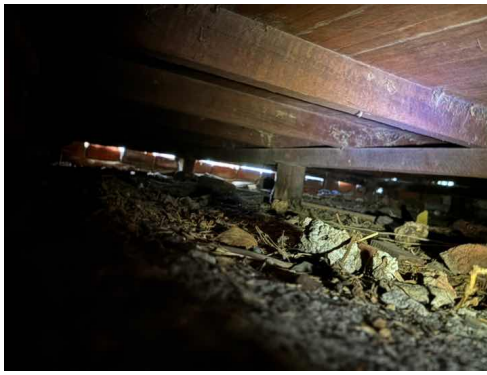
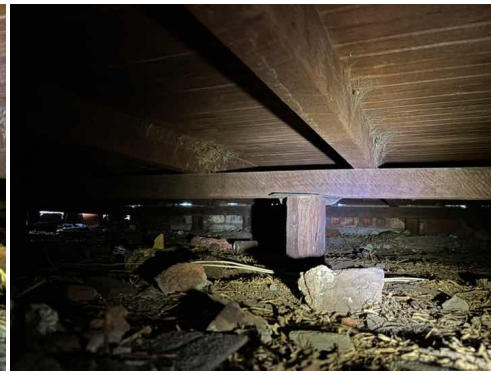
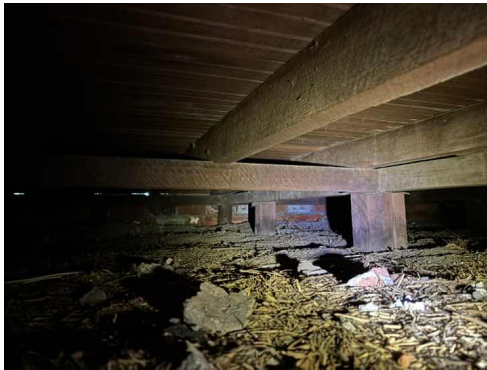
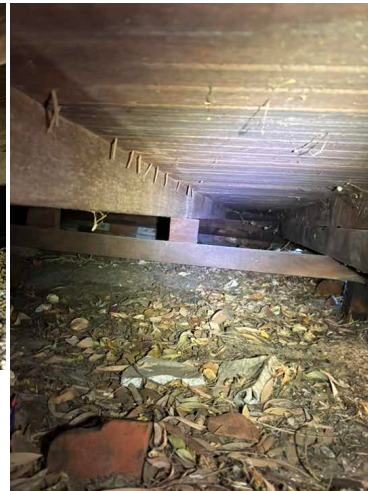
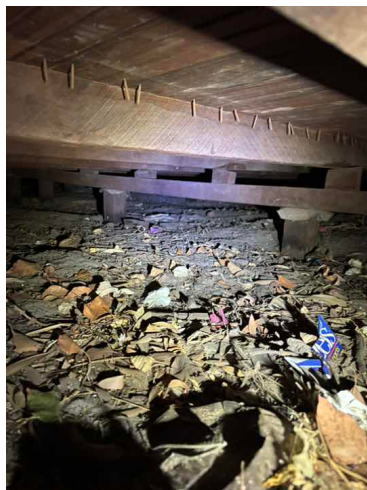
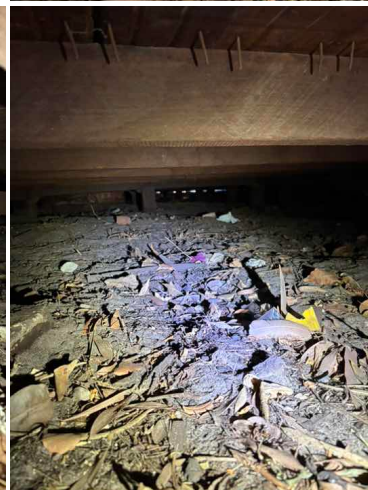
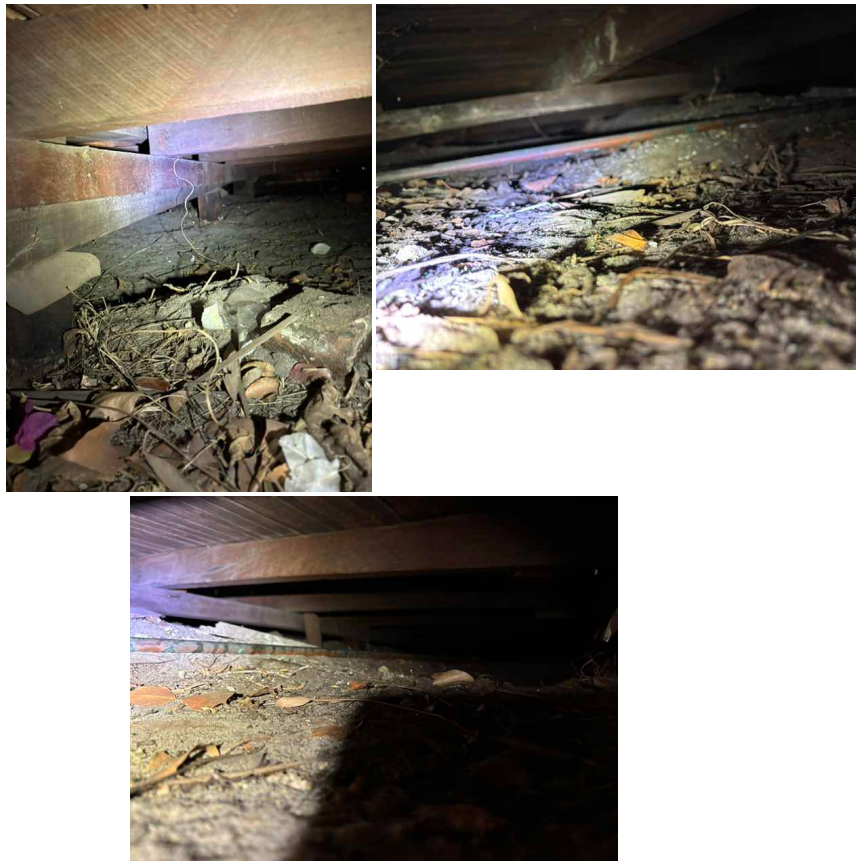
## Piers And Foundation Walls

| Section | Location | Name | Comment |
|---|---|---|---|
| SUB-FLOOR | Sub-Floor Observation | Piers And Foundation Walls | Structural Major: Evidence of major subsidence (sinking) was noted to the footings. Recommendation: Engage a re-stumping company/contractor to complete repair works. |

**Structural Major:** Evidence of major subsidence (sinking) was noted to the footings. Recommendation: Engage a re-stumping company/contractor to complete repair works.
