# Structural Inspection

**SURE Building Inspections**

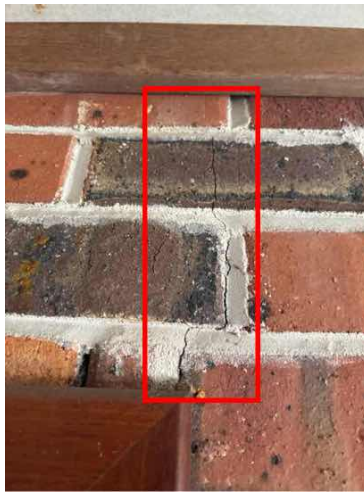
| Section | Location | Name | Comment |
|---|---|---|---|
| GARAGING | Attached Garage | Internal Wall Observations | <p>#1. Structural Minor: There appears to have been some settlement in the building which has caused some cracking to the walls. These crack/s are categorised as 0 to 2. This can also cause some doors to bind or be out of square. In the inspectors opinion these cracks are due to settlement, usually due to ground movement and subsequent movement to building materials can be expected. All cracks should be monitored and if cracks increase in size, further investigation should be carried out by a structural engineer. Engage a bricklayer to repair.</p> <p>For clarification on the category of cracks with a damage category of 0 to 2, please refer to Cracking of Building Elements in Section 2G of the Terms and Conditions of this report.</p> |

#1. **Structural Minor:** There appears to have been some settlement in the building which has caused some cracking to the walls. These crack/s are categorised as 0 to 2. This can also cause some doors to bind or be out of square. In the inspectors opinion these cracks are due to settlement, usually due to ground movement and subsequent movement to building materials can be expected. All cracks should be monitored and if cracks increase in size, further investigation should be carried out by a structural engineer. Engage a bricklayer to repair.

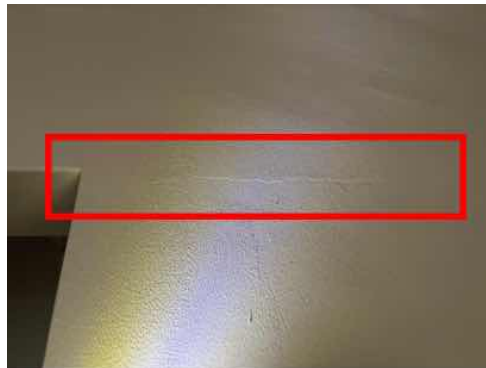
| Section | Location | Name | Comment |
|---|---|---|---|
| INTERIORS | Lounge Room | Walls Observations | <p>#2. Structural Minor: There appears to have been some settlement in the building which has caused some cracking to the walls. These crack/s are categorised as 0 to 2. This can also cause some doors to bind or be out of square. In the inspectors opinion these cracks are due to settlement, usually due to ground movement and subsequent movement to building materials can be expected. All cracks should be monitored and if cracks increase in size, further investigation should be carried out by a structural engineer.</p> <p>Recommendation: Engage a painter to patch and paint.</p> <p>For clarification on the category of cracks with a damage category of 0 to 2, please refer to Cracking of Building Elements in Section 2G of the Terms and Conditions of this report.</p> |

#2. **Structural Minor:** There appears to have been some settlement in the building which has caused some cracking to the walls. These crack/s are categorised as 0 to 2. This can also cause some doors to bind or be out of square. In the inspectors opinion these cracks are due to settlement, usually due to ground movement and subsequent movement to building materials can be expected. All cracks should be monitored and if cracks increase in size, further investigation should be carried out by a structural engineer. Recommendation: Engage a painter to patch and paint.

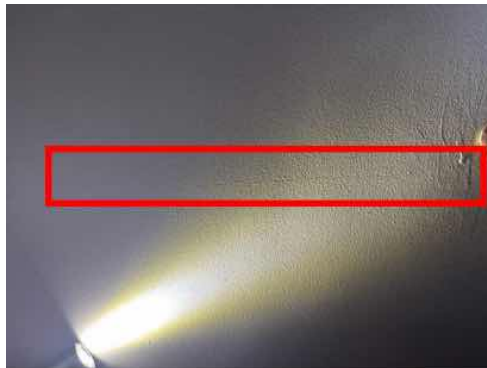
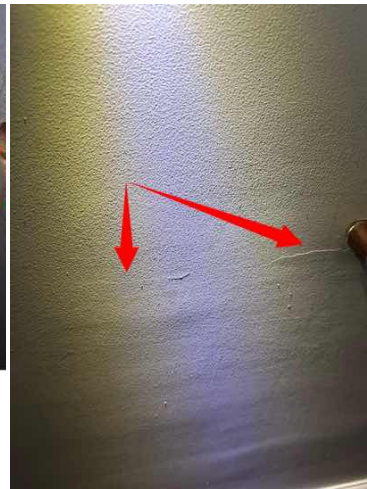
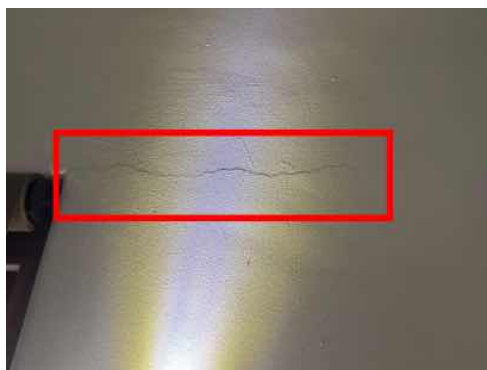
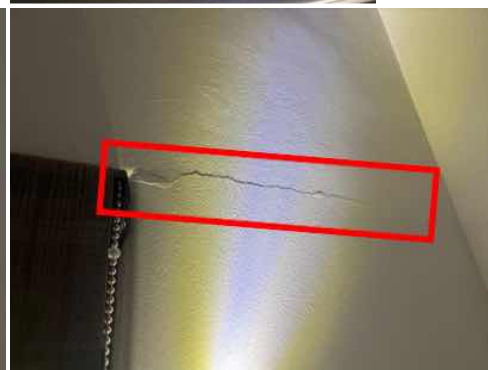
| Section | Location | Name | Comment |
|---|---|---|---|
| INTERIORS | Dining Room | Walls Observations | <p>#3. Structural Minor: There appears to have been some settlement in the building which has caused some cracking to the walls. These crack/s are categorised as 0 to 2. This can also cause some doors to bind or be out of square. In the inspectors opinion these cracks are due to settlement, usually due to ground movement and subsequent movement to building materials can be expected. All cracks should be monitored and if cracks increase in size, further investigation should be carried out by a structural engineer.</p> <p>Recommendation: Engage a painter to patch and paint.</p> <p>For clarification on the category of cracks with a damage category of 0 to 2, please refer to Cracking of Building Elements in Section 2G of the Terms and Conditions of this report.</p> |

#3. **Structural Minor:** There appears to have been some settlement in the building which has caused some cracking to the walls. These crack/s are categorised as 0 to 2. This can also cause some doors to bind or be out of square. In the inspectors opinion these cracks are due to settlement, usually due to ground movement and subsequent movement to building materials can be expected. All cracks should be monitored and if cracks increase in size, further investigation should be carried out by a structural engineer. Recommendation: Engage a painter to patch and paint.

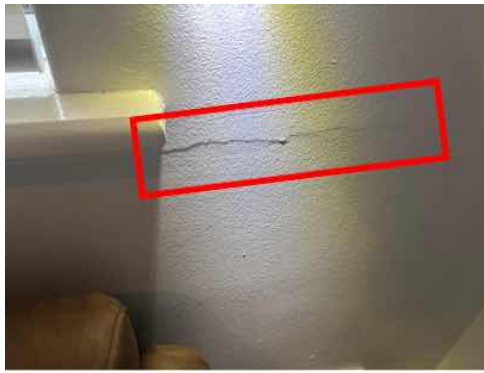
| INTERIORS | Living / Retreat Room | Walls Observations | <p>#4. Structural Minor: There appears to have been some settlement in the building which has caused some cracking to the walls. These crack/s are categorised as 0 to 2. This can also cause some doors to bind or be out of square. In the inspectors opinion these cracks are due to settlement, usually due to ground movement and subsequent movement to building materials can be expected. All cracks should be monitored and if cracks increase in size, further investigation should be carried out by a structural engineer.</p> <p>Recommendation: Engage a painter to patch and paint. For clarification on the category of cracks with a damage category of 0 to 2, please refer to Cracking of Building Elements in Section 2G of the Terms and Conditions of this report.</p> |

#4. **Structural Minor:** There appears to have been some settlement in the building which has caused some cracking to the walls. These crack/s are categorised as 0 to 2. This can also cause some doors to bind or be out of square. In the inspectors opinion these cracks are due to settlement, usually due to ground movement and subsequent movement to building materials can be expected. All cracks should be monitored and if cracks increase in size, further investigation should be carried out by a structural engineer. Recommendation: Engage a painter to patch and paint.

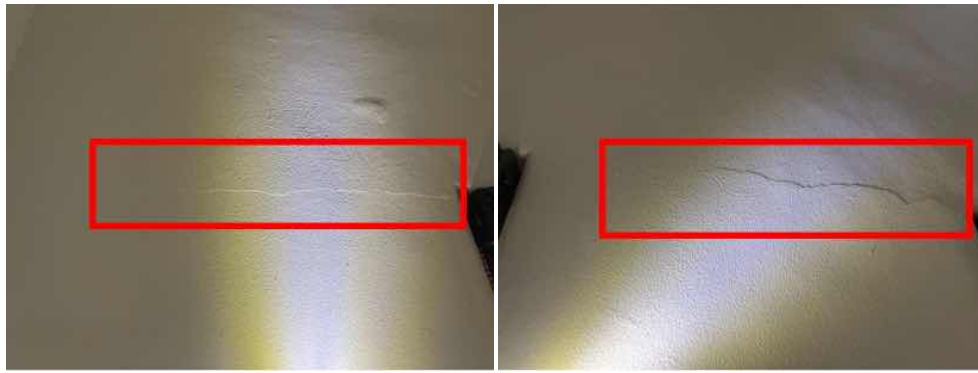
| INTERIORS | Living Room | Walls Observations | <p>#5. Structural Minor: There appears to have been some settlement in the building which has caused some cracking to the walls. These crack/s are categorised as 0 to 2. This can also cause some doors to bind or be out of square. In the inspectors opinion these cracks are due to settlement, usually due to ground movement and subsequent movement to building materials can be expected. All cracks should be monitored and if cracks increase in size, further investigation should be carried out by a structural engineer.</p> <p>Recommendation: Engage a painter to patch and paint. For clarification on the category of cracks with a damage category of 0 to 2, please refer to Cracking of Building Elements in Section 2G of the Terms and Conditions of this report.</p> |

#5. **Structural Minor:** There appears to have been some settlement in the building which has caused some cracking to the walls. These crack/s are categorised as 0 to 2. This can also cause some doors to bind or be out of square. In the inspectors opinion these cracks are due to settlement, usually due to ground movement and subsequent movement to building materials can be expected. All cracks should be monitored and if cracks increase in size, further investigation should be carried out by a structural engineer. Recommendation: Engage a painter to patch and paint.

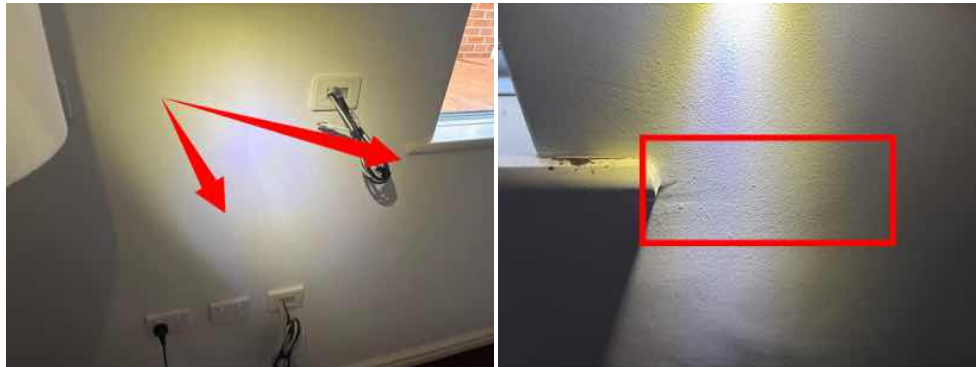
#6. **Structural Minor:** There appears to have been some settlement in the building which has caused some cracking to the walls. These crack/s are categorised as 0 to 2. This can also cause some doors to bind or be out of square. In the inspectors opinion these cracks are due to settlement, usually due to ground movement and subsequent movement to building materials can be expected. All cracks should be monitored and if cracks increase in size, further investigation should be carried out by a structural engineer. Recommendation: Engage a painter to patch and paint.

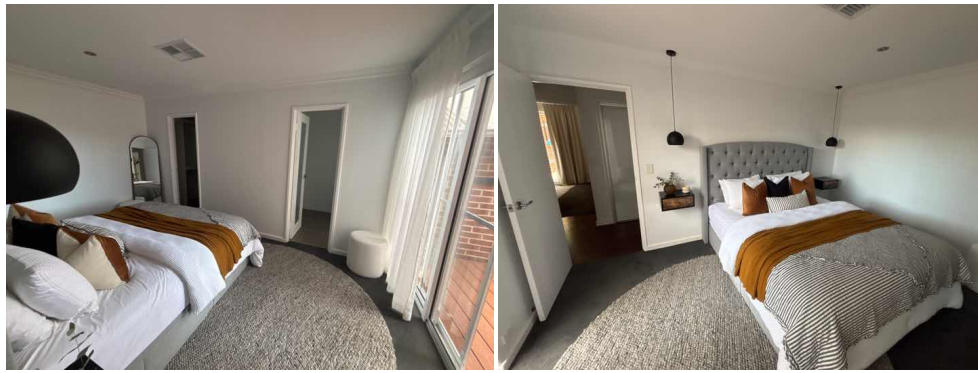
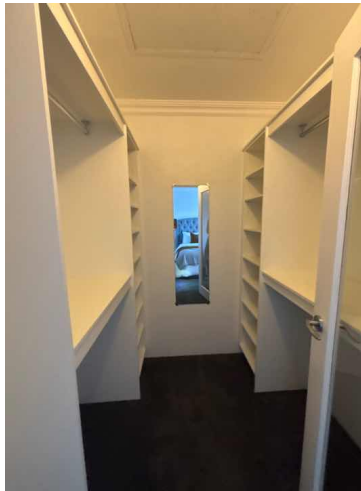
#7. **Structural Minor:** There appears to have been some settlement in the building which has caused some cracking to the walls. These crack/s are categorised as 0 to 2. This can also cause some doors to bind or be out of square. In the inspectors opinion these cracks are due to settlement, usually due to ground movement and subsequent movement to building materials can be expected. All cracks should be monitored and if cracks increase in size, further investigation should be carried out by a structural engineer. Recommendation: Engage a painter to patch and paint.

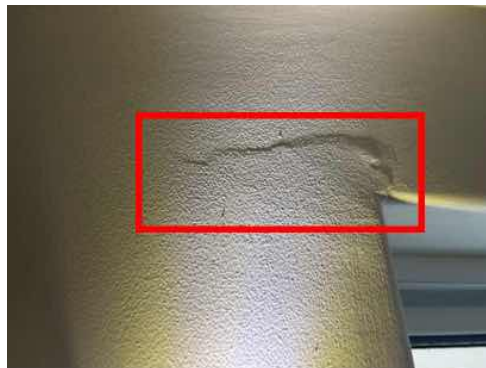
#8. **Structural Minor:** There appears to have been some settlement in the building which has caused some cracking to the walls. These crack/s are categorised as 0 to 2. This can also cause some doors to bind or be out of square. In the inspectors opinion these cracks are due to settlement, usually due to ground movement and subsequent movement to building materials can be expected. All cracks should be monitored and if cracks increase in size, further investigation should be carried out by a structural engineer. Engage a painter to patch and paint.

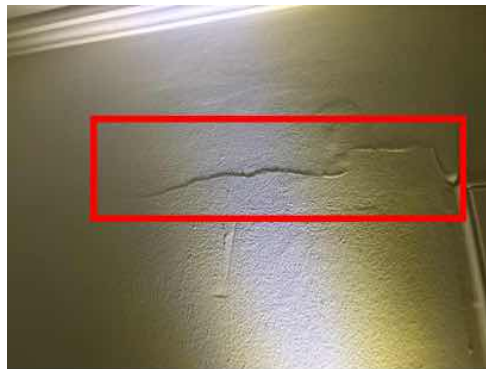
#9. **Structural Minor:** There appears to have been some settlement in the building which has caused some cracking to the walls. These crack/s are categorised as 0 to 2. This can also cause some doors to bind or be out of square. In the inspectors opinion these cracks are due to settlement, usually due to ground movement and subsequent movement to building materials can be expected. All cracks should be monitored and if cracks increase in size, further investigation should be carried out by a structural engineer. Engage a painter to patch and paint.

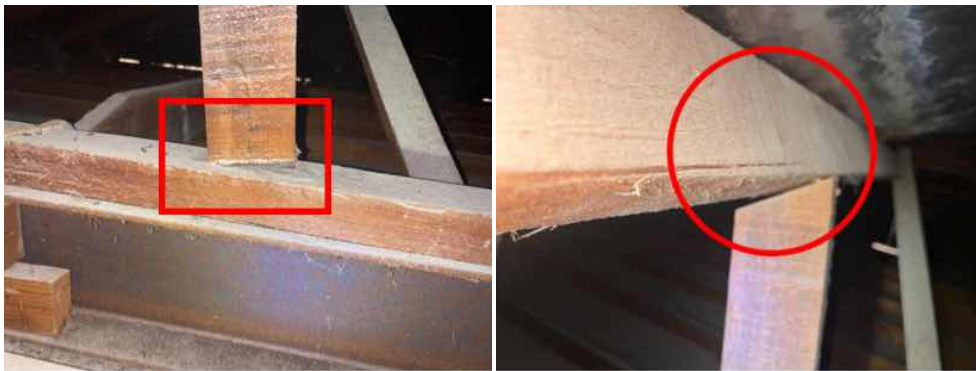
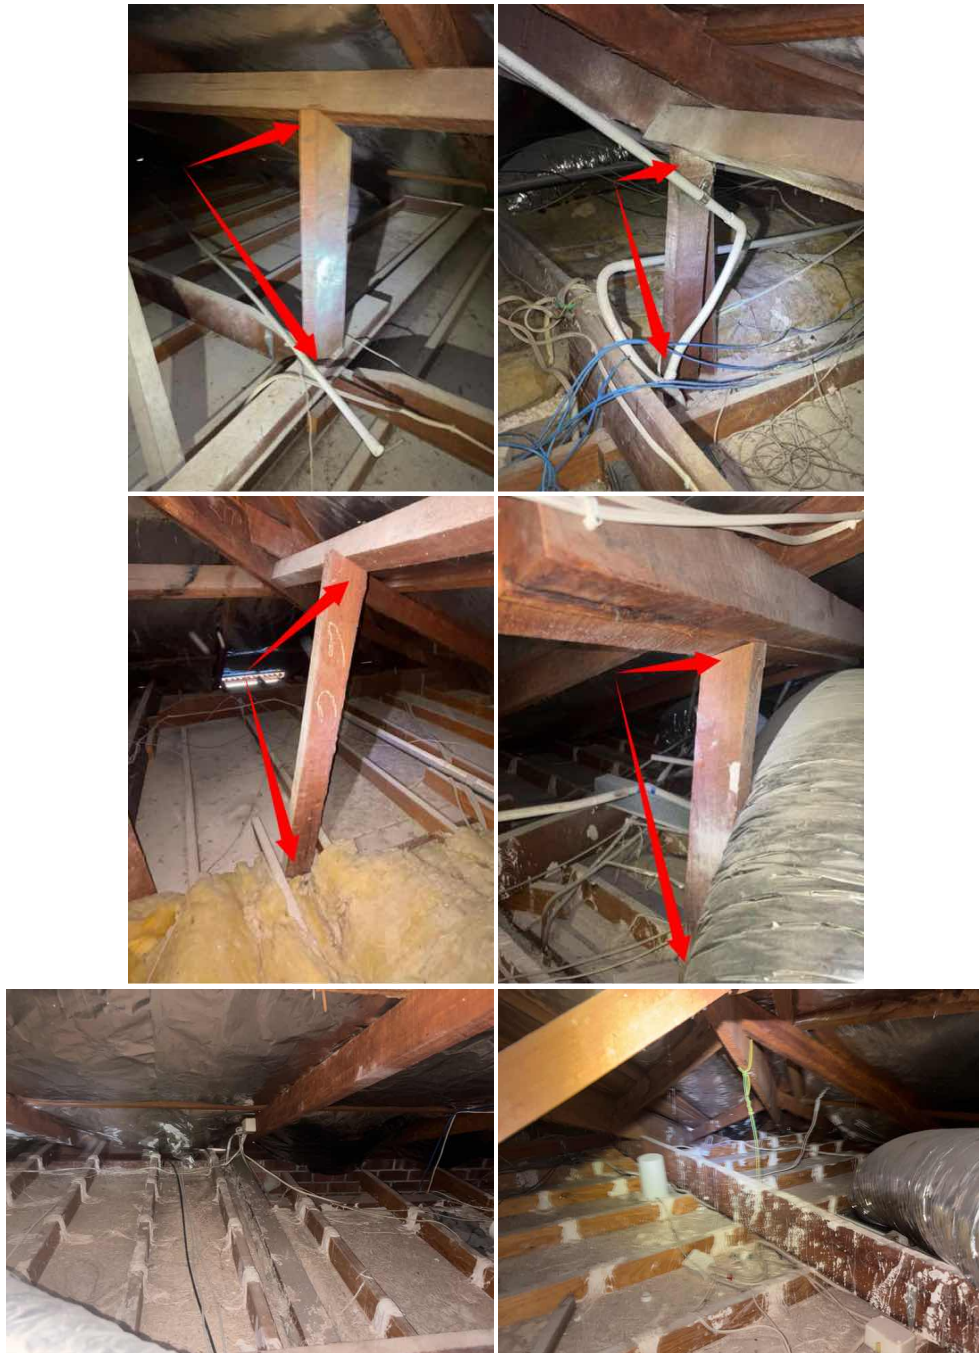
#10. **Structural Major:** Struts observed to be installed flush to underpurlin are missing straps at top and bottom junction connections. This form of timber joint connection is not inline with current compliance requirements and would have been considered non-compliant tie down methods at time of build. Recommendation: Engage a carpenter to install strapping / multi clips to all strutting Timbers as to comply with AS1684.1 & 2.

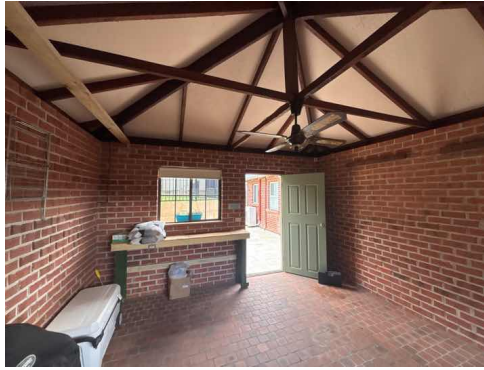
#11. **Structural Minor:** There appears to have been some settlement in the building which has caused some cracking to the walls. These crack/s are categorised as 0 to 2. This can also cause some doors to bind or be out of square. In the inspectors opinion these cracks are due to settlement, usually due to ground movement and subsequent movement to building materials can be expected. All cracks should be monitored and if cracks increase in size, further investigation should be carried out by a structural engineer. Engage a bricklayer to repair.

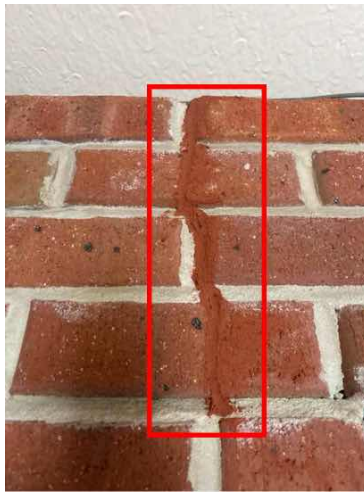
#13. **Structural Minor:** There appears to have been some settlement in the building which has caused some cracking to the walls. These crack/s are categorised as 0 to 2. This can also cause some doors to bind or be out of square. In the inspectors opinion these cracks are due to settlement, usually due to ground movement and subsequent movement to building materials can be expected. All cracks should be monitored and if cracks increase in size, further investigation should be carried out by a structural engineer. Engage a bricklayer to repair.
