# Timber Pest Inspection

**SURE Building Inspections**

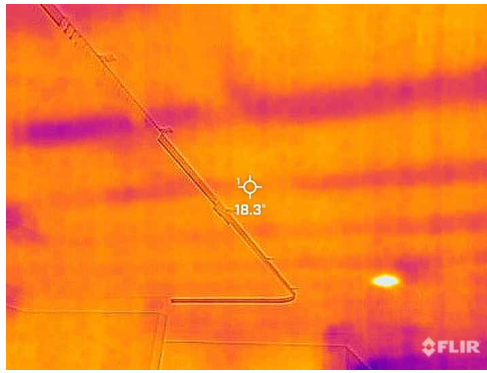
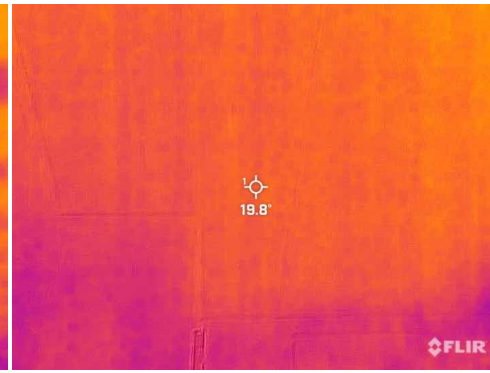
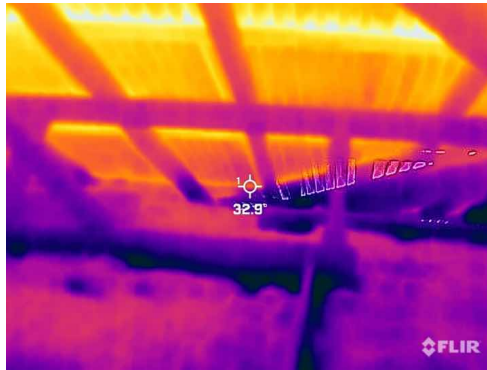
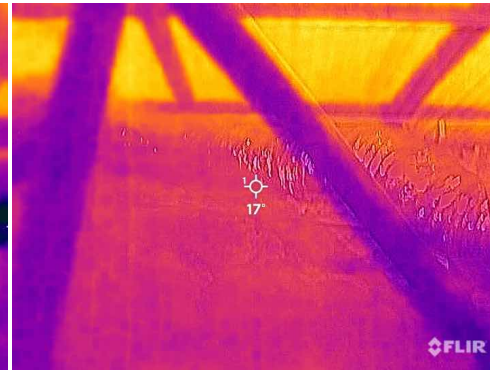
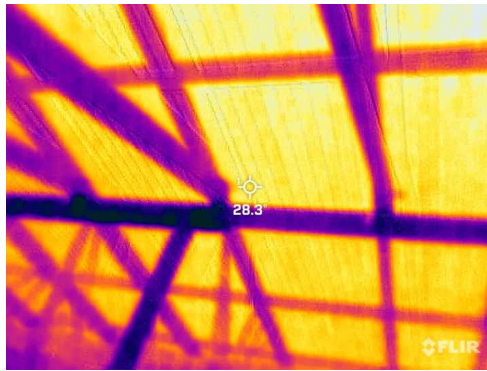
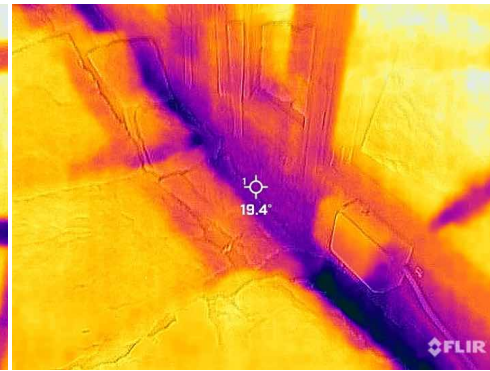
An infrared thermal imager was utilised during the inspection. No thermal anomalies were detected during this inspection, however various factors must be taken into effect which may hamper or impede the reading obtainable by the imager. These factors include obstructions, ambient temperature, wall material and thickness etc. If any surface is restricted visually or otherwise, a proper thermal reading is not possible and is not within the scope of this inspection. Any findings or otherwise is reported on at the time of the inspection only.

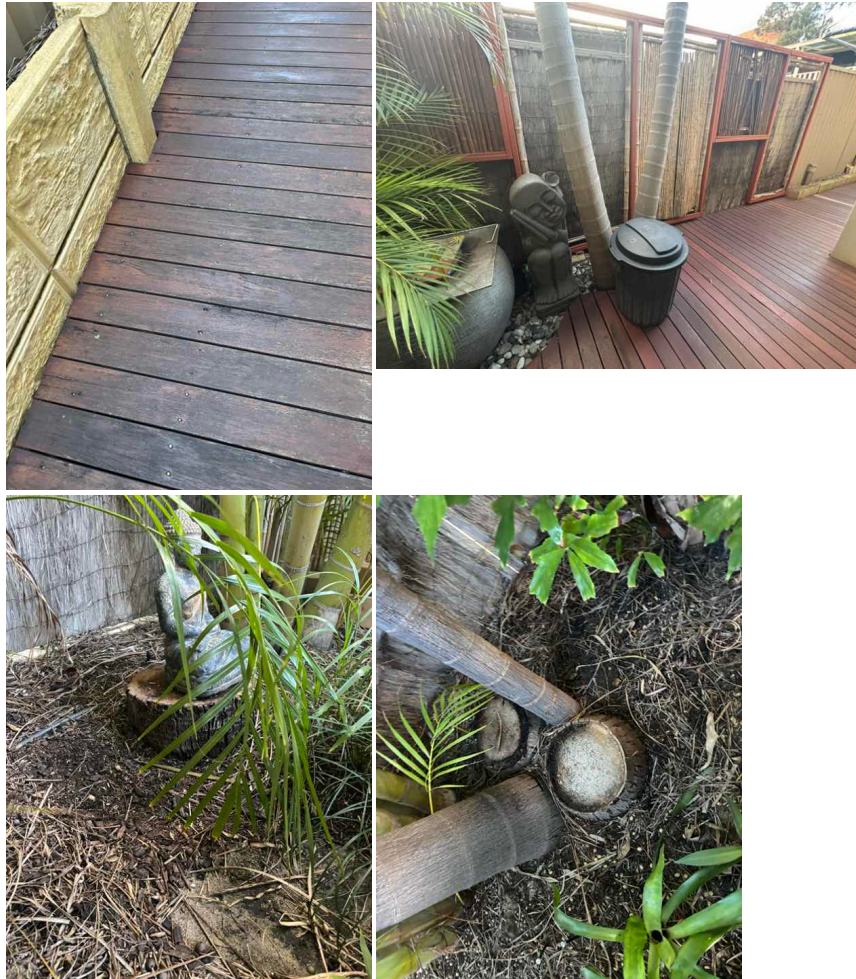
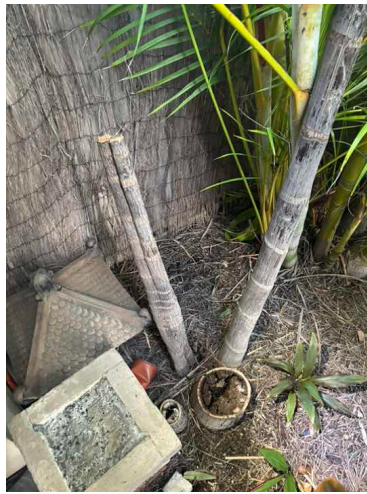
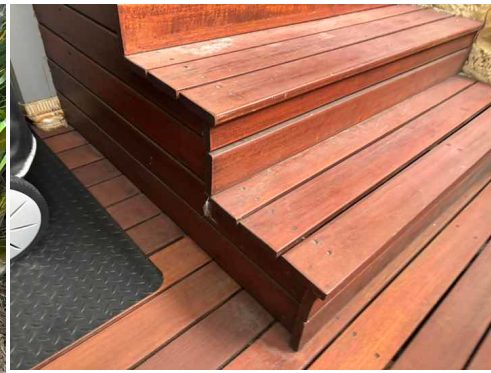
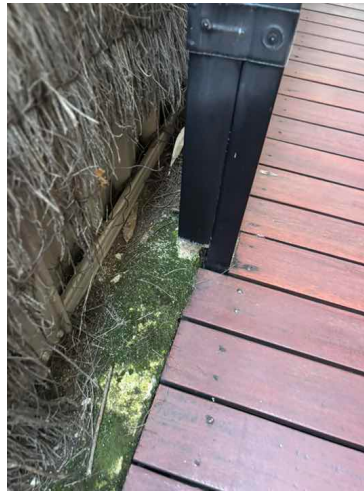
Tree stump/s are located at the site. These provide conducive conditions for a termite nest.

Tree/leafy environment: This property is located in a suburb which is high risk due to the environmental surrounds. It is close to large trees and parkland. A termite management plan/treatment is **strongly advised**.
