# 6 Month Warranty Inspection

**SURE Building Inspections**

### Building Maintenance Inspection

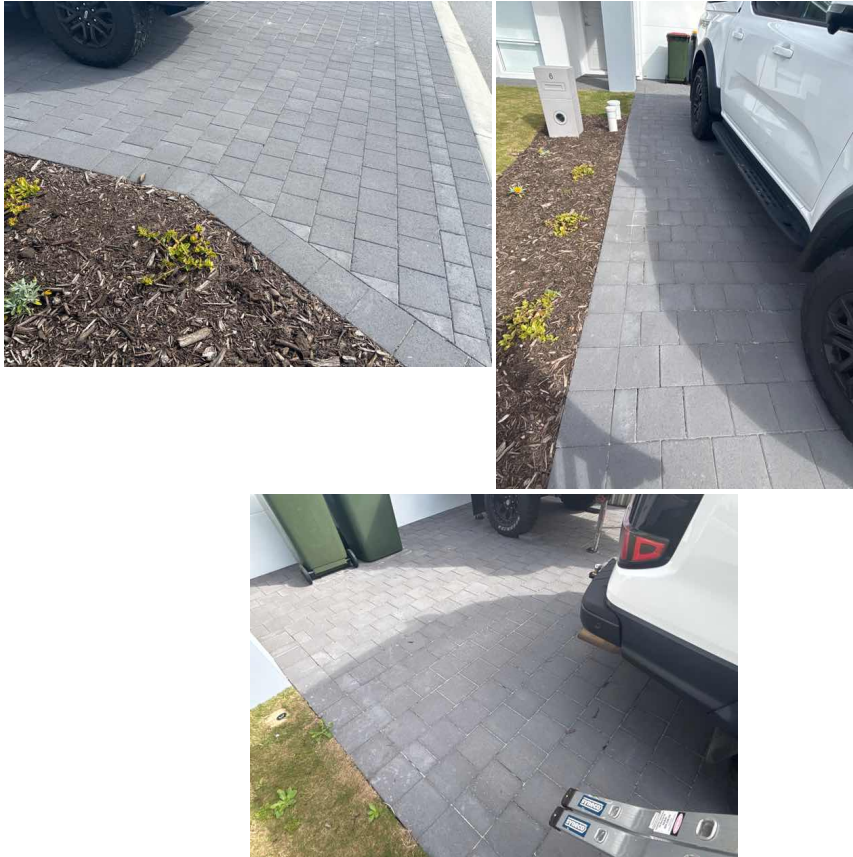
| Section | Location | Name | Comment |
|---|---|---|---|
| SITE | Driveway | Driveway Observations | #1. Maintenance: Driveway edging has started to collapse where there is insufficient retaining system in place. Recommendation: Engage a landscaper for repair. |

#1. **Maintenance:** Driveway edging has started to collapse where there is insufficient retaining system in place.

Recommendation: Engage a landscaper for repair.

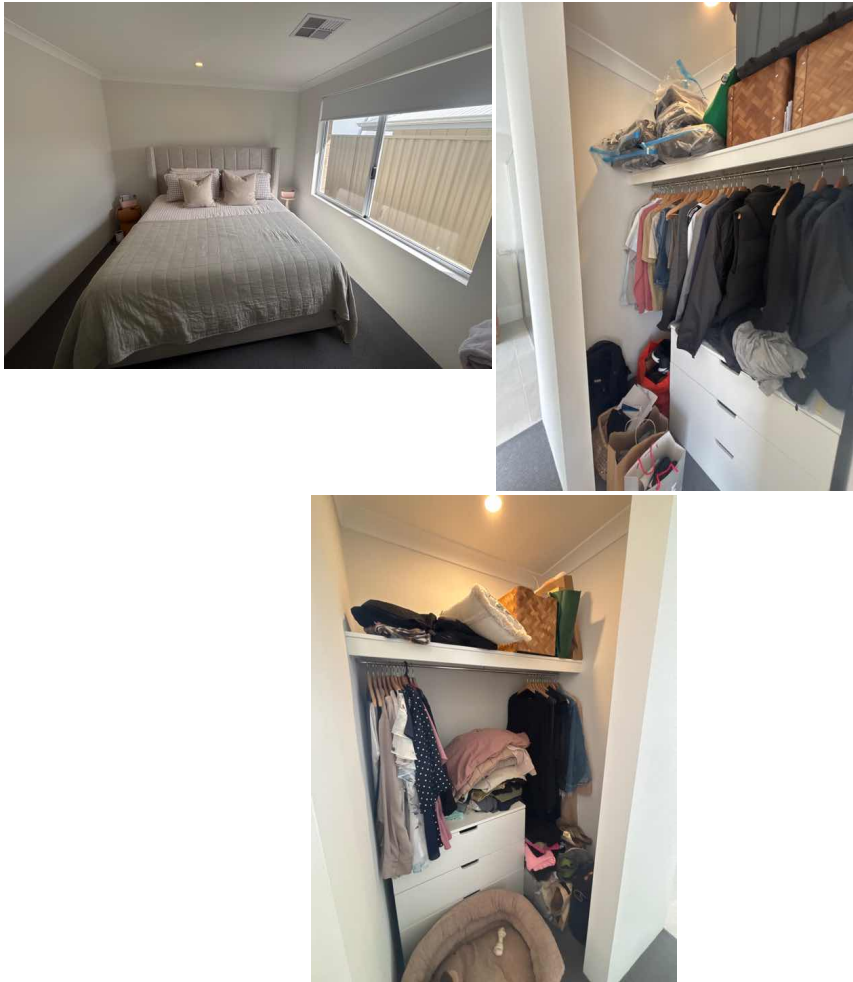
#2. **Maintenance:** Carpet grippers protruding through carpet across threshold.

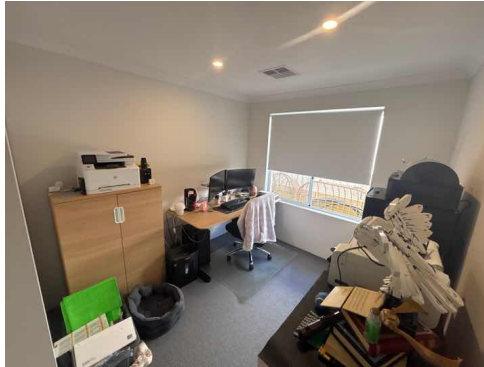
| Section | Location | Name | Comment |
|---|---|---|---|
| INTERIORS | Bedroom 2 | Door Observations | #3. Maintenance: Binding when opened and closed. Recommendation: Engage a carpenter to repair. |

#3. **Maintenance:** Binding when opened and closed. Recommendation: Engage a carpenter to repair.

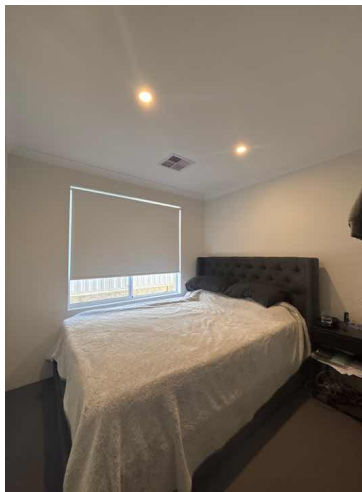
| Section | Location | Name | Comment |
|---|---|---|---|
| INTERIORS | Bedroom 3 | Door Observations | #5. Maintenance: Binding when opened and closed. Recommendation: Engage a carpenter to repair. |

#5. **Maintenance:** Binding when opened and closed. Recommendation: Engage a carpenter to repair.

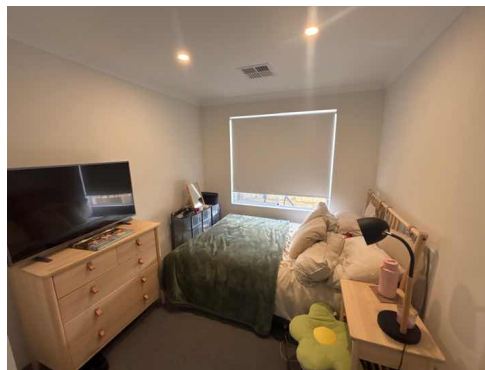
#7. **Maintenance:** Carpet grippers protruding through carpet across threshold.

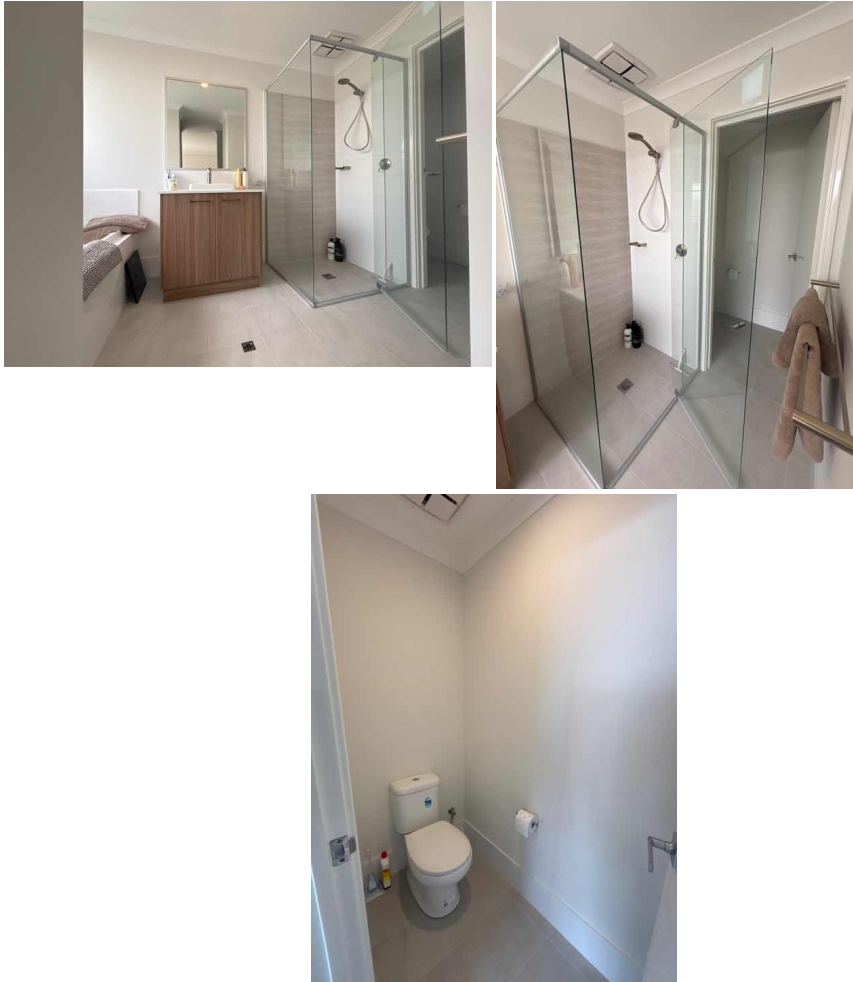
#### Shower Observations

#8. **Maintenance:** Cracked tile/s noted. Recommendation: Engage a tiler for repairs.

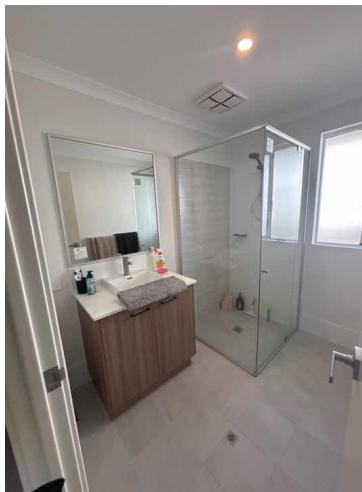
### **Door Observations**

#9. **Maintenance:** Binding when opened and closed. Recommendation: Engage a carpenter to repair.

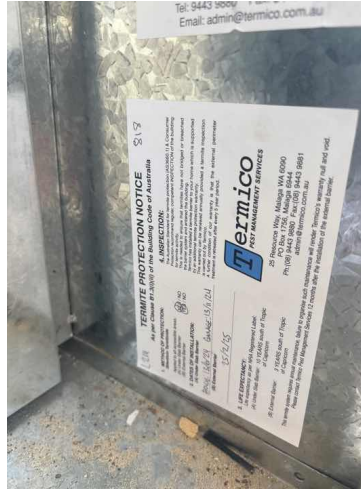
A durable notice was found in the meter-box during the inspection. Recommendation: Engage a pest control technician to review the termite site management plan and complete annual inspection/management.
