# Commercial Comprehensive Inspection

**SURE Building Inspections**

### Commercial Comprehensive Building and Timber Pest Inspection

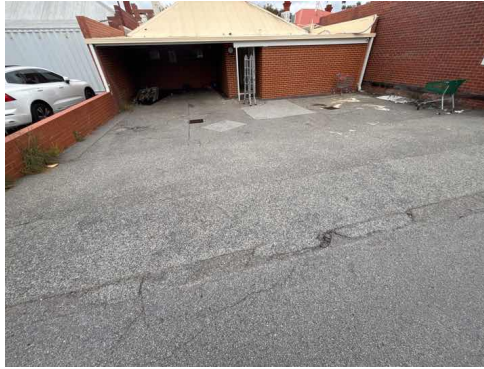
**Maintenance:** Common cracks and settlement were observed on the driveway. Recommendation: Whilst these cracks appeared to be typical at the time of inspection, we recommend you monitor these cracks and if worsening occurs engage a concreter for further advice and repair.

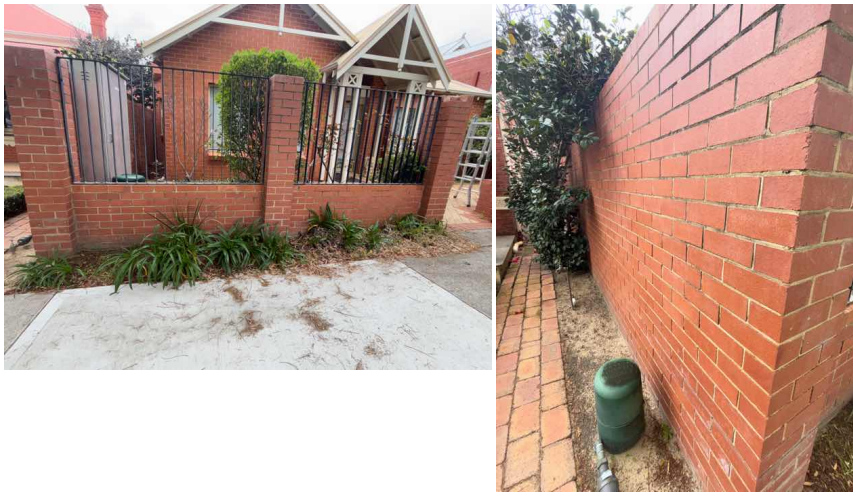
**Maintenance:** Damage was noted to the fence. Recommendation: Engage a fencing contractor for repairs.

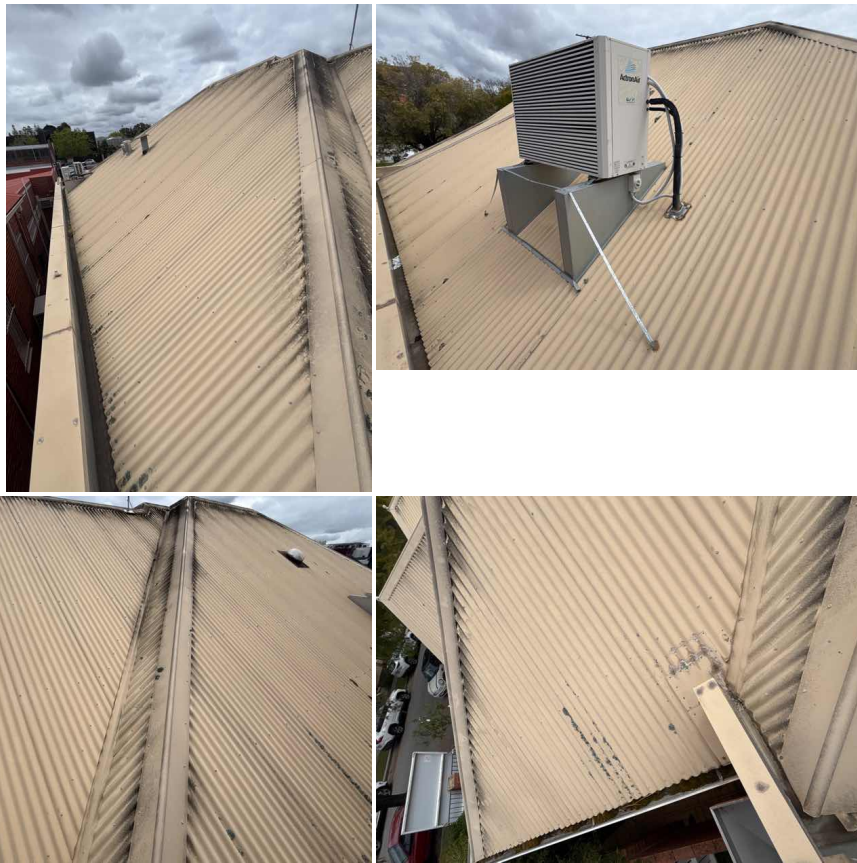
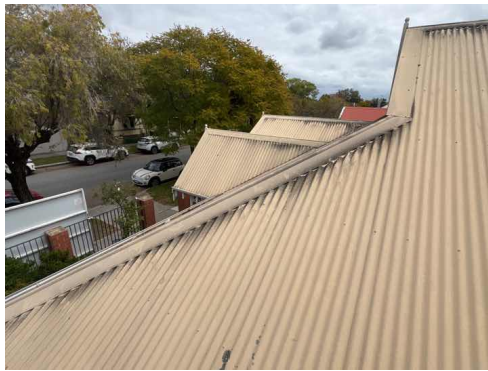
**Maintenance:** Moss / mould has built up on the roofing sheets over time. Recommendation: It is preferable to have moss removed / cleaned to prevent deterioration. Engage a roofing contractor for removal.

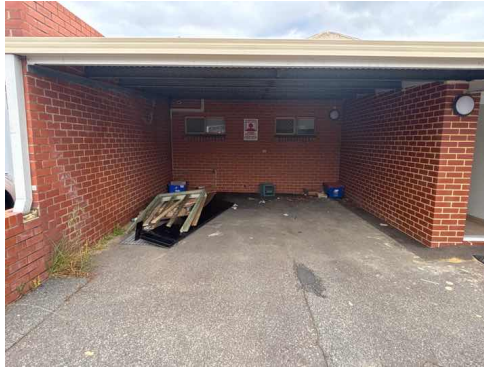
**Maintenance:** Rust penetration observed to sections of the metal roof - leakage to roof void imminent.  
 Recommendation: Engage a roofing contractor for repairs or replacement of affected areas.

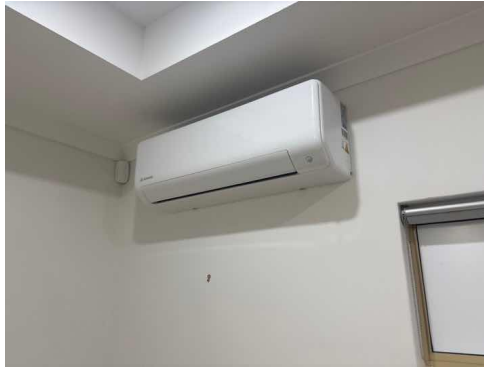
**Maintenance:** The air-conditioning unit in examination room 5 did not operate when tested (remote appears to operate). Recommendation: Engage a technician for investigation and repairs.

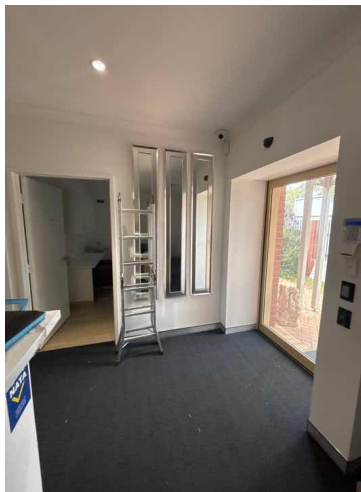
**Maintenance:** General scuffs and marks to walls. Recommendation: Engage a painter for repairs.

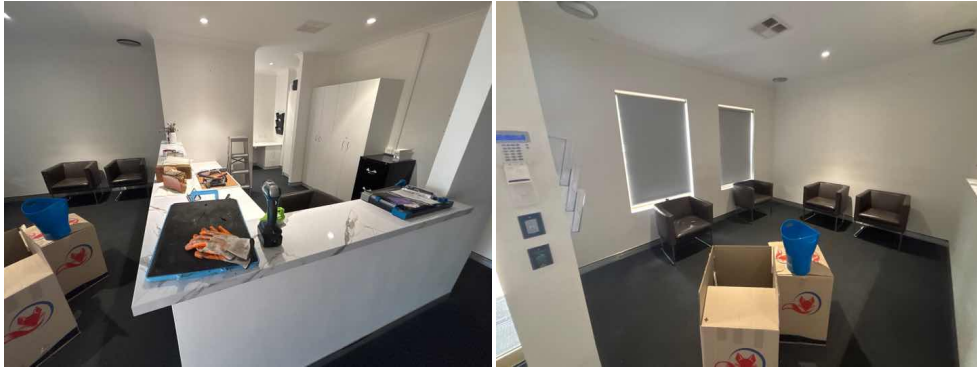
**Maintenance:** Ceiling/cornice join crack/s observed. Recommendation: Engage a painter for repairs.

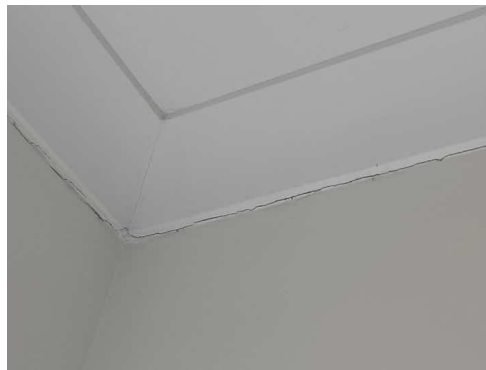
| Section | Location | Name | Comment |
|---|---|---|---|
| INTERIORS | Reception Area | Walls Observations | #1. Structural Minor: There appears to have been some settlement in the building which has caused some cracking to the walls. These crack/s are categorised as 0 to 2. This can also cause some doors to bind or be out of square. In the inspectors opinion these cracks are due to settlement, usually due to ground movement and subsequent movement to building materials can be expected. All cracks should be monitored and if cracks increase in size, further investigation should be carried out by a structural engineer.<br>Recommendation: Engage a painter to patch and paint. For clarification on the category of cracks with a damage category of 0 to 2, please refer to Cracking of Building Elements in Section 2G of the Terms and Conditions of this report. |

#1. **Structural Minor:** There appears to have been some settlement in the building which has caused some cracking to the walls. These crack/s are categorised as 0 to 2. This can also cause some doors to bind or be out of square. In the inspectors opinion these cracks are due to settlement, usually due to ground movement and subsequent movement to building materials can be expected. All cracks should be monitored and if cracks increase in size, further investigation should be carried out by a structural engineer. Recommendation: Engage a painter to patch and paint.

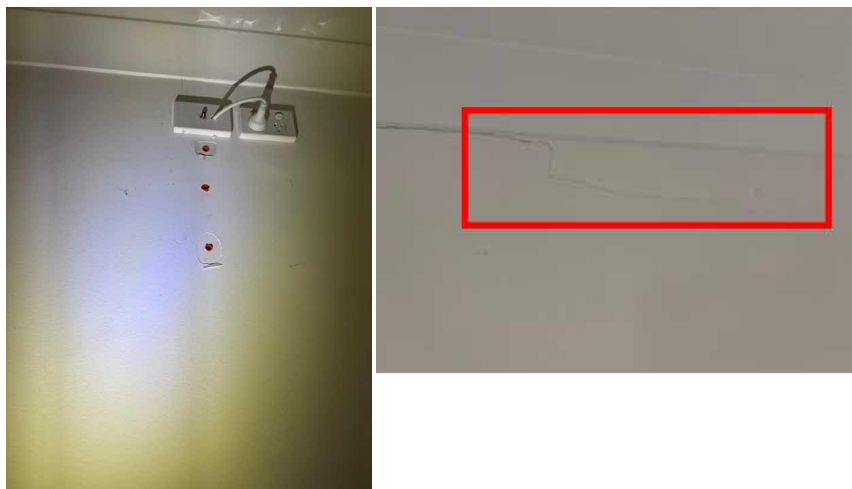
**Maintenance:** Join cracking observed.

Engage a maintenance contractor for repairs.

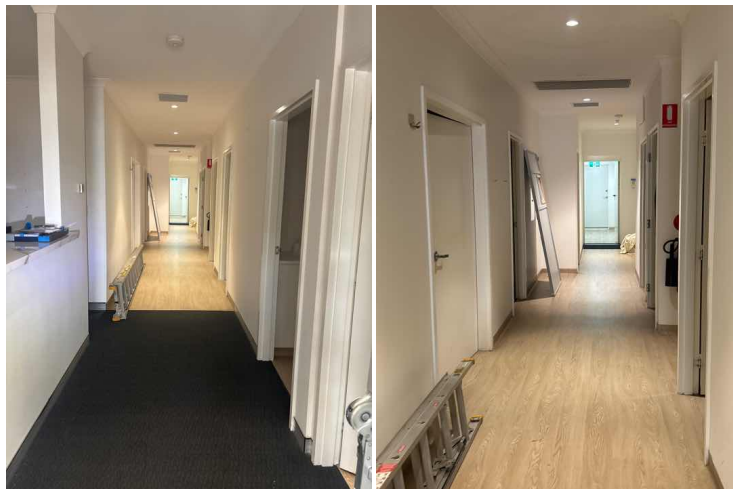
| Section | Location | Name | Comment |
|---|---|---|---|
| INTERIORS | Hallway / Corridor | Walls Observations | #2. Structural Minor: There appears to have been some settlement in the building which has caused some cracking to the walls. These crack/s are categorised as 0 to 2. This can also cause some doors to bind or be out of square. In the inspectors opinion these cracks are due to settlement, usually due to ground movement and subsequent movement to building materials can be expected. All cracks should be monitored and if cracks increase in size, further investigation should be carried out by a structural engineer.<br>Recommendation: Engage a painter to patch and paint. For clarification on the category of cracks with a damage category of 0 to 2, please refer to Cracking of Building Elements in Section 2G of the Terms and Conditions of this report. |

#2. **Structural Minor:** There appears to have been some settlement in the building which has caused some cracking to the walls. These crack/s are categorised as 0 to 2. This can also cause some doors to bind or be out of square. In the inspectors opinion these cracks are due to settlement, usually due to ground movement and subsequent movement to building materials can be expected. All cracks should be monitored and if cracks increase in size, further investigation should be carried out by a structural engineer. Recommendation: Engage a painter to patch and paint.

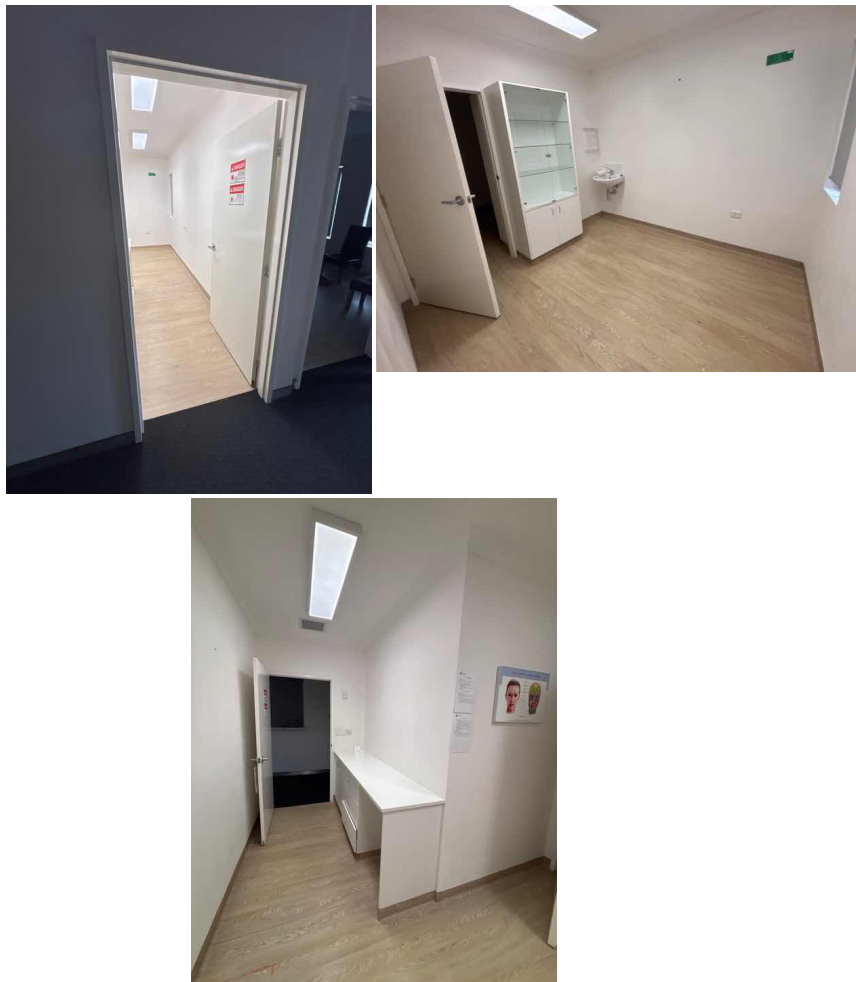
**Maintenance:** Ceiling/cornice join crack/s observed. Recommendation: Engage a painter for repairs.

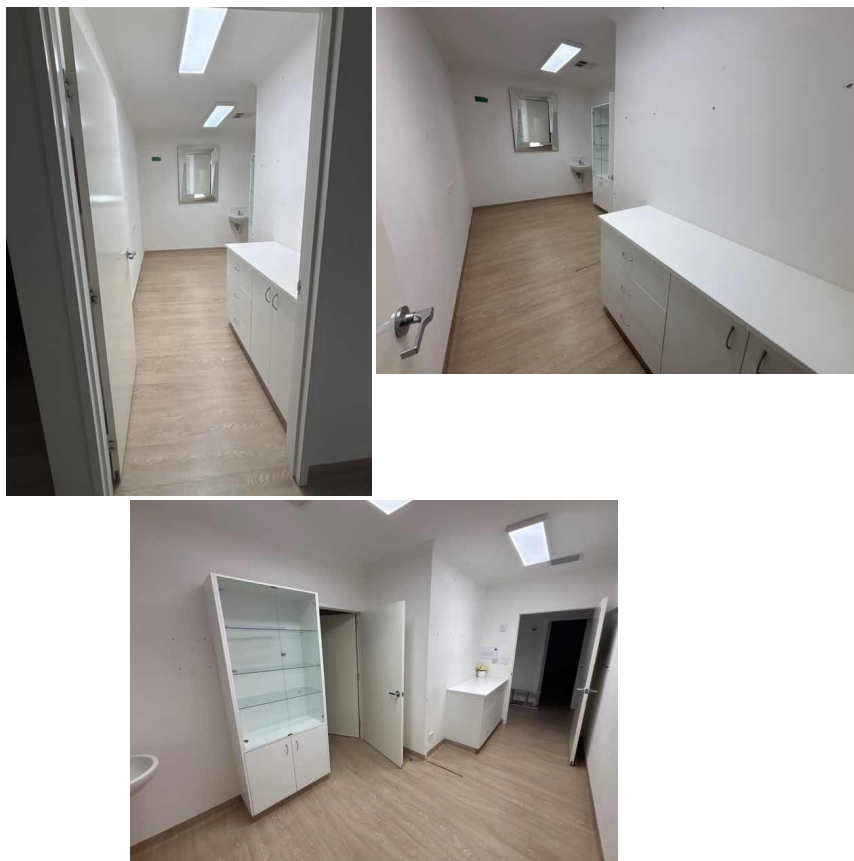
**Maintenance:** Ceiling/cornice join crack/s observed. Recommendation: Engage a painter for repairs.

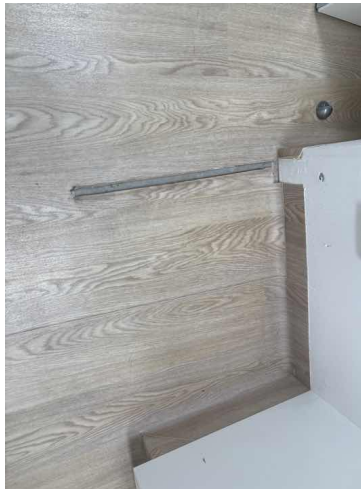
**Maintenance:** Area of linoleum flooring requires repair.

Engage a flooring contractor for repairs.

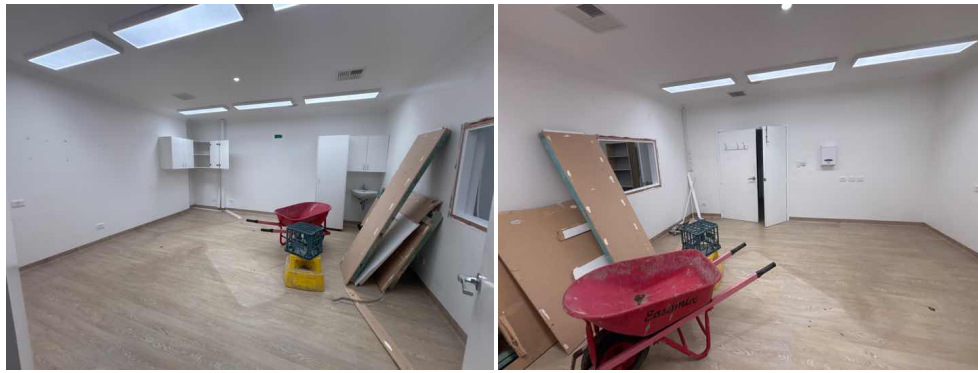
**Maintenance:** General scuffs and marks to walls. Recommendation: Engage a painter for repairs.

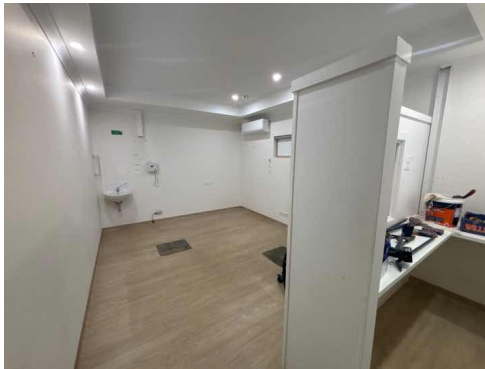
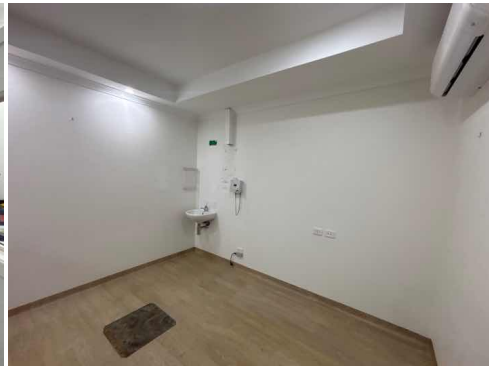
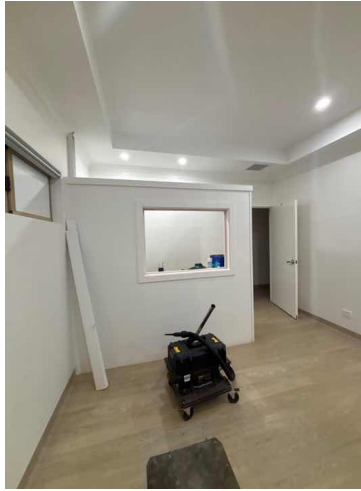
**Maintenance:** Ceiling lining damage observed. Recommendation: Engage a plasterer for repairs.

**Maintenance:** Marks & scuffs observed to areas of ceiling lining.

Engage a painter for repair if desired.

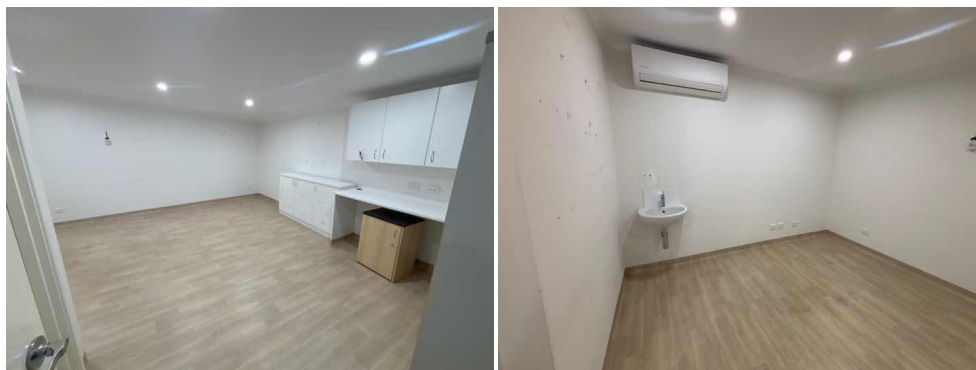
**Maintenance:** General scuffs and marks to walls. Recommendation: Engage a painter for repairs.

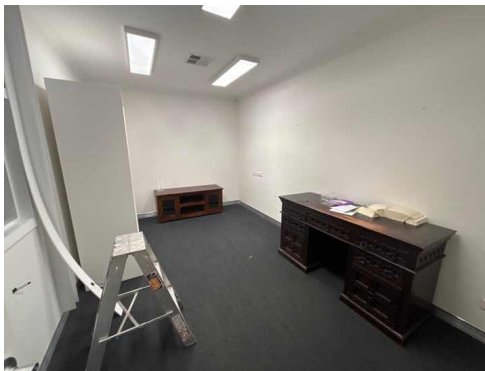
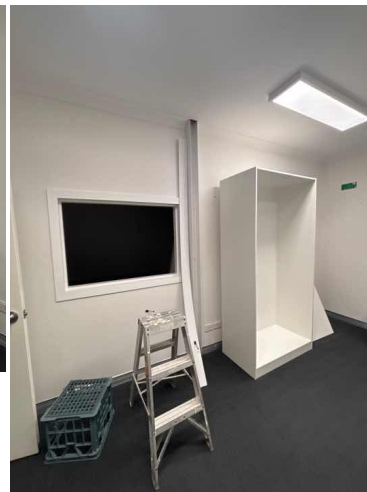
**Maintenance:** Ceiling/cornice join crack/s observed. Recommendation: Engage a painter for repairs.

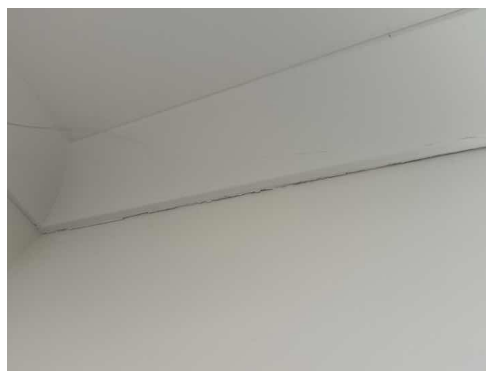
**Maintenance:** General scuffs and marks to walls. Recommendation: Engage a painter for repairs.

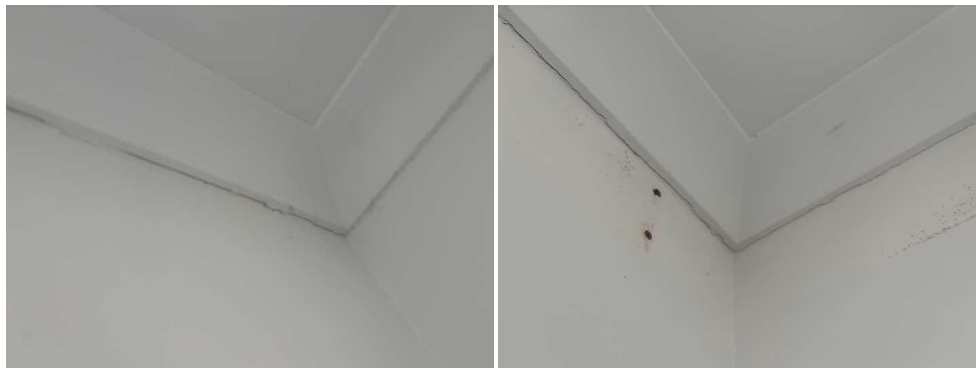
**Maintenance:** General scuffs and marks to walls. Recommendation: Engage a painter for repairs.

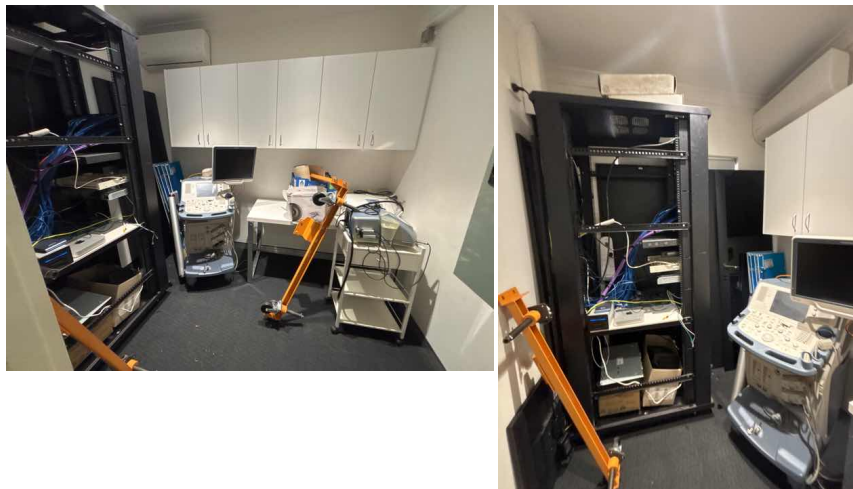
**Maintenance:** Ceiling/cornice join crack/s observed. Recommendation: Engage a painter for repairs.

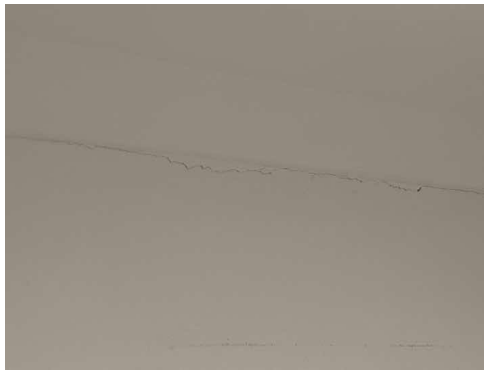
**Maintenance:** General scuffs and marks to walls. Recommendation: Engage a painter for repairs.

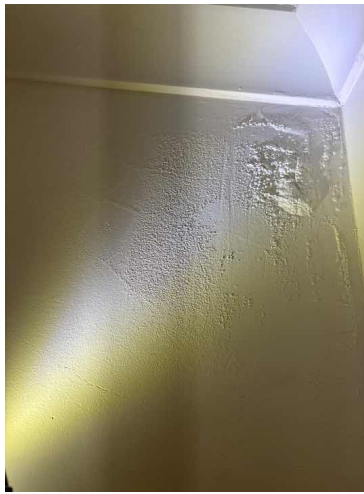
**Maintenance:** General scuffs and marks to walls. Recommendation: Engage a painter for repairs.

**Maintenance:** Moisture damage observed to the wall/skirting. Recommendation: Engage a painter for repairs.

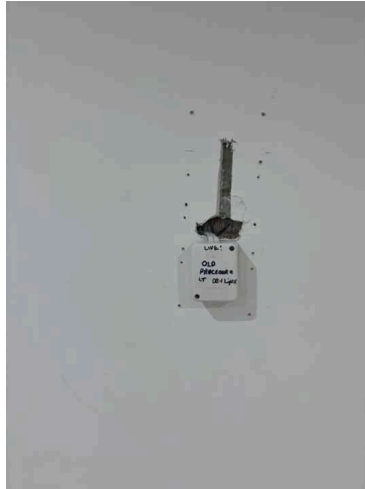
- #6. It is recommended by the inspector that an electrical inspection - Certificate of Compliance - be carried out.  
Incomplete electrical wiring.

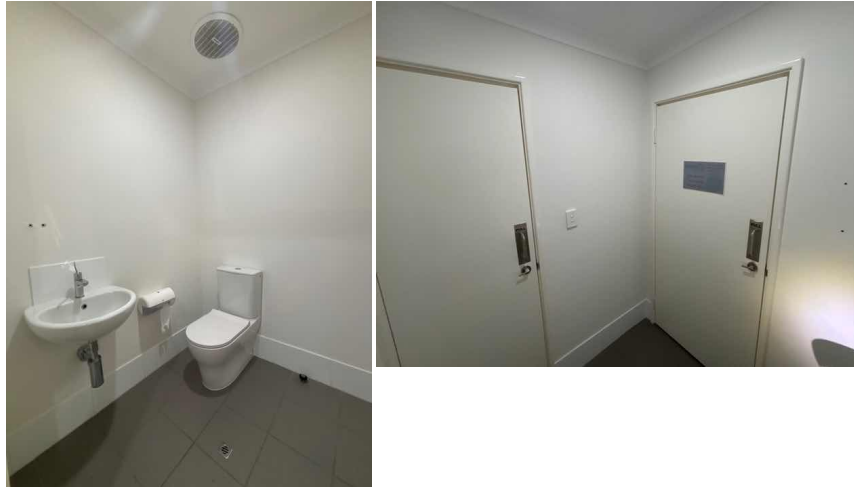
**Maintenance:** General scuffs and marks to walls. Recommendation: Engage a painter for repairs.

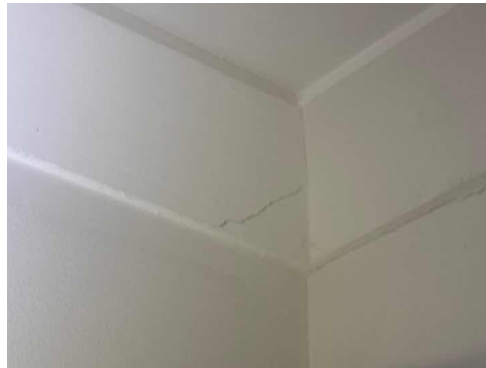
#8. **Structural Minor:** There appears to have been some settlement in the building which has caused some cracking to the walls. These crack/s are categorised as 0 to 2. This can also cause some doors to bind or be out of square. In the inspectors opinion these cracks are due to settlement, usually due to ground movement and subsequent movement to building materials can be expected. All cracks should be monitored and if cracks increase in size, further investigation should be carried out by a structural engineer. Engage a painter to patch and paint.

**Maintenance:** Typical marks/scuffs/gouges. Engage a painter for repair.

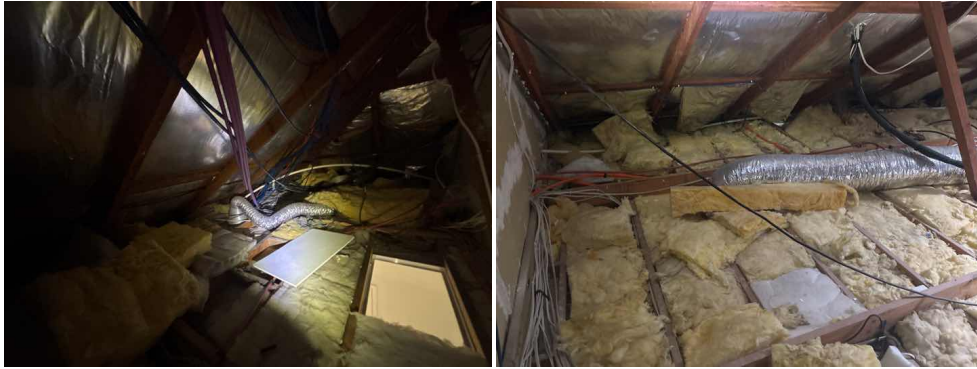
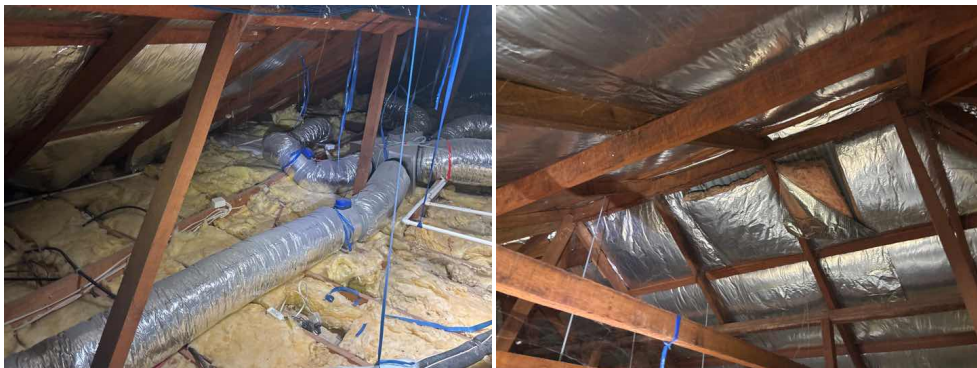
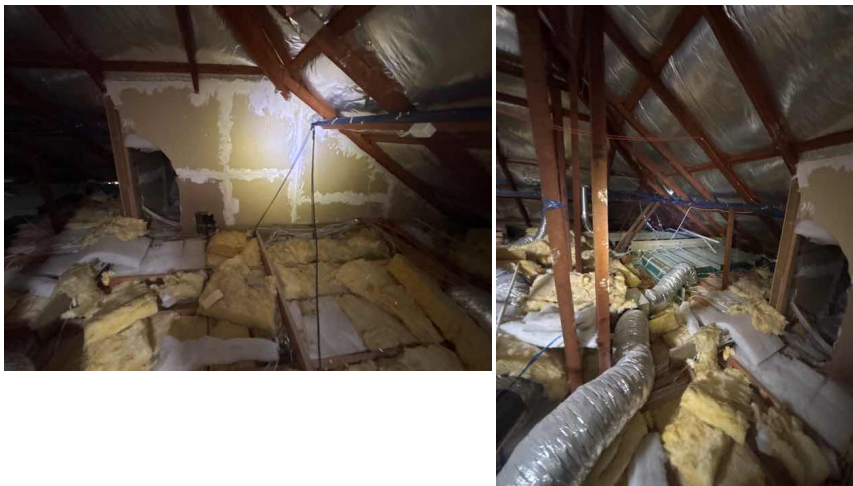
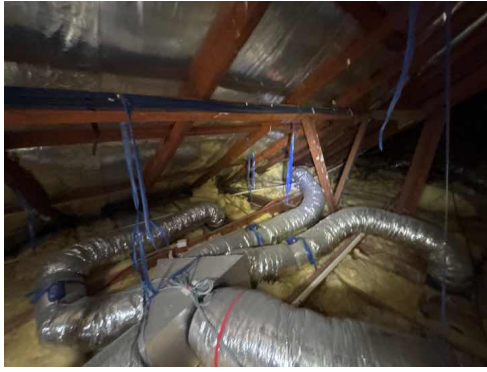
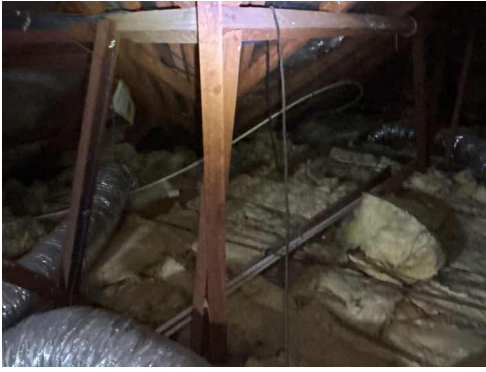
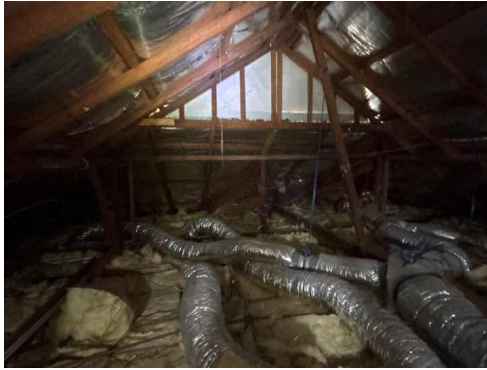
**Maintenance:** Strapping to struts and triple grips to rafters for metal roof cover construction do not comply with today's standards (note the property was built prior to standards implementation). Recommendation: Engage a carpenter for maintenance work if desired.

**Maintenance:** General scuffs and marks to manhole cover. Recommendation: Engage a painter for repairs.

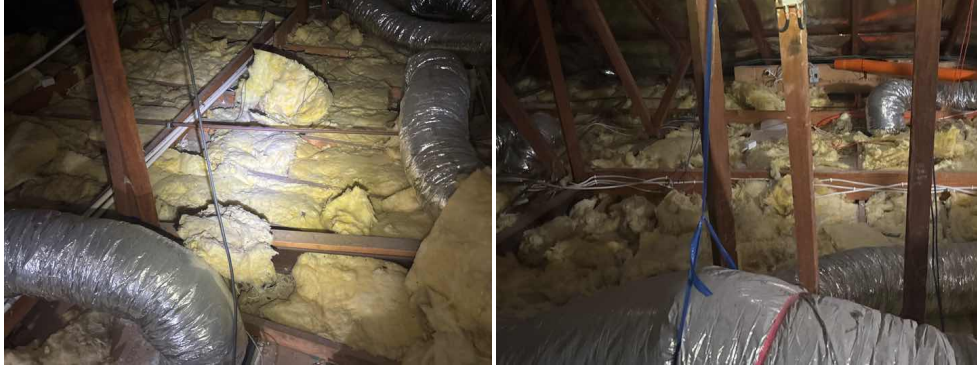
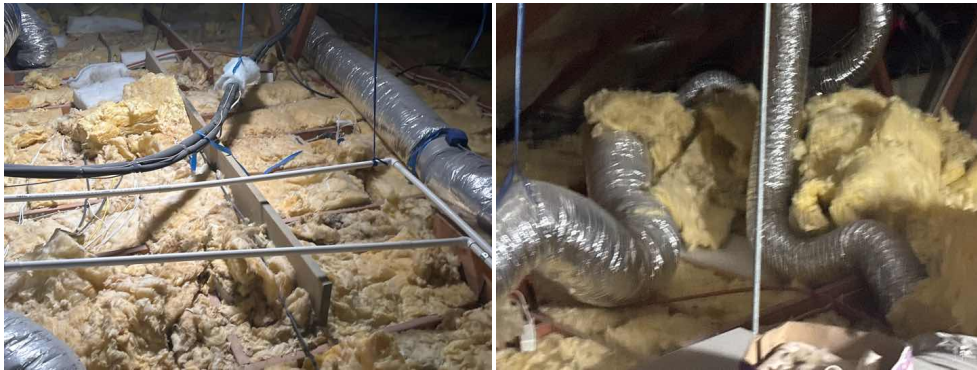
### Insulation Observations

From the visible and accessible areas, the general condition of the roof void insulation is serviceable for the age of the building.

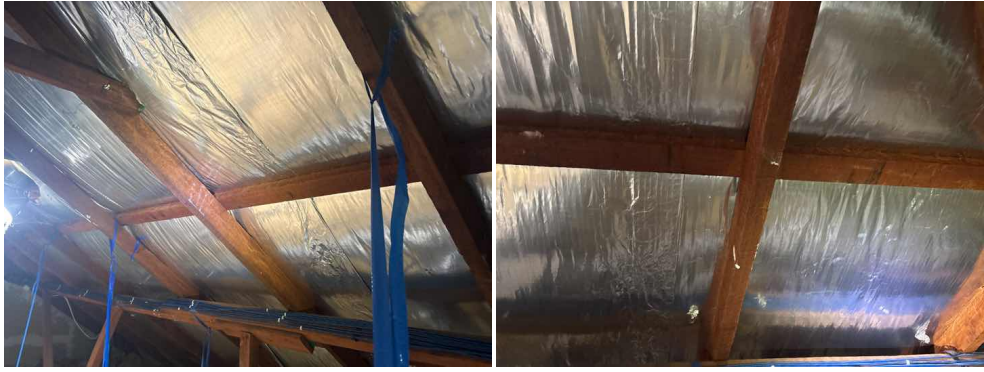
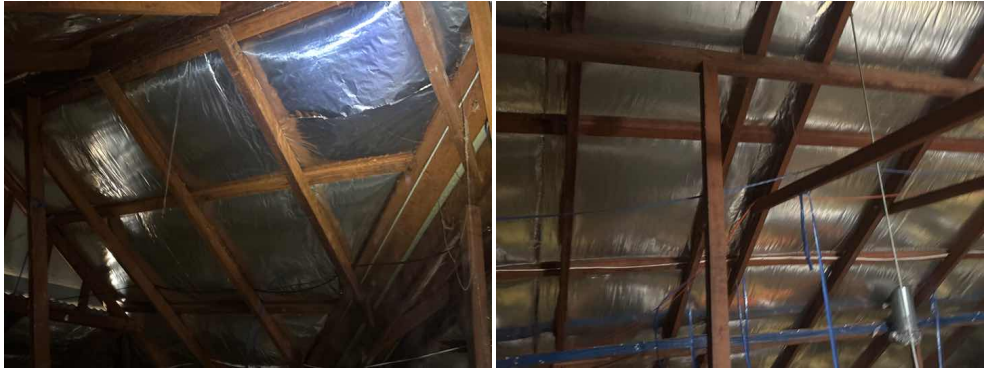
### Sarking Observations

From the visible and accessible areas, the general condition of the roof void sarking is serviceable for the age of the building.

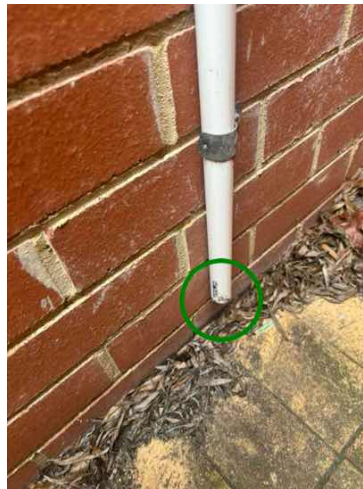
#### **Was the Air Conditioner Sufficiently Drained**

No. Airconditioning overflow should be diverted away from the building perimeter or into a drain.
