# Comprehensive Inspection

**SURE Building Inspections**

### Comprehensive Building and Timber Pest Inspection

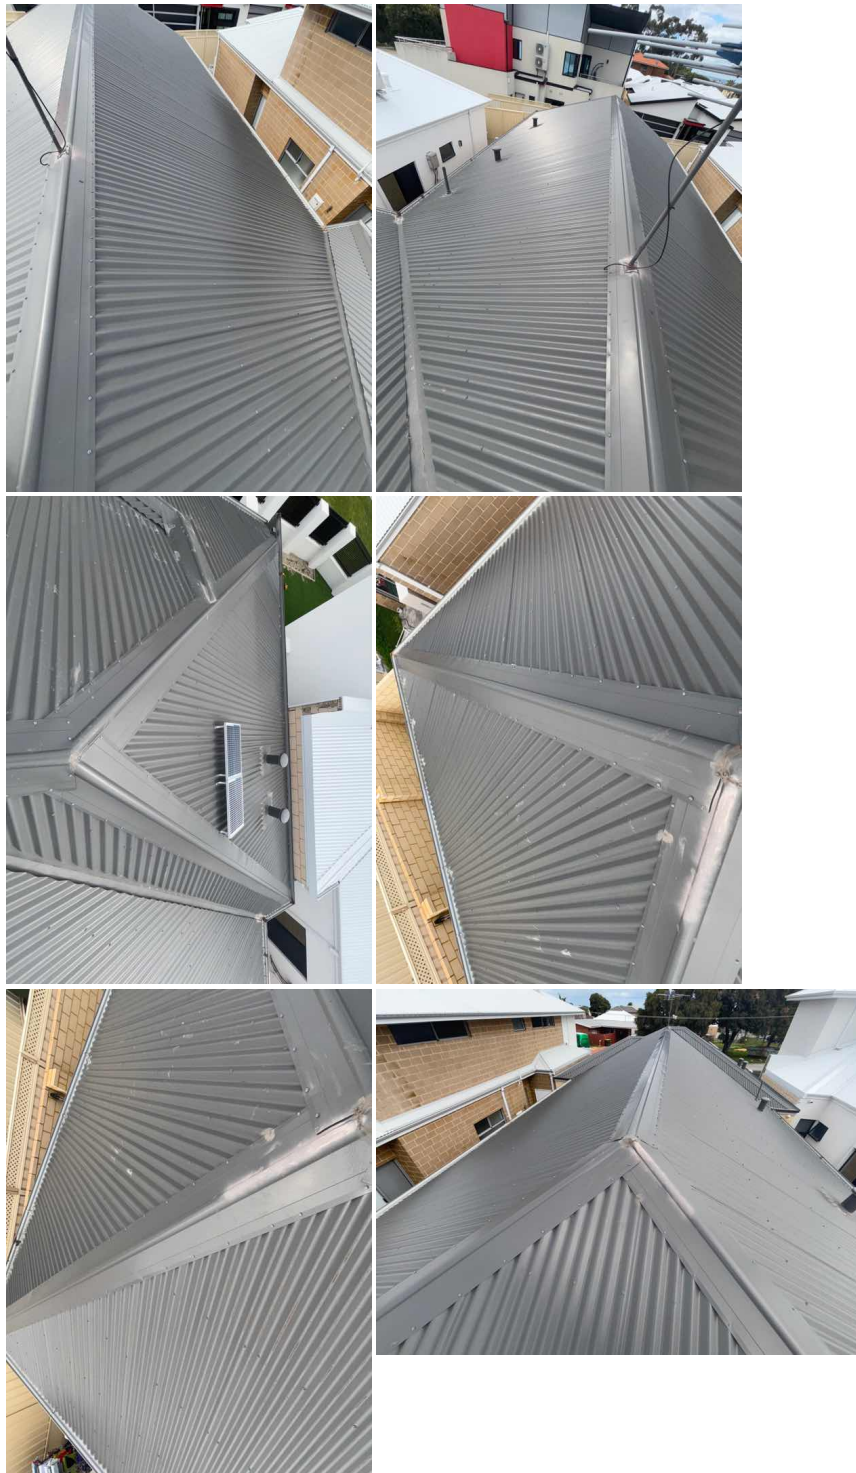
**Maintenance:** Metal swarf debris on roof cover. The debris has corroded causing rust, which if left may cause corrosion to sections of the metal roof. Recommendation: Engage a roofing contractor for repairs (cleaning) of affected areas.

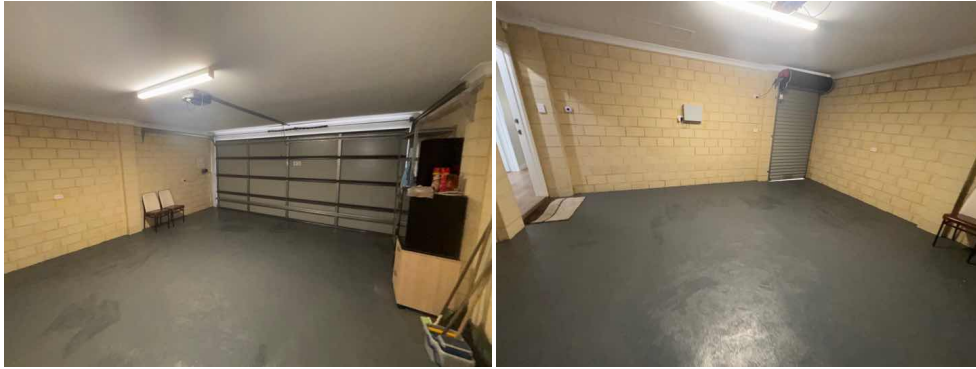
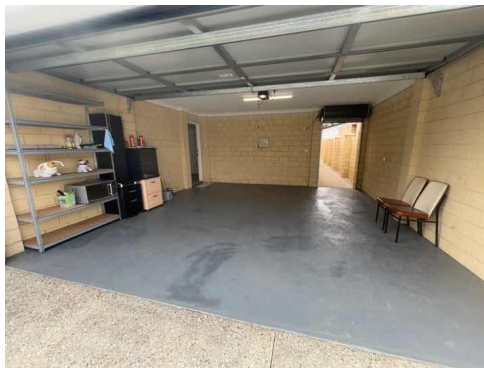
**Maintenance:** Cornice damage observed. Recommendation: Engage a painter for repairs.

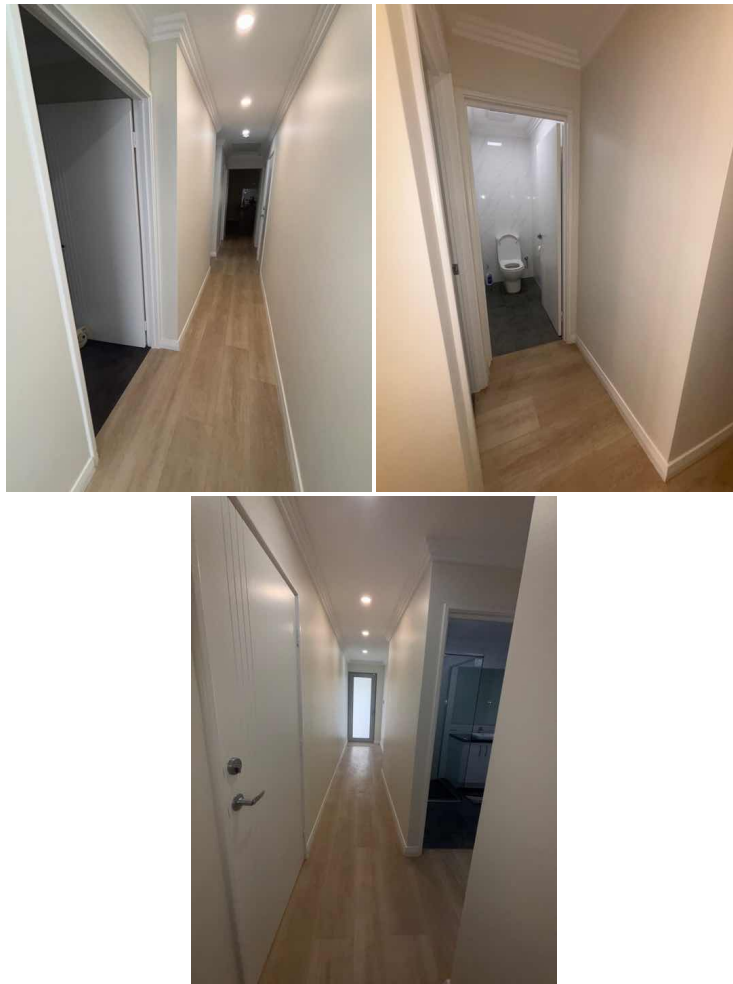
**Maintenance:** General scuffs and marks to walls. Recommendation: Engage a painter for repairs.

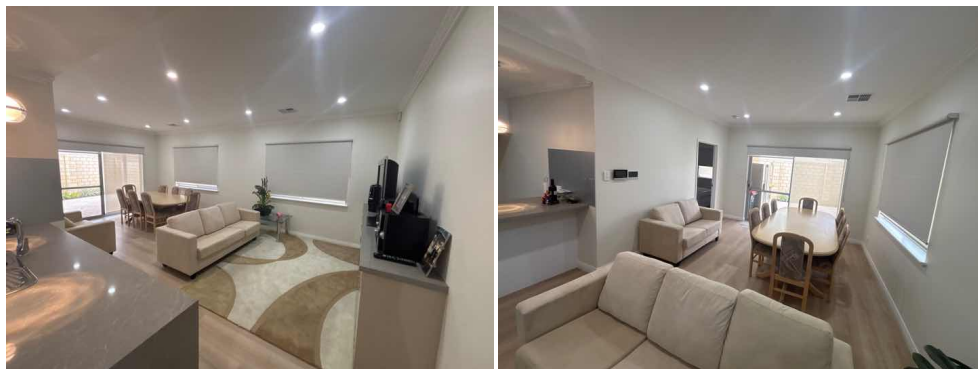
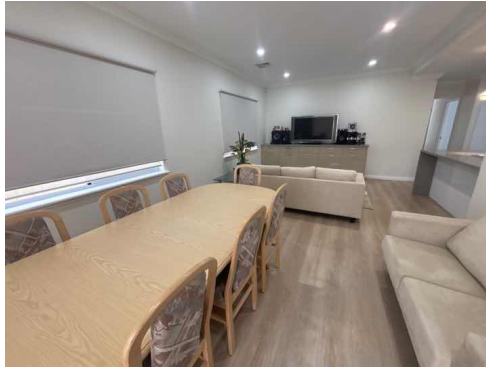
**Maintenance:** General scuffs and marks to walls. Recommendation: Engage a painter for repairs.

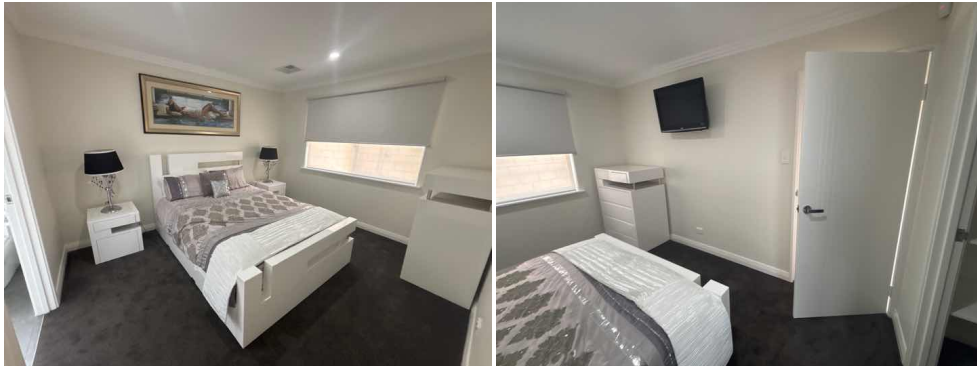
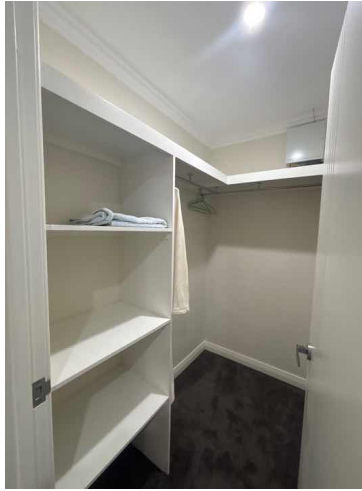
**Maintenance:** General scuffs and marks to walls. Recommendation: Engage a painter for repairs.

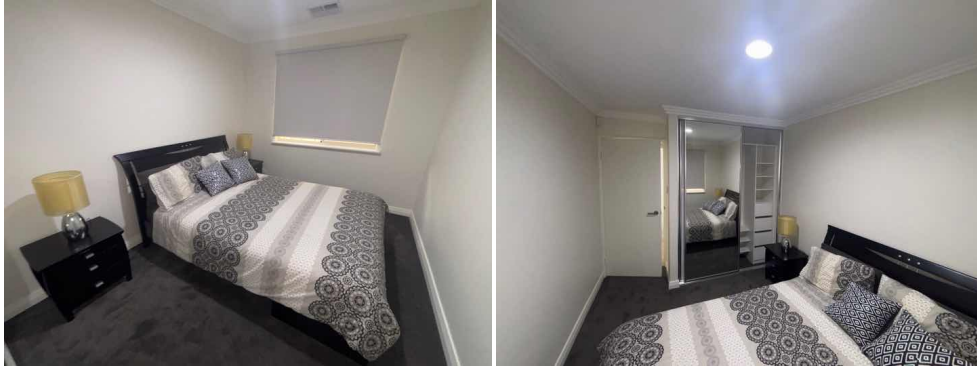
**Maintenance:** General scuffs and marks to walls. Recommendation: Engage a painter for repairs.

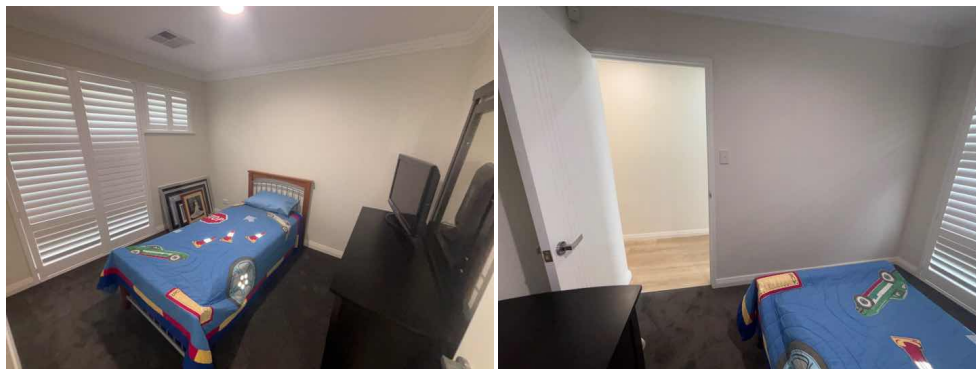
**Maintenance:** Door handle/hardware damage observed. Can not open from inside bedroom. Recommendation: Engage a handyman or carpenter for repair.

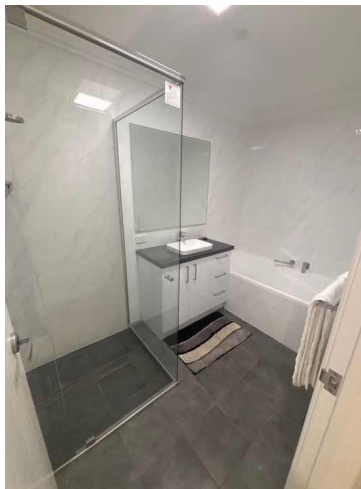
**Maintenance:** Marks / scuffs observed to areas of ceiling linings.

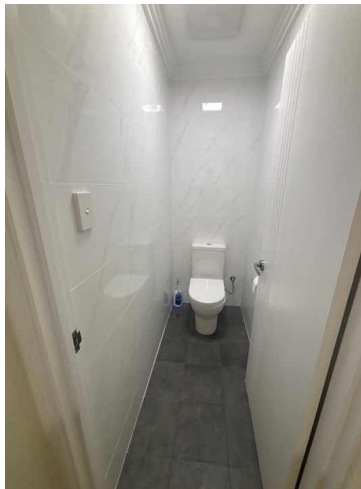
**Maintenance:** The toilet roll holder is damaged/loose. Recommendation: Engage a handyman to repair or replace.

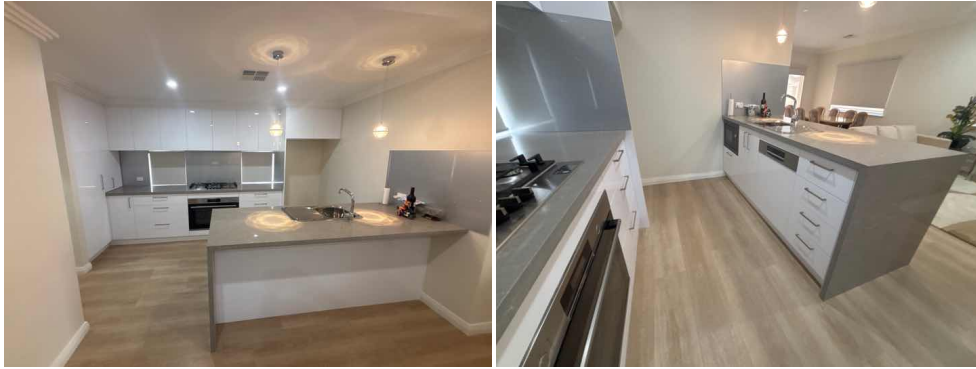
**Maintenance:** Ceiling/cornice join crack/s observed. Recommendation: Engage a painter for repairs.

**Maintenance:** The cornice is separating from the ceiling/wall. Recommendation: Engage a plasterer for repairs.

**Maintenance:** Marks / scuffs observed to areas of ceiling linings.

Recommendation - Engage a painter for repair.

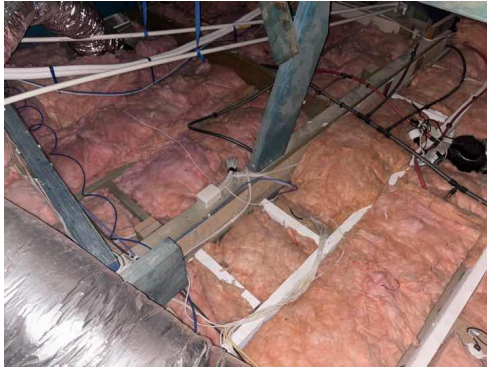
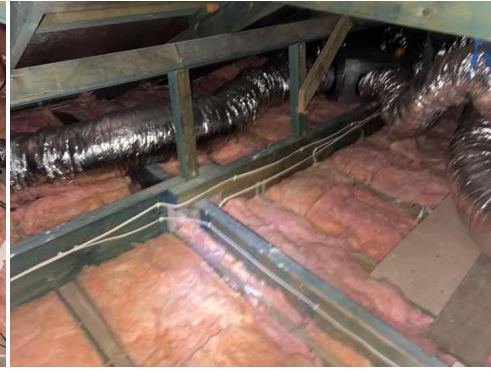
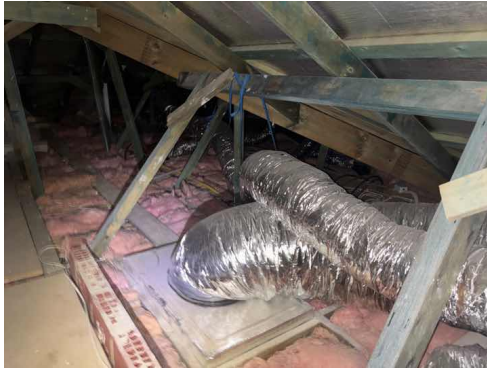
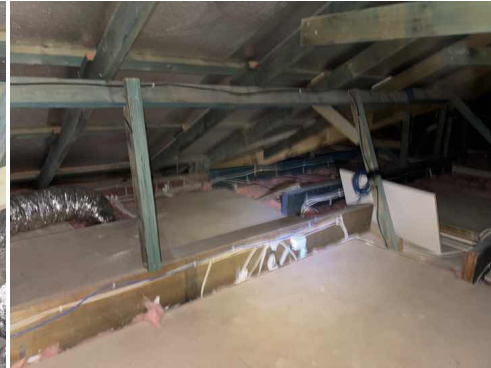
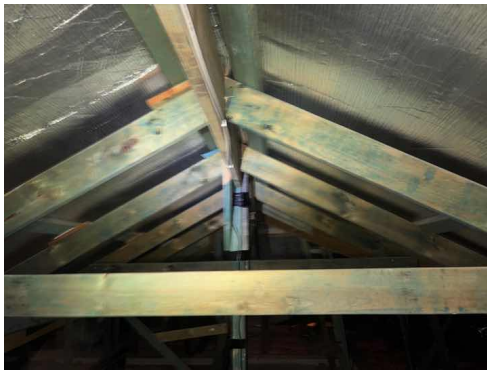
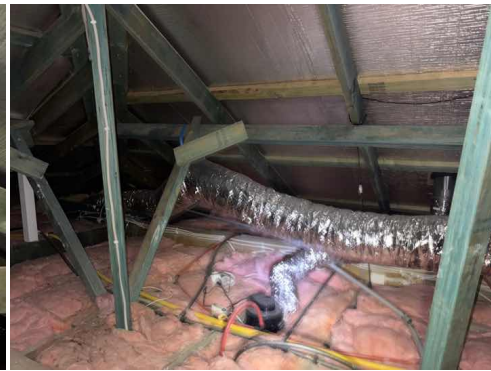
#2. **Structural Major:** Strapping to struts (top and bottom connections) and triple grips to rafters for metal roof cover construction do not comply with current standards set out in AS1684.2. This standard was a requirement at the time of build.

Strapping/anchors missing from base and top of struts. This is a requirement to homes with metal roof covers.  
Recommendation: Engage a carpenter for repair.

Triple Grips not fitted securing rafters to underpurlin. This is a requirement to homes with metal roof covers.  
Recommendation: Engage a carpenter for repair.

Recommendation: Engage a carpenter to install metal connectors to all timber connections and joints.

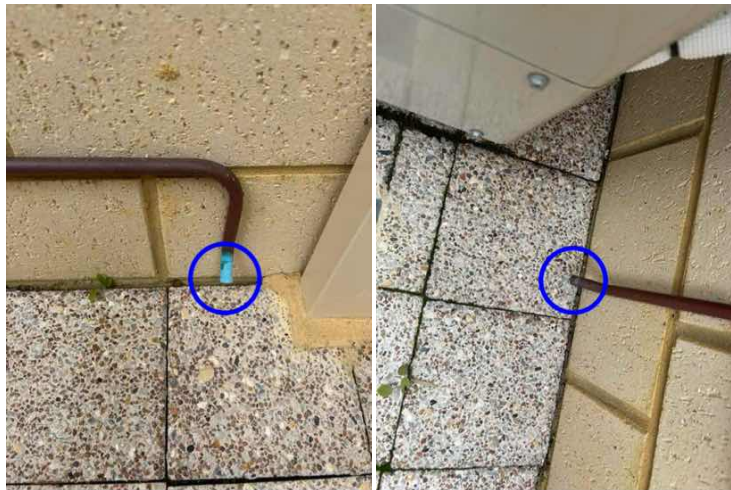
No. Hot water overflow should be diverted away from the building perimeter or into a drain.

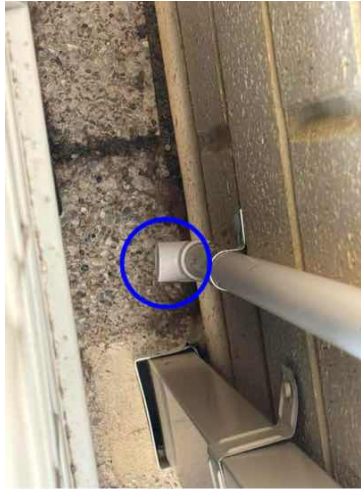
No. Airconditioning overflow should be diverted away from the building perimeter or into a drain.
