# Dilapidation Inspection

**SURE Building Inspections**

### Dilapidation Inspection Report

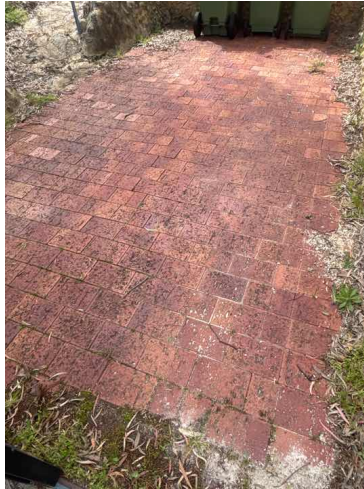
#### Driveway

No cracking observed.

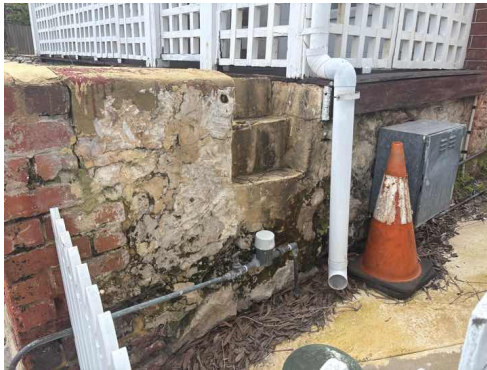
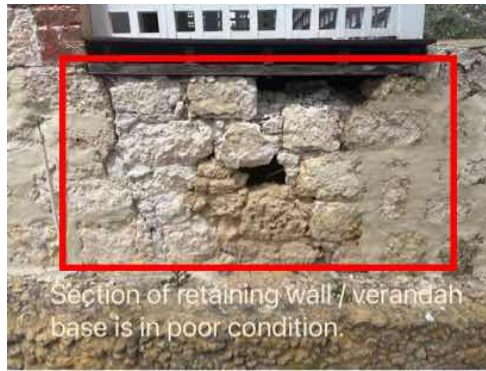
**Retaining Wall/s**  
Cracking 1mm - 5mm

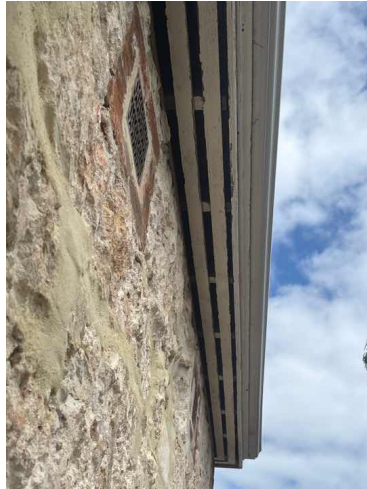
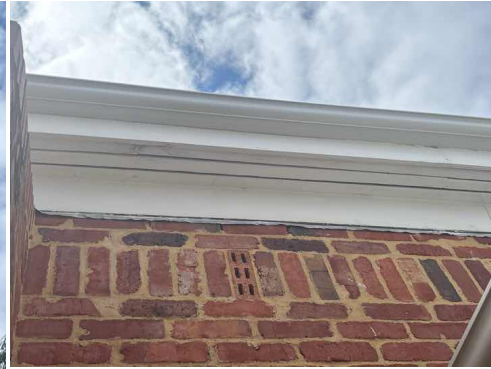
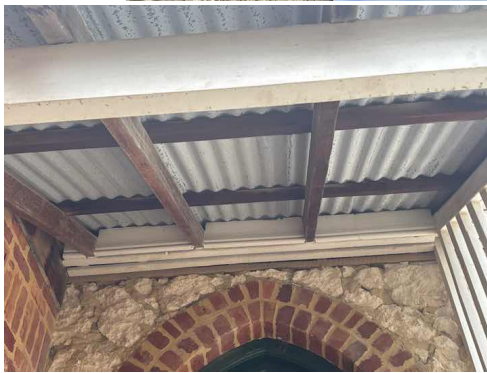
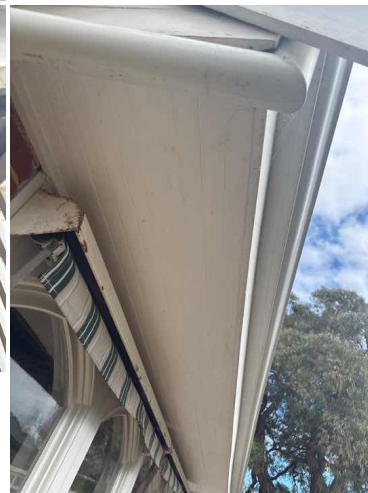
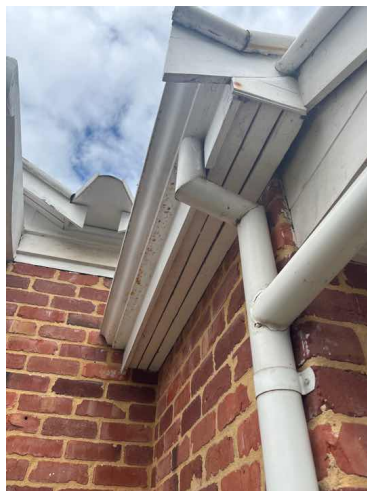
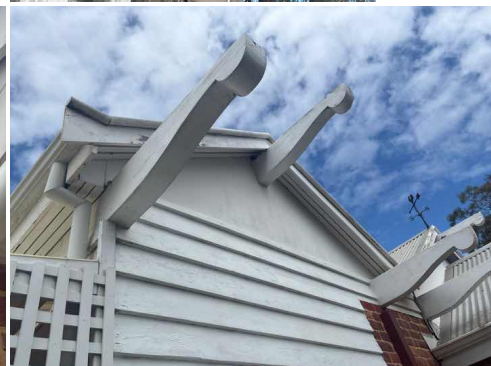
#### Eaves / Linings

No cracking observed - typical age related defects.

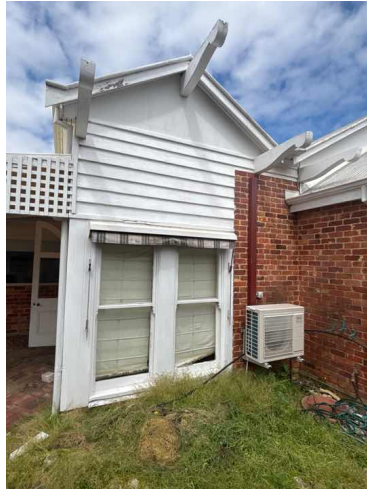
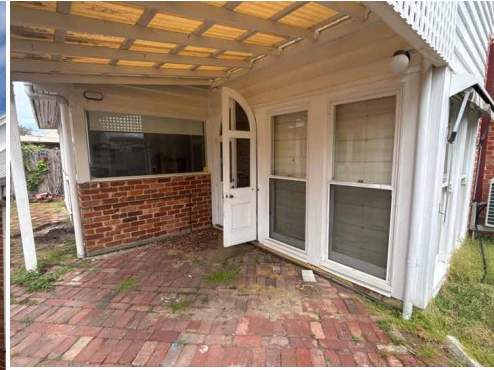
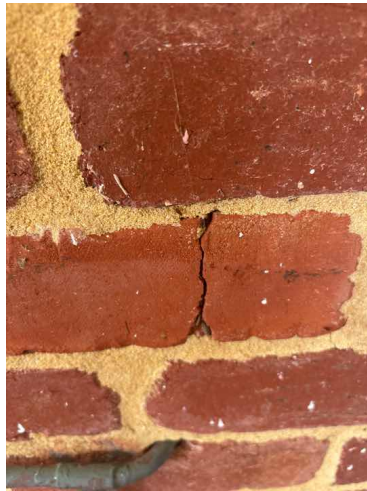
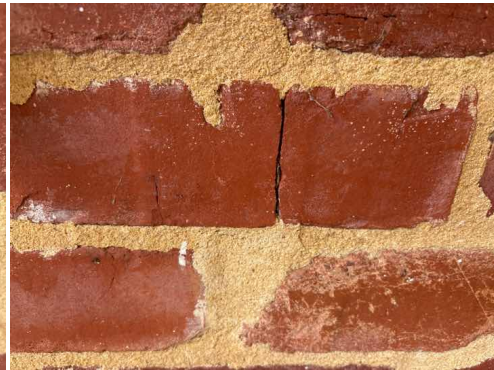
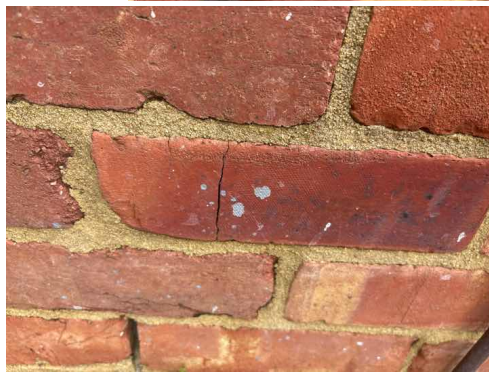
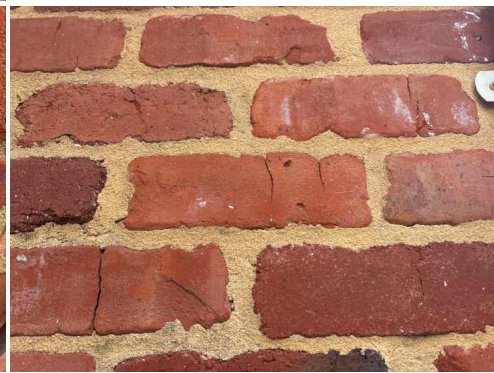
## Walls

Numerous Hairline mortar cracks observed.

Cracking 0.01mm - 0.5mm

Brick cracking to areas observed.

Not considered to be of structural concern.

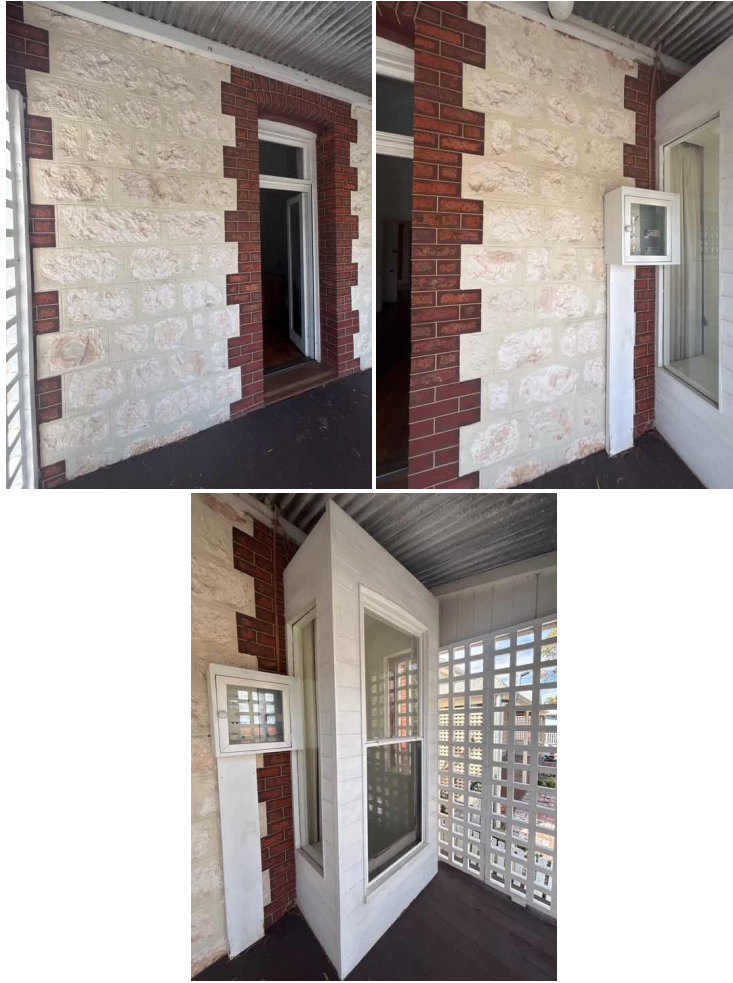
### **Walls**

No cracking observed.

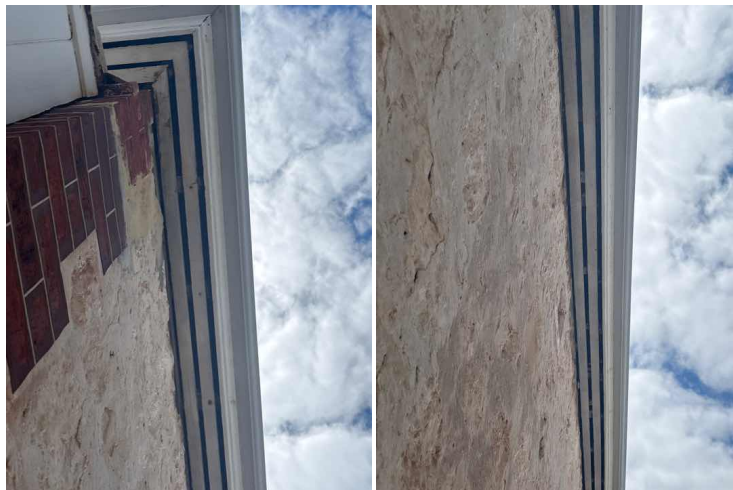
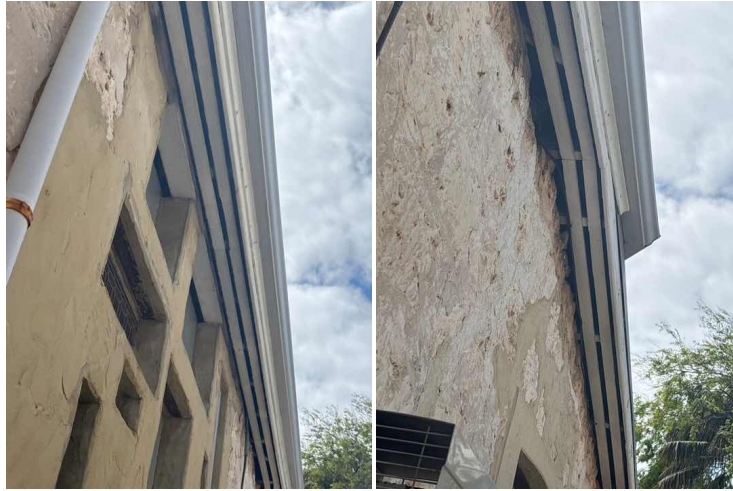
### **Eaves / Linings**

No cracking observed.

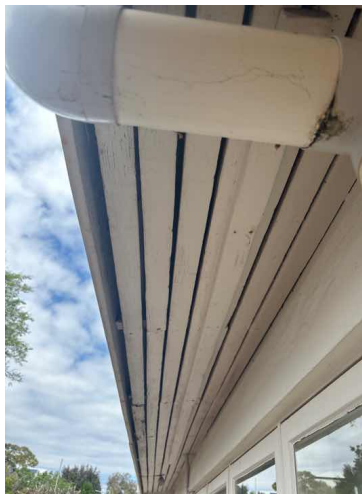
### **Eaves / Linings**

No cracking observed - Age related defects present.

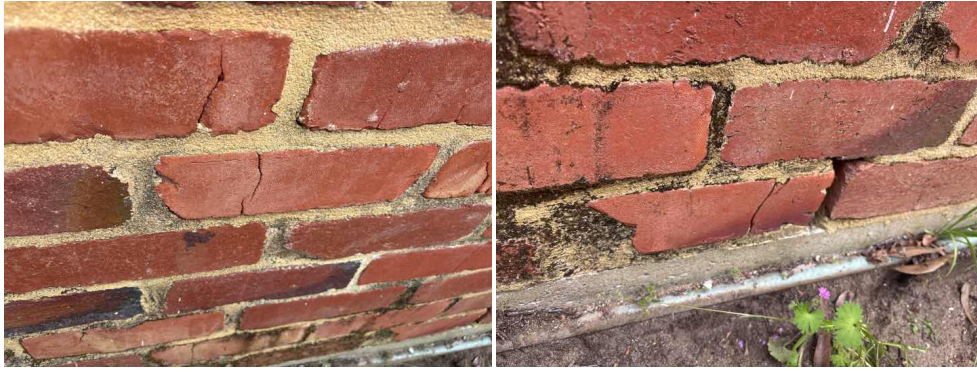
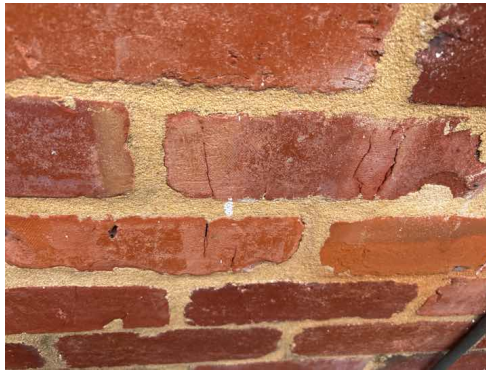
### **Walls**

Brick cracking to areas observed.

Not considered to be of structural concern.

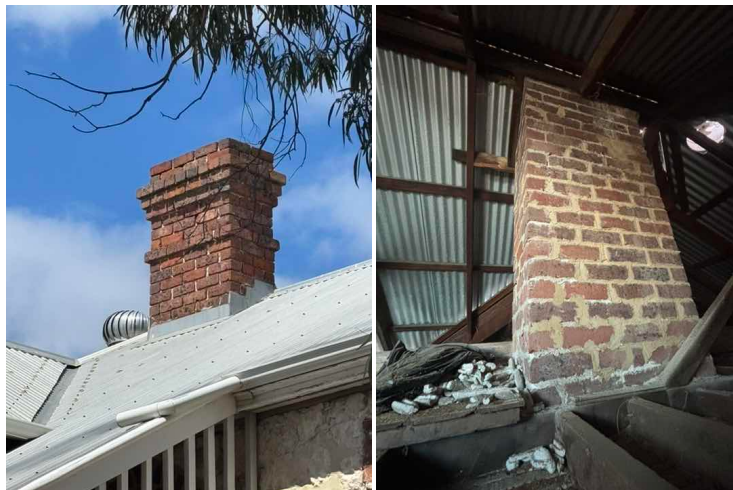
### **Brickwork**

No cracking observed.

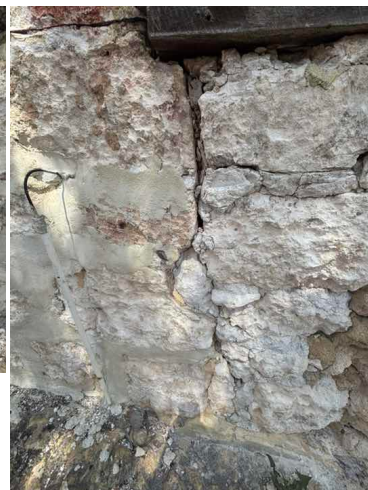
### **Walls / Base Walling**

Areas of mortar / limestone block deterioration noted.

This is age related - With cracking and movement observed.

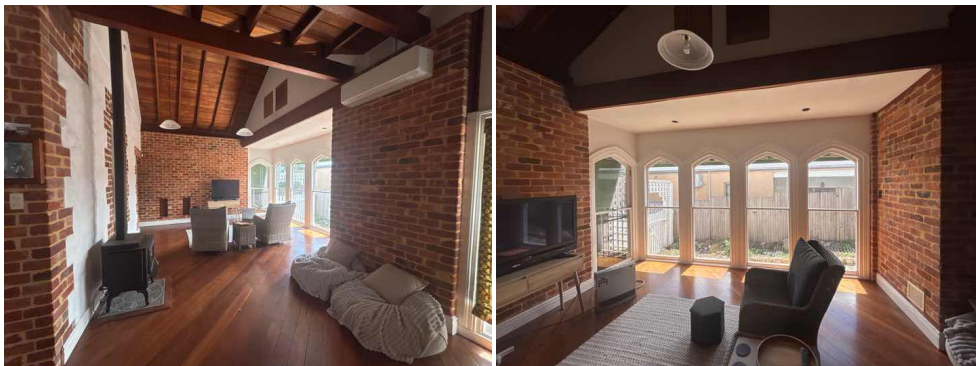
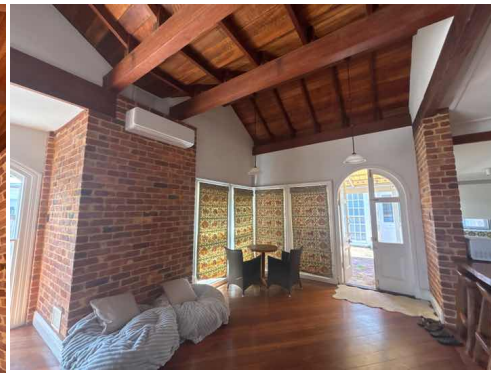
### **Overview**

No cracking observed

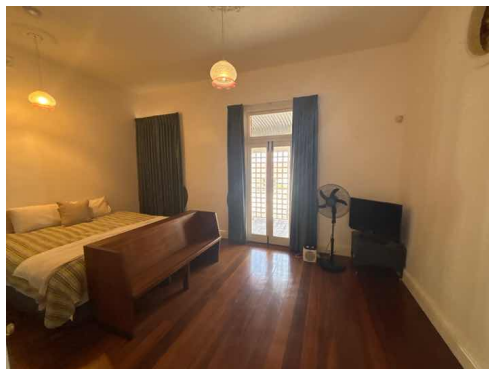
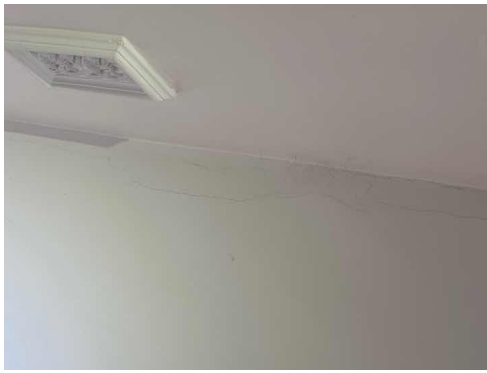
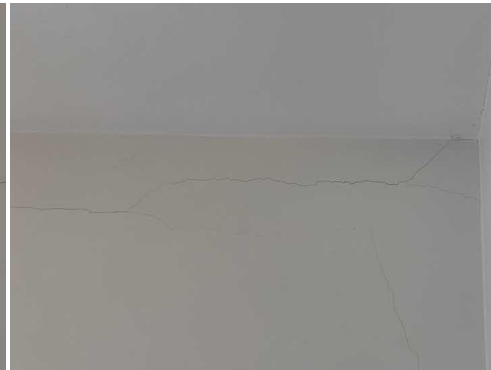
General View

Cracking 0.01mm - 0.5mm

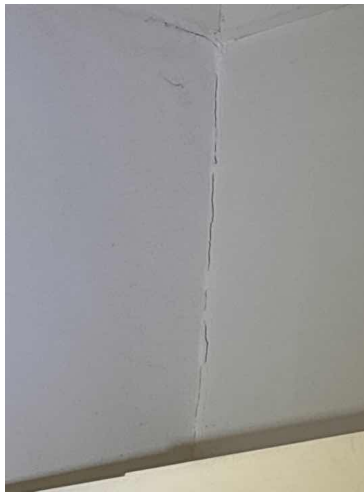
### **Western Wall**

Cracking 1mm - 5mm

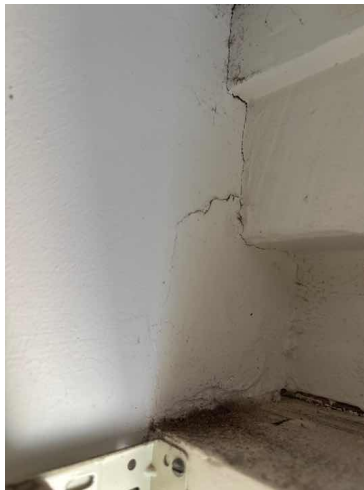
### **Eastern Wall**

Cracking 0.5mm - 1mm

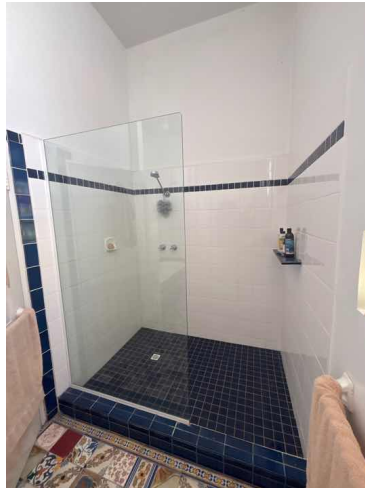
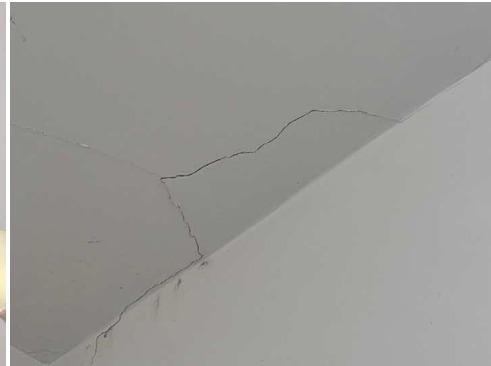
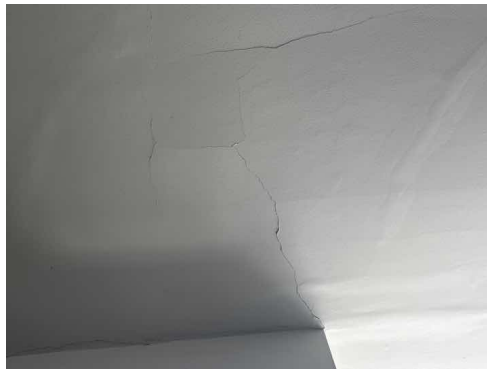
Overview

Cracking 1mm - 5mm

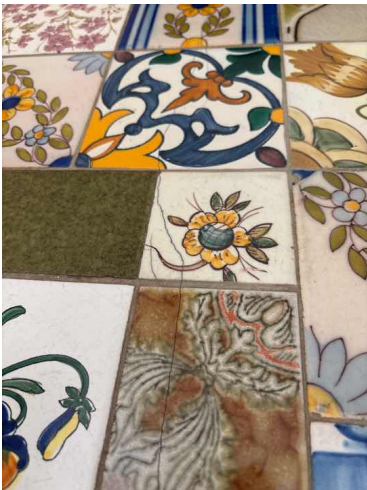
Cracking 0.01mm - 0.5mm

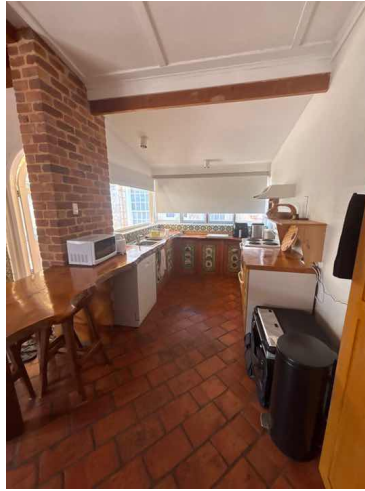
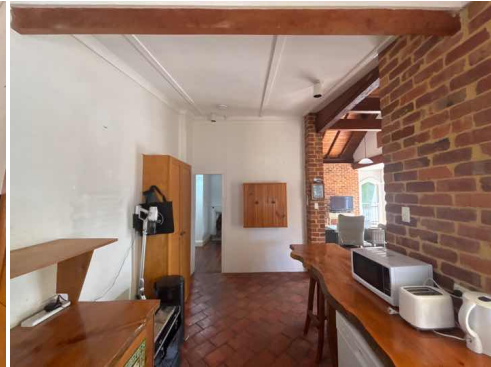
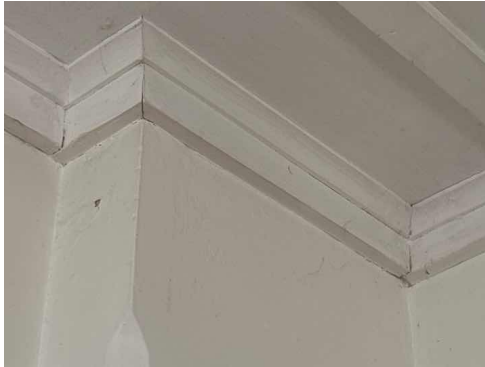
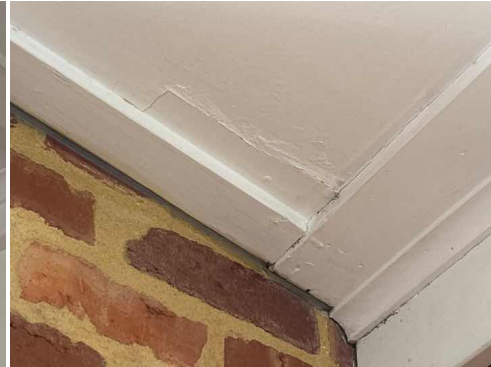
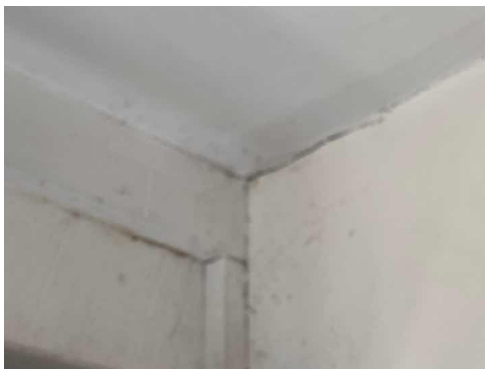
General View

Hairline crack less than 0.01mm

Cracking 0.5mm - 1mm

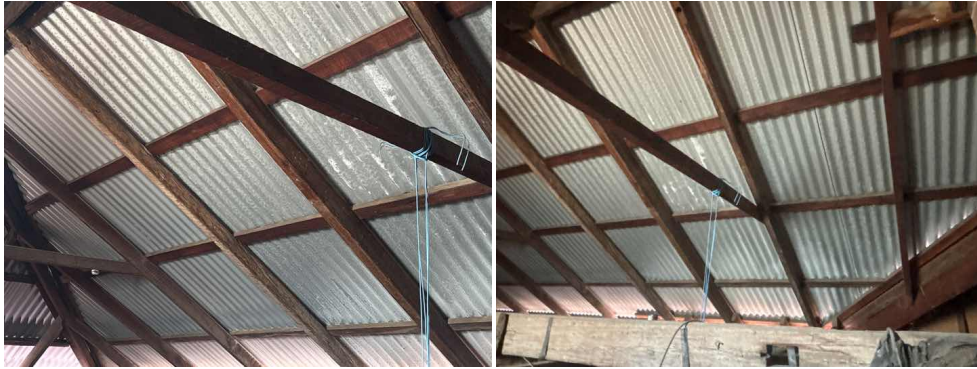
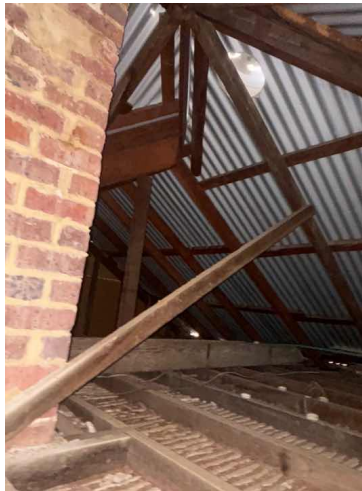
#### Northern Wall

No cracking observed

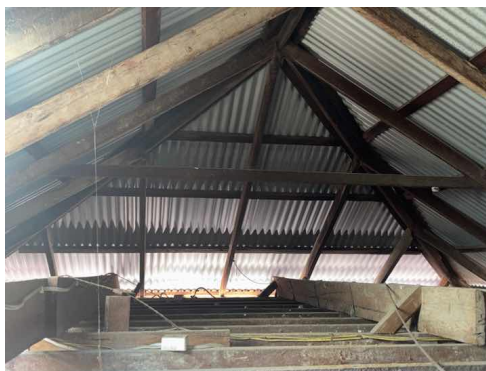
#### Western Wall

No cracking observed

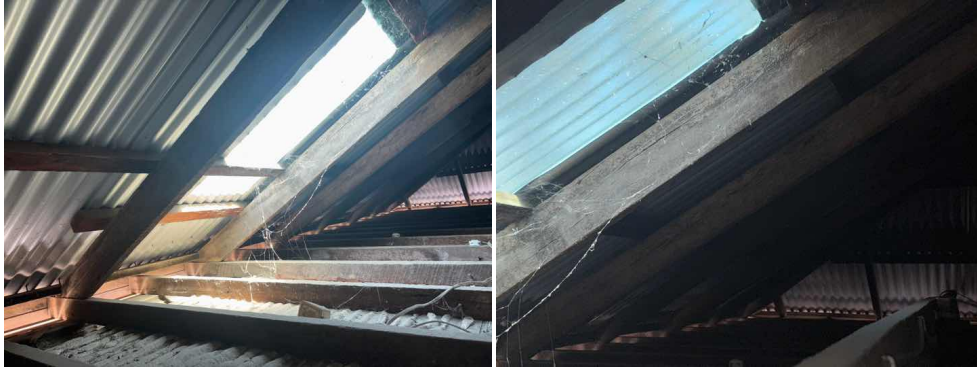
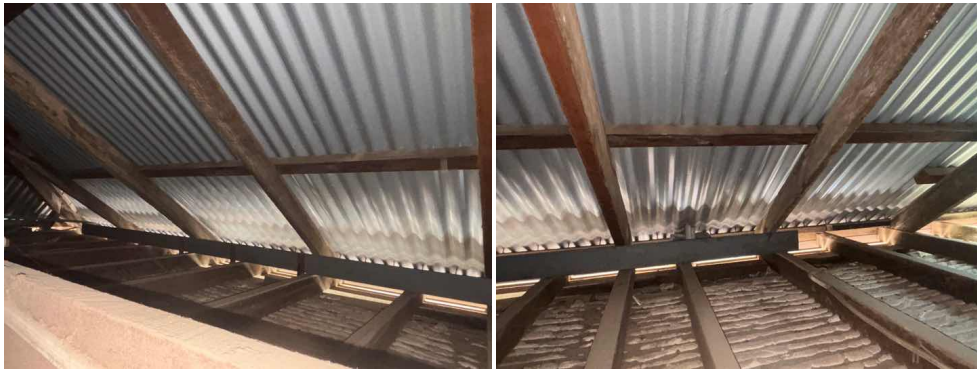
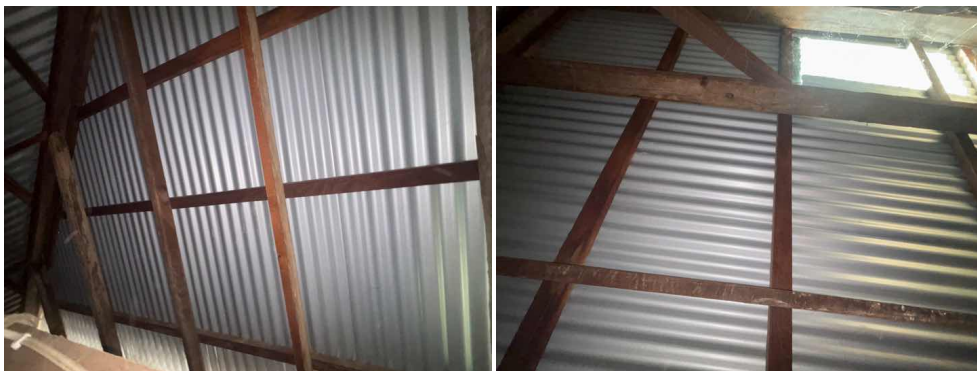
**Southern Wall**

No cracking observed

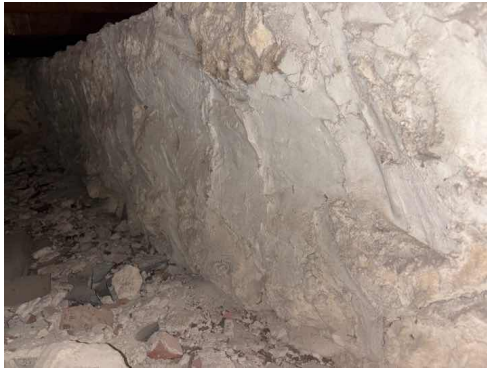
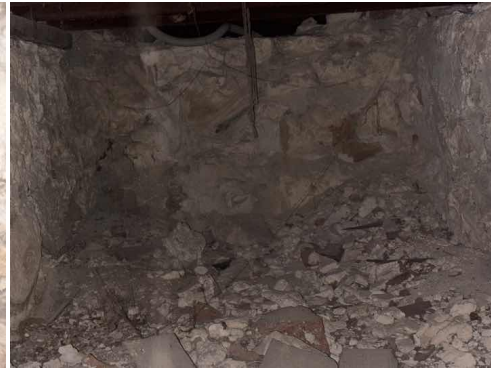
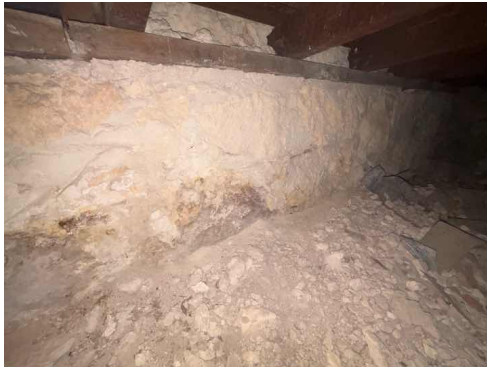
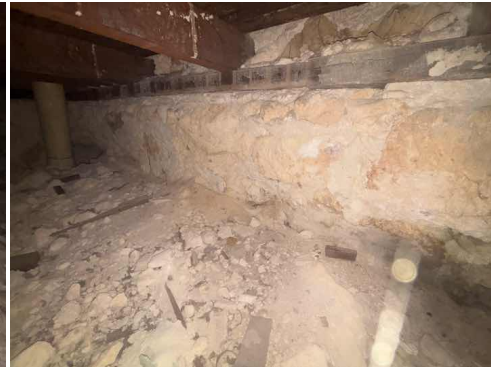
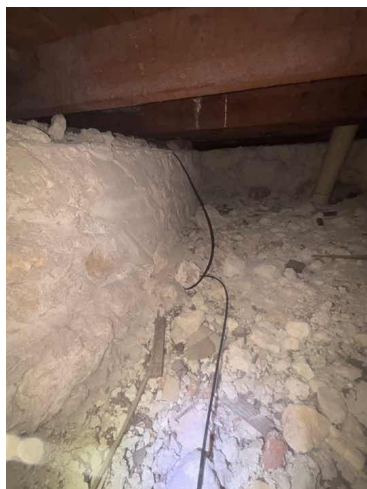
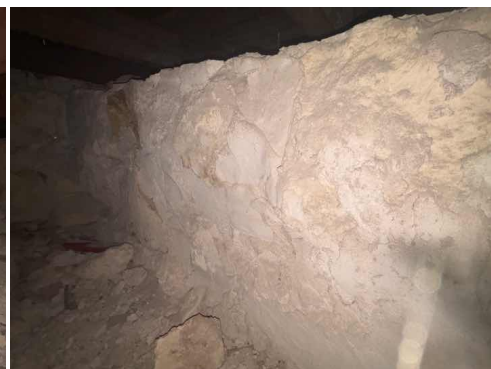
#### Foundations Wall

No cracking observed

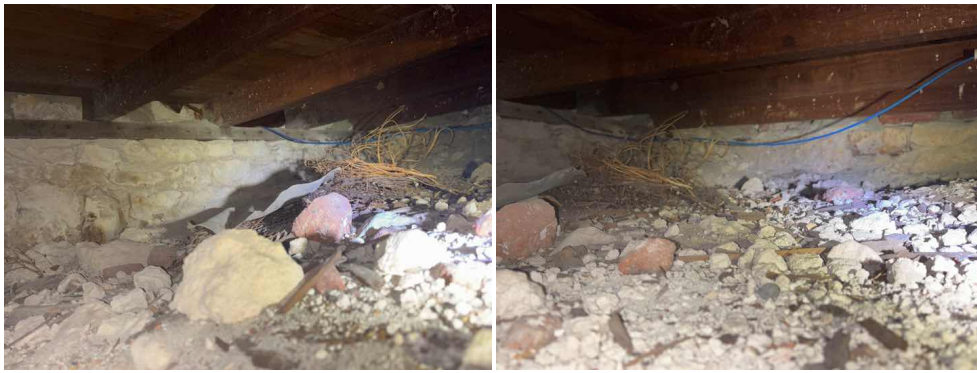
Cracking 1mm - 5mm
